TIN FLAKES/SPLASHES IN SMT

Jose M. Servin, Miguel Dominguez, Tabata Nöthel, Indira Vazquez,
Pedro Juarez, Ivan Roman
Continental

ABSTRACT

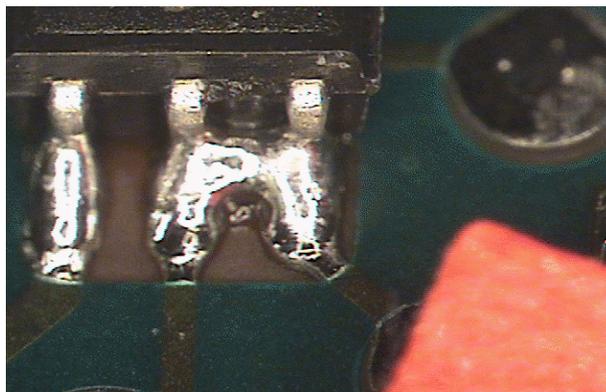
The most common short in SMT assemblies is due to solder excess between two leads or PCB pads. See Figure 1. This mainly happens in solder printing due to several factors, such as, solder excess, solder slump, assembly misalignment in printing, stencil damage, etc.

Figure 1. Typical Short in SMT Lines

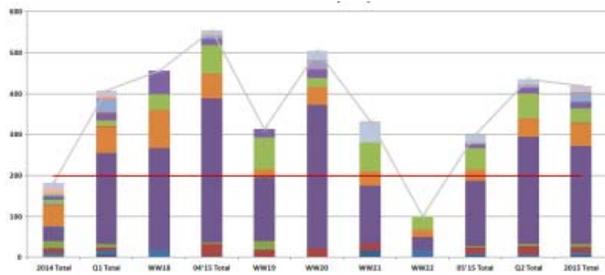
During a specific time period, the shorts reported in back-end testers increased out of the goal. The tester was an ICT which can detect this non-conformity. An immediate action was required according to our internal quality system, see Figure 2.

Figure 2. Increasing of short issues in our indicator, see the purple part of the columns.

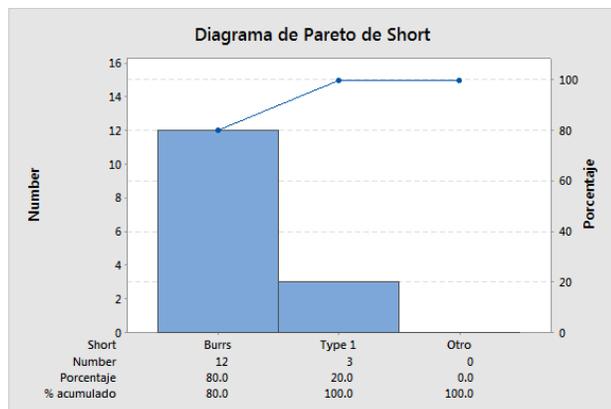
Figure 3. Pareto of short types

80% of the shorts were related to the burrs, see Figures 4 and 5. This type of short looks not related to solder paste because they don't like as solder excess but a better and deeper investigation was needed.

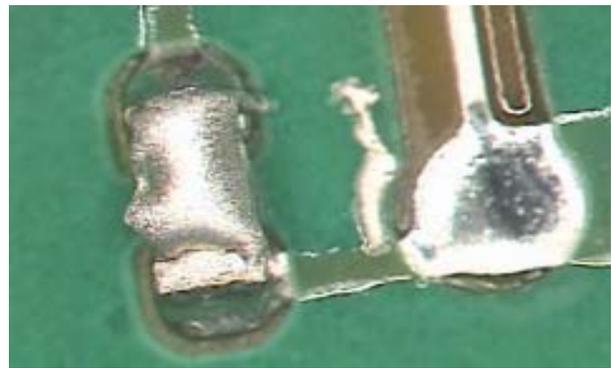
Figure 4. Example of a burr (1)

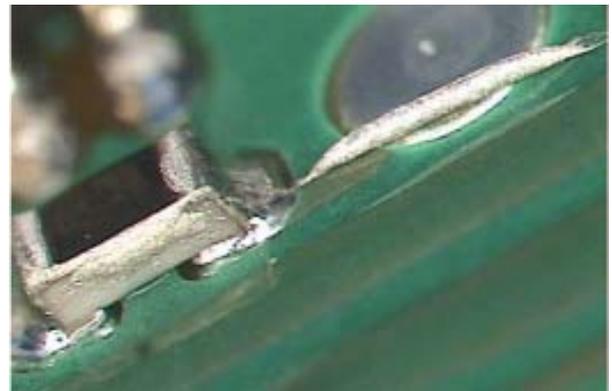
Figure 5. Example of a burr (2)

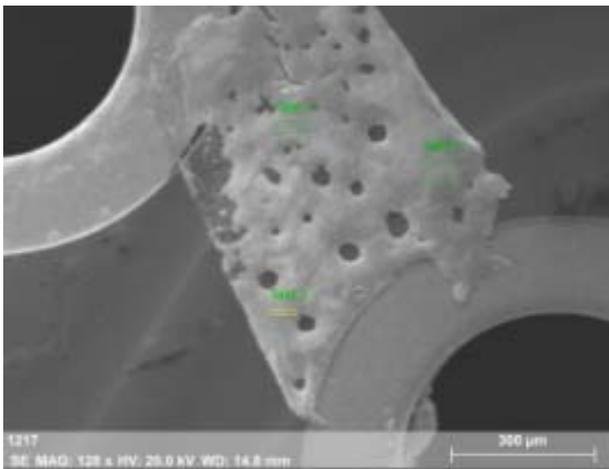
The Scanning Electronic Microscopy (SEM) Analysis shows that the burrs are made of tin mainly with some traces of C, N, and O.

Figure 7. Burr SEM Image

Small amount of Si, Na and Cl are present as traces in some burrs, see Table 1. In the next analyses, these types of burrs have to be found.

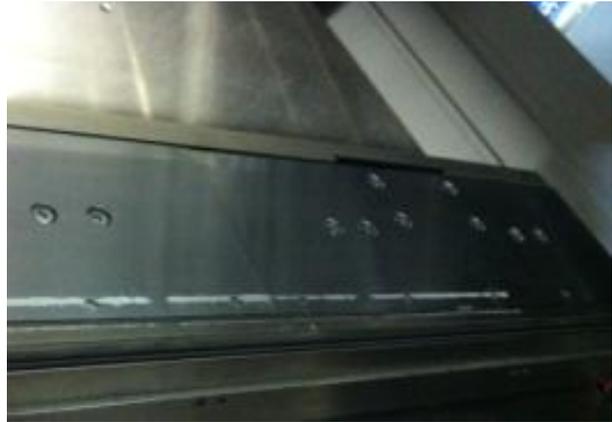
A deep scanning for possible source of metallic burrs was done. Residues from stencil and printing machine were taken, see Figure 8 and 9.

Figure 8. Printing Machine Residues

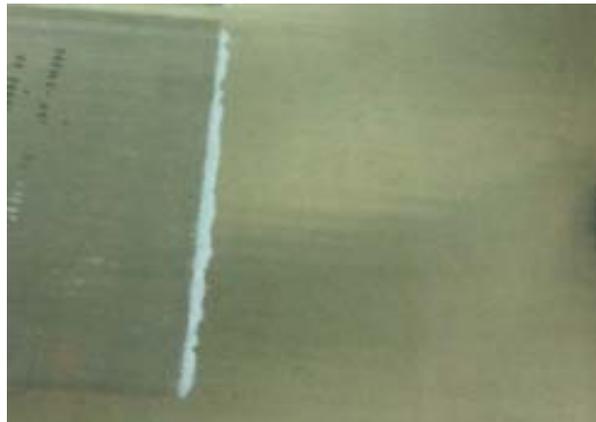
Figure 9. Stencil Residues

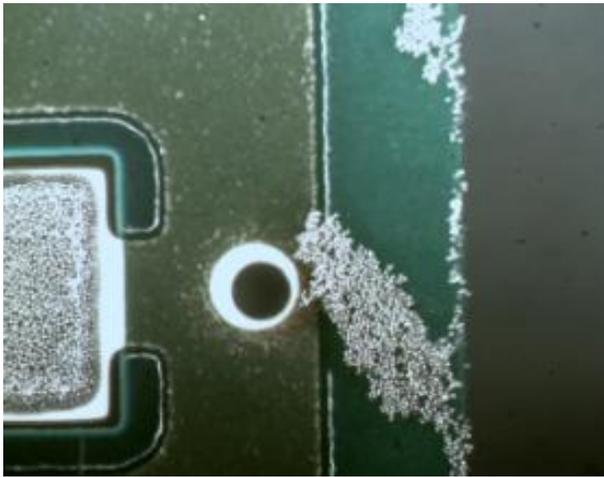
Figure 10. Residues before reflow

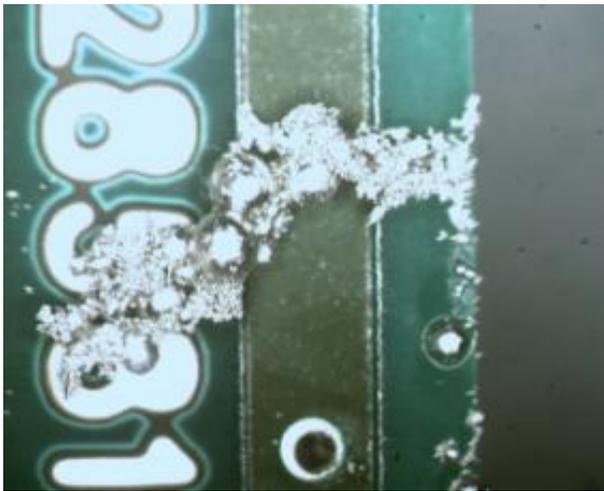
The residues after reflow are melted forming solder balls. The ball formation is because flux is still active and cleans the oxides to coalesce the solder particles all together. However, because some flux is dry and not so active, the small tiny solder balls cannot melt together and keep dry.

Figure 11. Residues after reflow

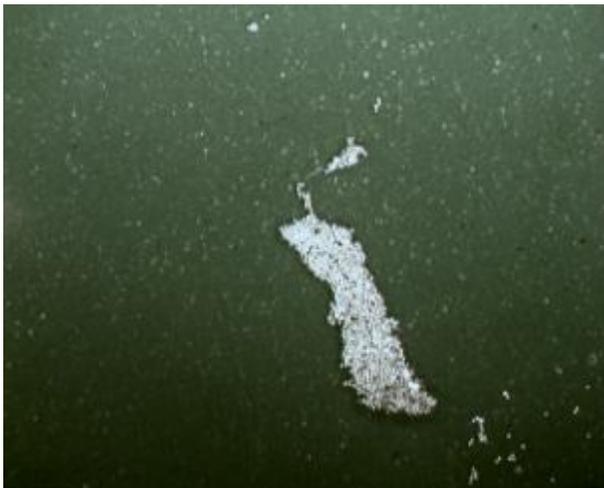
Some residues are too dry, and solder residues are not completely coalesced after reflow. Many tinny balls keep their forms.

Figure 12. Dry Residues before reflow

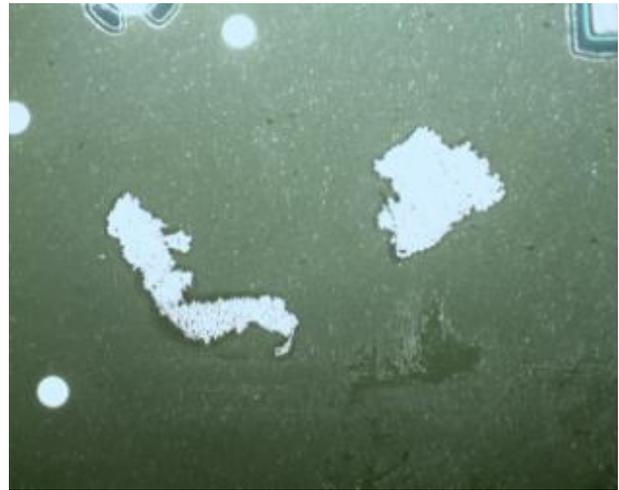
Figure 13. Dry Residues after reflow

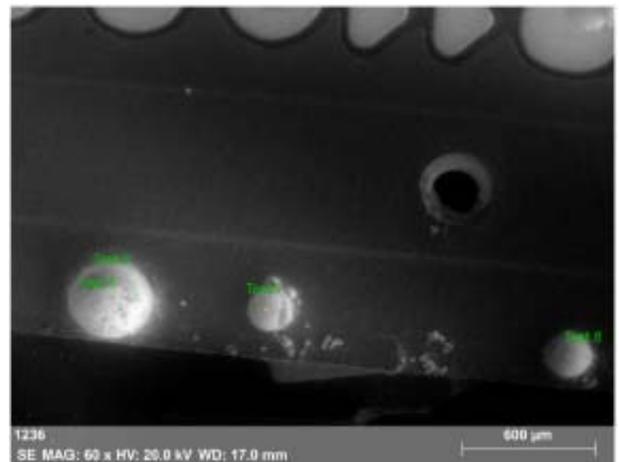
The SEM analysis shows the solder paste residues form solder balls of different sizes. When solder paste is dried, the balls are the same size as the powder (too small). When they coalesced, there is a flux residue around them.

Figure 14. SEM of reflowed solder paste residues

Therefore, solder residues are either dry solder tinny balls or flux-wetted balls but not metallic flakes. This cause is ruled out.

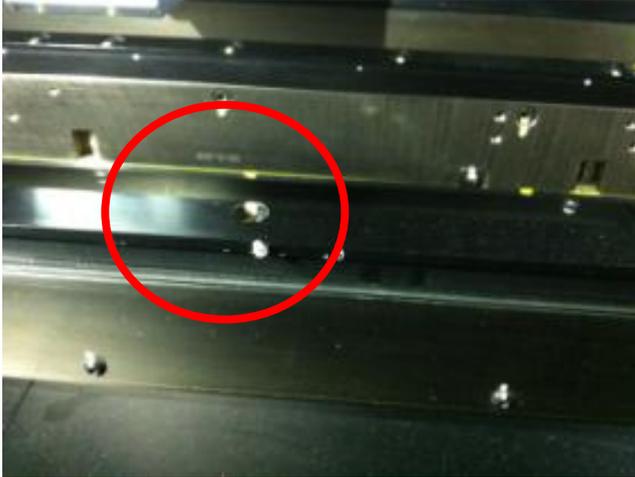
During verification inside of the Pick and Place (P&P) equipment, some solder residues were found, see Figure 15. Solder residues were found in one reel of the pick and place machine due to the clamping. When PCB with solder paste

is hold by the pick and place conveyor, the reel removed some solder paste from the PCB. A pad that is not used by the product (because no component is set on it) had solder paste deposition and was slightly close to one edge. Due to this, solder paste was removed by clamping. The correction was done in the stencil avoiding solder paste deposition on that pad.

Figure 15. Solder residues in Pick and Place Equipment

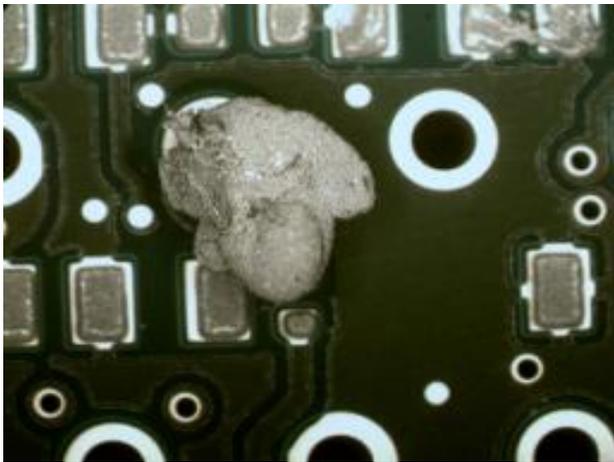
Figure 16. Pick and Place residues before reflow

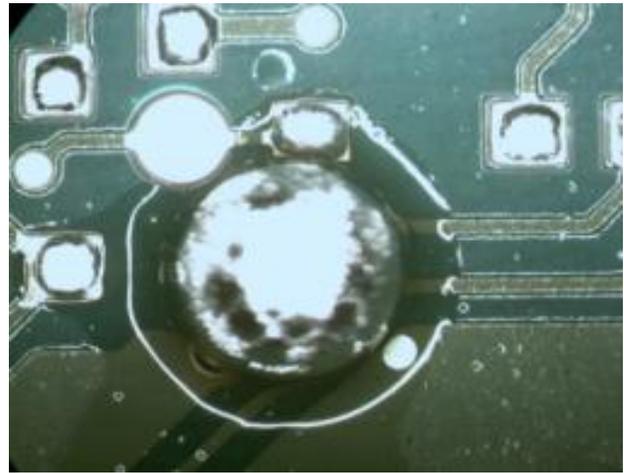
Figure 17. Pick and Place residues after reflow

Solder residues formed a big ball with a lot of flux around it. The form and size don't correspond to the metallic flakes, so this cause was ruled out.

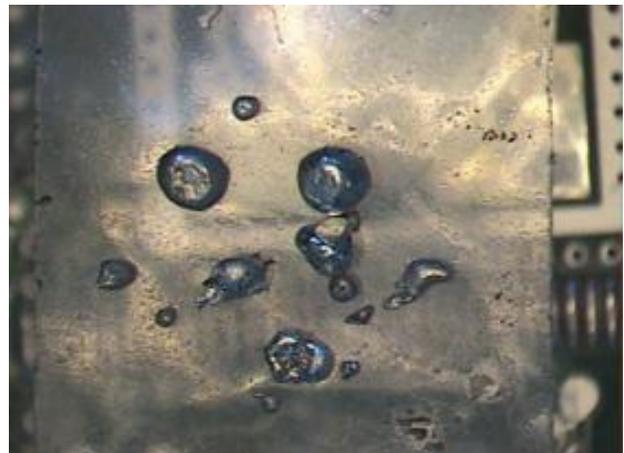
The particles created during rework are big and with volume, and not are flat or shaped-irregular. They are not flakes. In some case, the solder residues from rework are similar to solder webs but not flake shape again.

Figure 18. Rework residues from the iron tip sponge

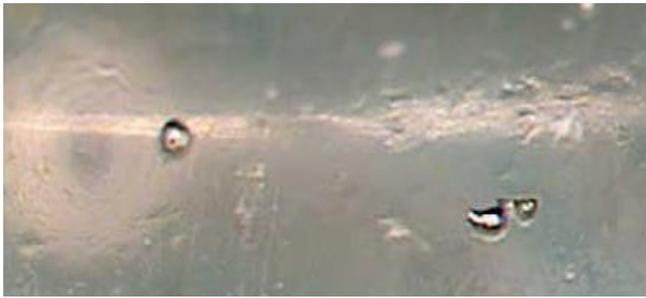
The residues from rework are without clear flux excess. Their edges are rounded or the residues are like solder ball. An example is shown in Figure 19.

Figure 19. Typical Rework residues

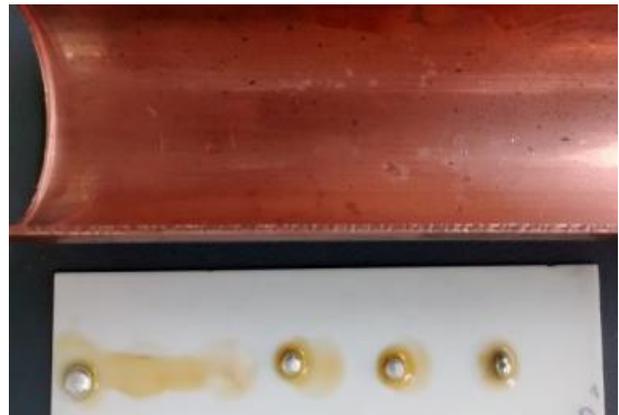
Figure 21. Results of the experiment to verify the contribution of solder ball/splashing from the solder paste

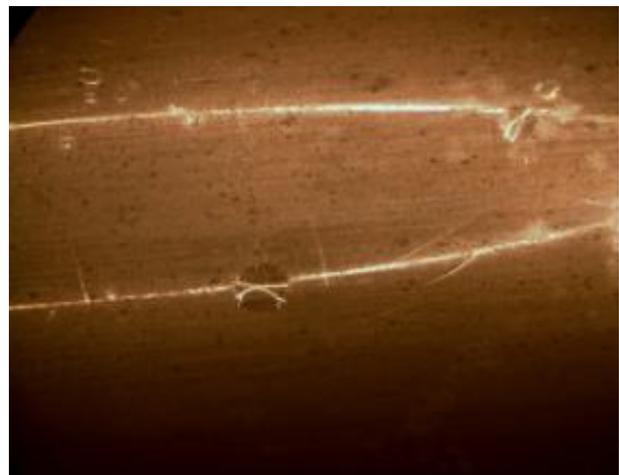
The residues adhered on the copper found can be divided into two groups: flux and solder balls. The flux residues can be in Figure 22 and is only flux splashing and not causing any issue. The solder balls of similar size to solder powder are shown in the Figure 23 and are too small to cause any issue. They are not similar to the problematic metallic burrs. This cause is ruled out too.

Figure 22. Flux splashes

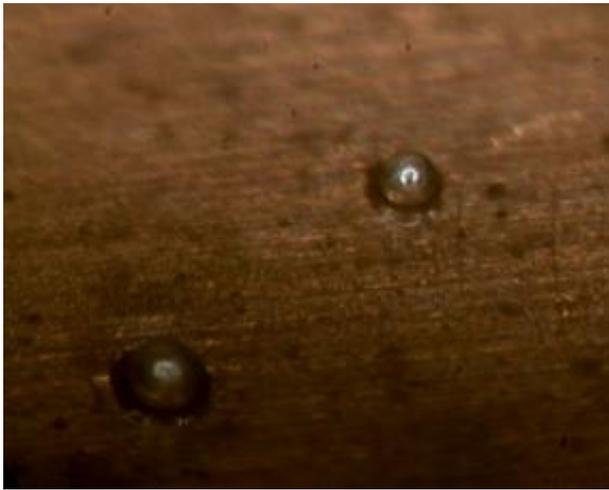
Figure 23. Tinny solder balls found on the copper pipe

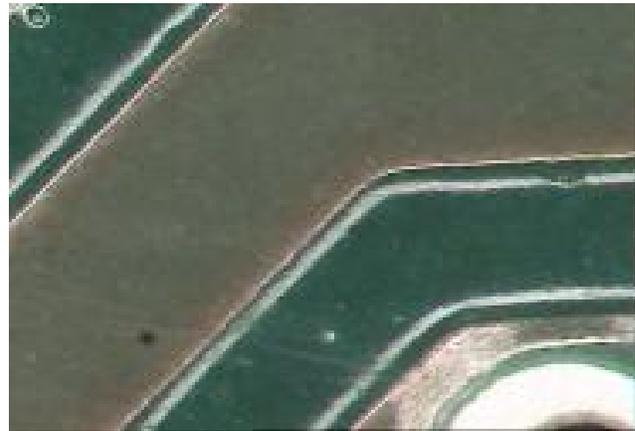
The results show, see Figure 24, the PCBs contain a few tiny and small burrs in all combinations. None of the PCBs contained large or significant particles to make a short circuit. Some contaminations such as solder resist residues were found, but none of importance for the purpose of the test. No relationship between Burr and Production line of PCB were found.

Figure 24. Results from PCB DOE

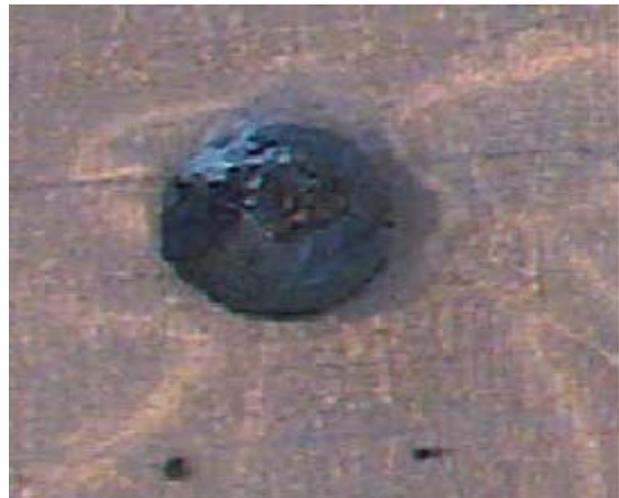
It is interesting that several types of residues were found. Because of that, completely the oven was inspected were PCB go through. Some residues were even found on the top side of the heating zone (This means the top hot plates). An example of this is shown in Figure 25.

Figure 25. The solder balls found inside of the oven in the peak zone show dark color due to the high temperatures.

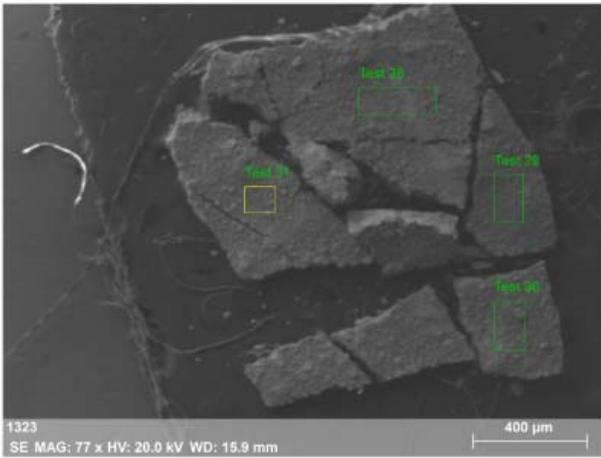
Figure 26. Crust found on the bottom plate of the reflow oven

On the bottom and top plates, several solder crust were found. In the Figure 26, you see an example. It is formed of tin mainly as EDX results show, see Table 6. But there are traces of Si and Al, elements found in the oven hot plates.

Another observation is the crust tin is reacting to the aluminum of the conveyor and oven plates forming a new alloy (tin-aluminum) due to the high temperatures in the zone. An issue found is the new alloy can be easily detached from the surface and it is deteriorating the oven.

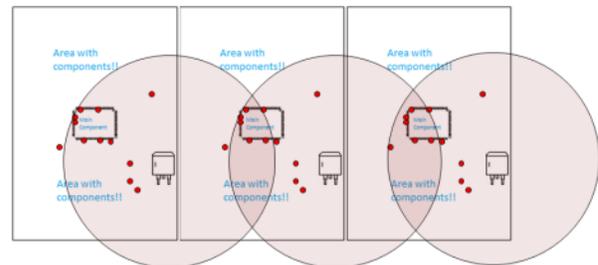
In Figure 28, the location of burrs causing shorts is shown. As we found, one component is in the center of the possible affecting area. This component is a D2PAK power transistor.

Figure 28. Analyzing what possible source of burrs is

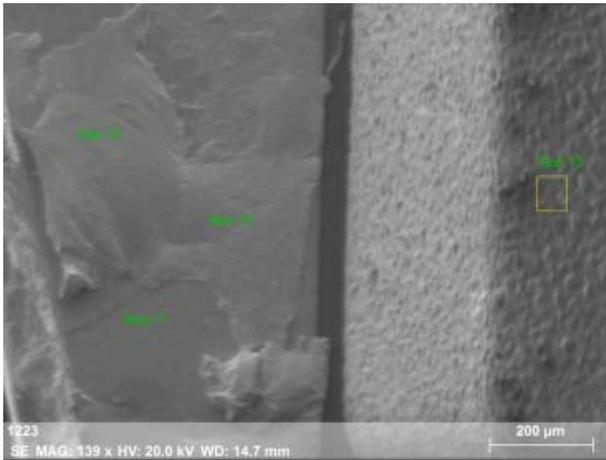
The analysis of the possible problematic component unveiled, that the tin surface of several parts after reflow showed a detached metallization. This means the tin metallization is lost in these areas, see Figure 29 and Table 7. However, in order to prove, some reproduction tests were proposed and made.

Figure 29. Component SEM Analysis (After reflow)

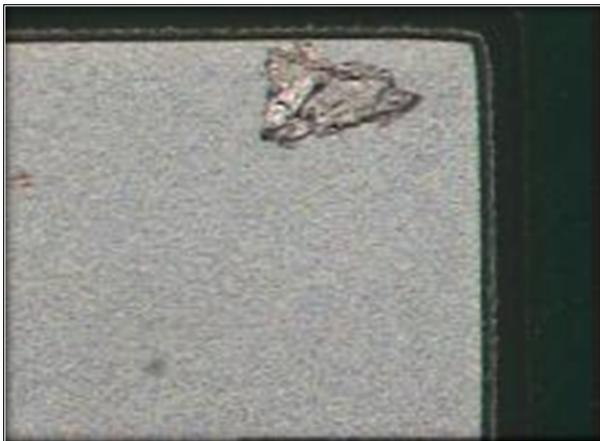
Figure 30. Results of Test 1

The results of the Test 1 show the presence of several metallic burrs around the components. The Figure 30 comes from the test 1. This means the component was losing metallization and was expelling metallic burrs around it.

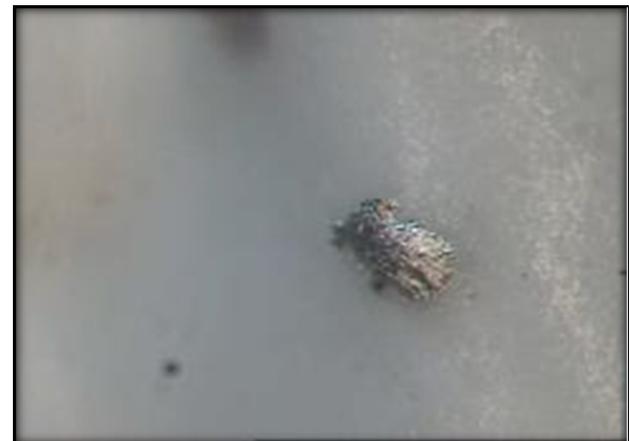
Several metallic burrs were also found in the second test. Most of them were found close to the component on the aluminum tape, but some also were found on the copper pipe surfaces.

Figure 32. Metallic Flake on the Al tape

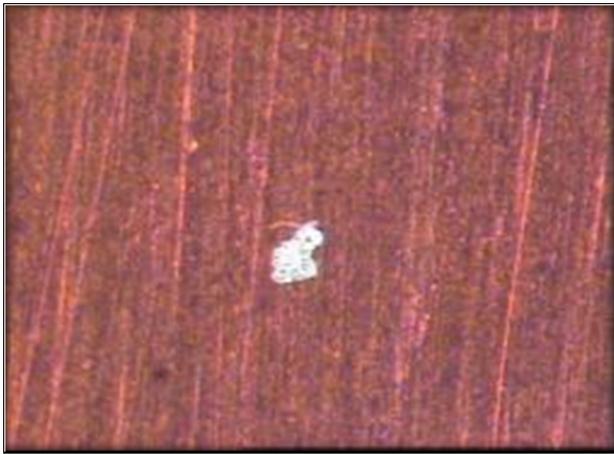
Figure 33. Metallic Flake on the Copper pipe

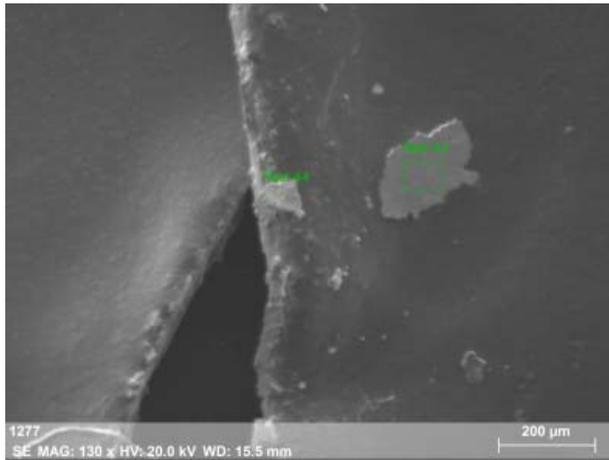
The particle analyses from the last two tests have shown similar results. The particles or flakes are made of tin, almost pure tin with some amount of oxygen and carbon, highly similar to one found in the shorts, see Table 8.

Figure 34. SEM Metallic Flake from Test 2

The source of the flakes is the D2PAK component metallization. In order to reduce the non-conformities a containment action was set: the suspicious date code was removed.

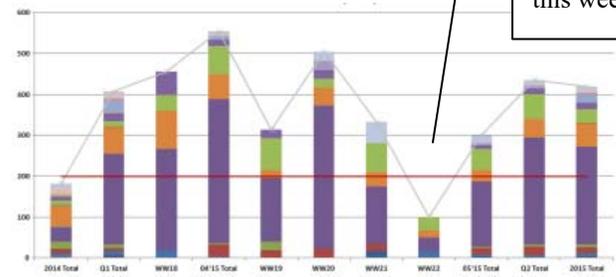
Figure 36. Reduction of the shorts after the containment action. The purple part is the short index.

After not using the affected date codes, there was a strong reduction of shorts. The containment action was useful but the root cause was unknown yet, see Figure 36.

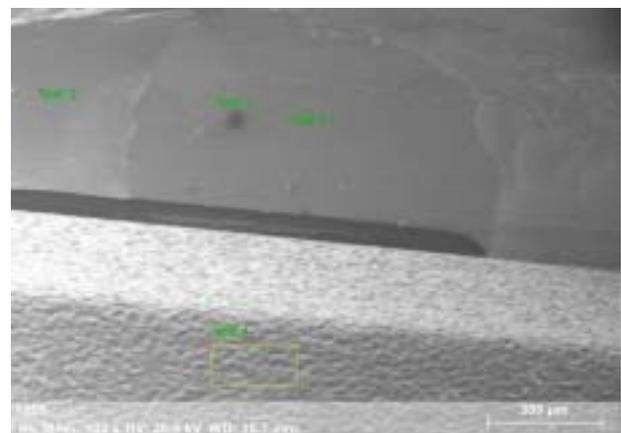
After several discussions and experiments with the component supplier, it was found the activation surface process was the one with more influence on the issue.

The activation process prepared the surface before the tin electroless process. If this process is not done correctly or is less efficient, a possible oxidation or contamination exists between base metal and metallization. Consequently, the metallization is poorly attached. See Figure 37.

Figure 37. Detachment metallization due to poor activation surface

In order to improve, a better activation process was selected by the supplier. This improves the quality indicator in the plant. This helped to reduce the presence of this type of burrs in the shorts.
