Bare Board Material Performance after Pb-Free Reflow

Abstract:

The High Density Packaging Users Group (HDPUG) consortia completed an extensive study of 29 different bare board material and stackup combinations and their associated performance after 6X Pb-free reflow at 260°C. Data presented will focus on the air-air thermal cycling, IST testing and material survivability after Pb-free assembly reflow portions of this testing. Test board design aspects, manufacturing processes, Weibull analysis, and failure analysis data will be presented. The impact of plated through hole pitch on laminate integrity and how material properties relate to the results will be discussed.

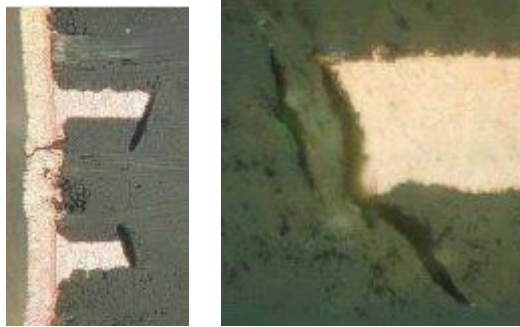
Figure 14

Eyebrow cracks (see Figure 14) were found at the outer periphery of some internal lands. These tend to occur at what appears to be the copper-to-resin interface along most of the vertical portion of the end of the internal land. These often extend for a short distance in a generally diagonal pathway above and/or below the unused land and/or may extend for a short distance along the horizontal interface between the land and the laminate.

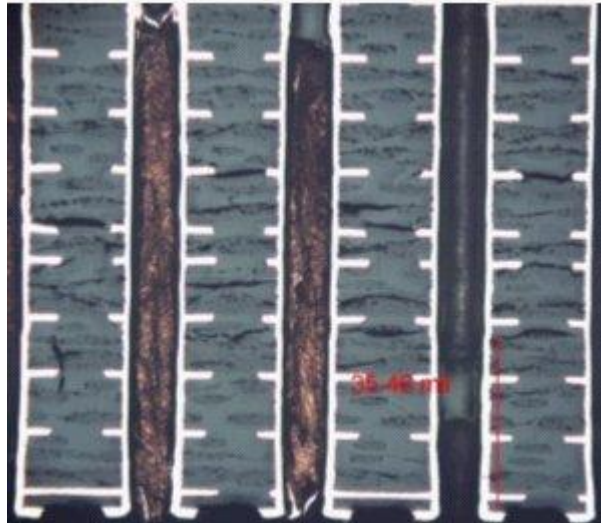
Figure 15

Longitudinal cracks (see Figure 15) extend horizontally (often completely or almost completely) between adjacent vias. These are seen in one or more layers within a given cross-section. These occur within layers that are within the middle third of the stack-up, with a predominance of these being near the center of the stack-up. The majority of cracks include at least some vertical component, sometimes following the sinusoidal pattern of the glass bundles. Besides being at the glass-to-resin interface, these may exist within the resin and/or at the copper-to-resin interface and/or at the core-to-prepreg interface.

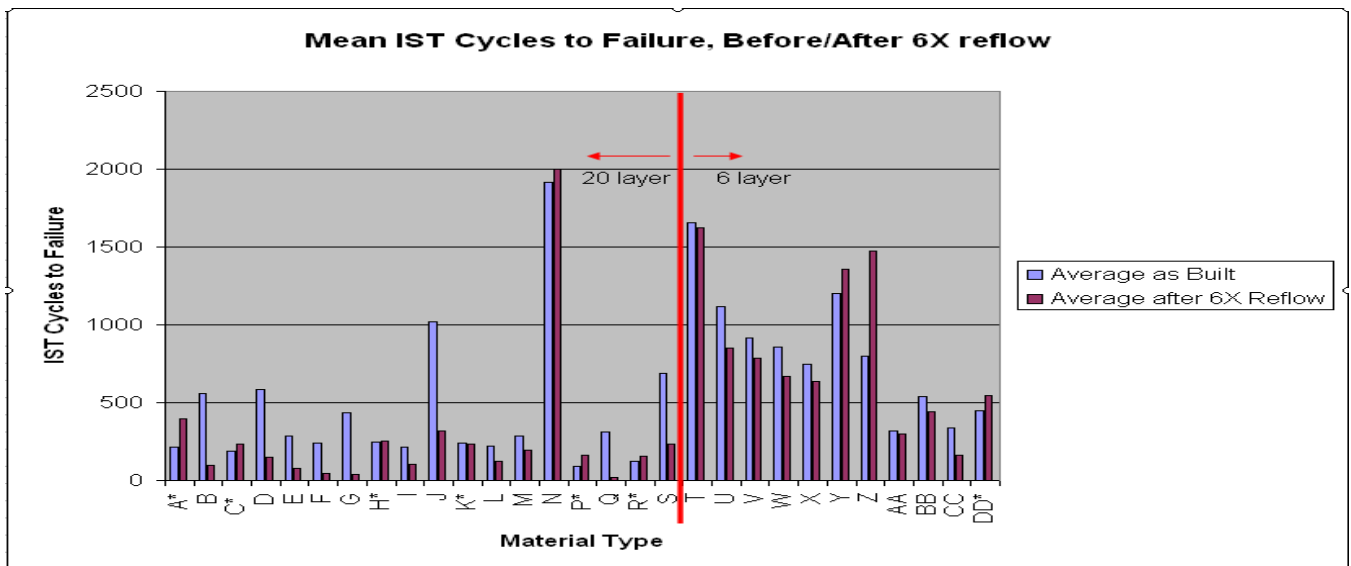
Figure 20: Mean IST Cycles to Failure before and after 6X@260°C Reflow (Asterisks indicate materials that improve after reflow – a probably indication of delamination)
