## **DIELECTRIC MATERIAL DAMAGE VS. CONDUCTIVE ANODIC FILAMENT FORMATION**

Paul Reid M. Sc.  
PWB Interconnect Solutions Inc.  
Nepean, Ontario, Canada  
paul.reid@pwbcorp.com

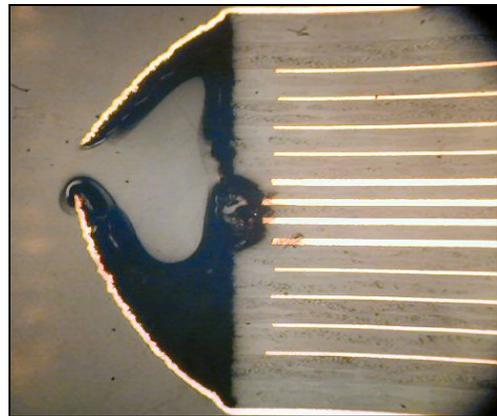
Photo 4. Example of a CAF Short

Photo 4 is an extreme example of a short that occurred in a circuit board that failed for CAF. The board was in use when it burnt up. It is obvious that a CAF formed between the internal power layer and the PTH, the short circuit was robust enough to melt the plated copper and scorch the dielectric material.

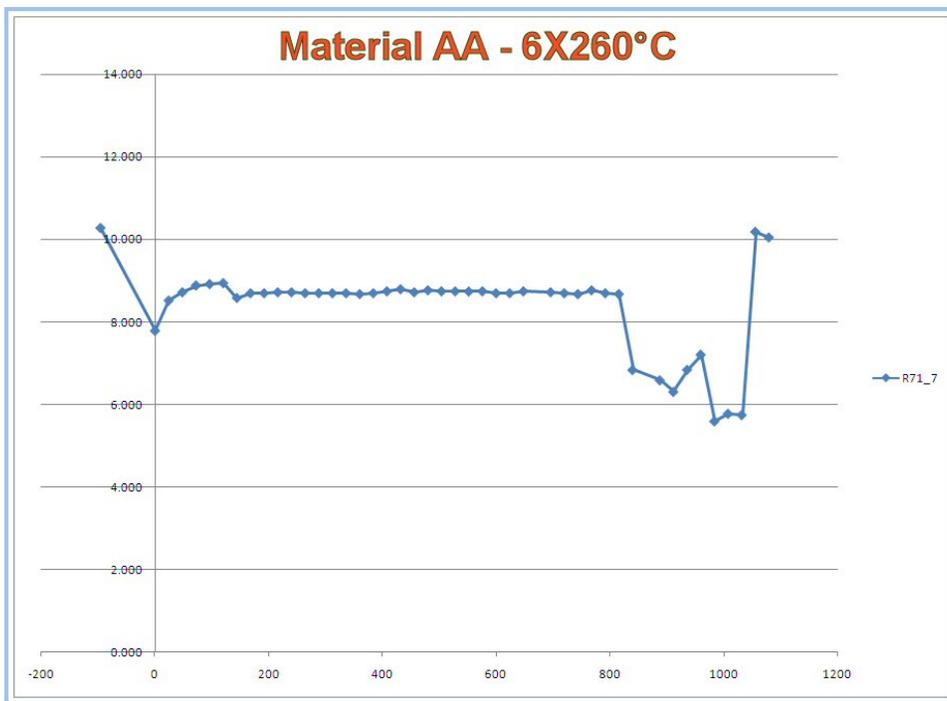
**Graph 2. Material AA –Failed 800 Hours**

The graph 1 below represents material “D” which did not have a failure after 1000 hours in the humidity chamber. The graph 2 is of material “AA” which demonstrates a CAF failure some time after 800 hours.

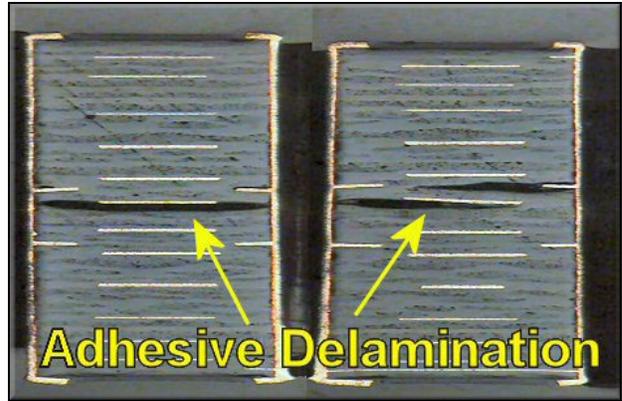
Photo 9. Microsection image of Adhesive Delamination

Adhesive Delamination is a separation between two laminated surfaces. It is usually between the B-stage and C-stage, B-stage and copper foil or between the glass bundle and the adjacent epoxy. This type of failure looks like a blister on microsection and usually ends in a single point that rarely branches. This is the only type of material damage that can respond to baking by driving down the amount of volatiles, like water, that are absorbed within the dielectric material. The problem is it is rare that baking will avoid the risk of delamination.

It is suggested that baking at 105°C for four hours is adequate to remove most of the latent moisture. Baking for a longer time or at a higher temperature can cause a degradation to the material that could increase the level of internal material damage.

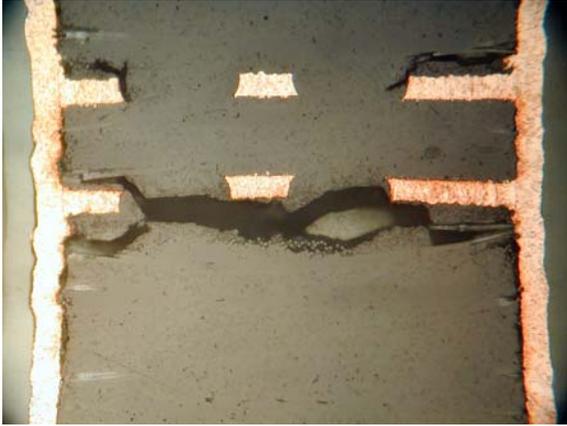
**Photo 10.** Example of a Gross Cohesive Failure (Material JJ)

Cohesive cracks tend to produce cracks in the epoxy that go through the C-stage, B-stage layers and glass bundles. These cracks tend to go off in any direction and frequently branch, ending with multiple points. What appears to happen during multiple high temperature exposures is the material becomes over cross linked, shrinks, builds up stress and then ultimately cracks.

There are many factors that cause cohesive failure, like problems in lamination or material that is beyond its shelf life. One of the most common causes is lead/free assembly and rework. Assembly temperatures of 260°C are at the limit of what most modern, FR4, materials can withstand. Of the 24 material tested we had 15 that showed various degrees of material damage, cohesive cracking was the most prevalent in this study.

When confronted with cohesive failure one should consider changing the material to one that is more robust in your assembly environment. Also it would be prudent to limit the temperature and the number of thermal excursions that are used for assembly and reduce the need for rework cycles. The goal of the assembly profile is to achieve a reliable solder joint at the lowest temperature possible.

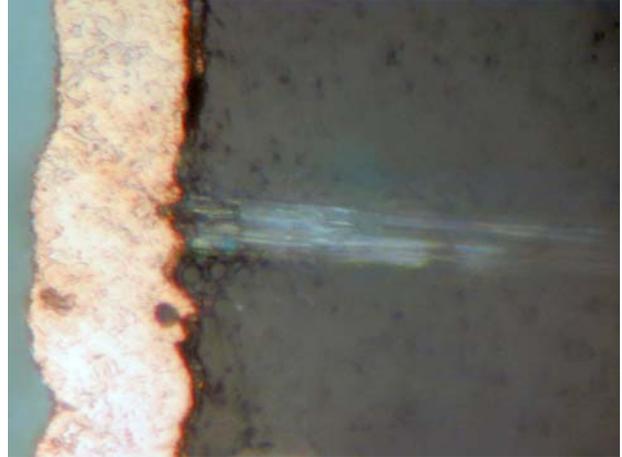
**Photo 11.** Example of Wicking (Material JJ)

Crazing is usually associated with copper wicking at the drilled hole side wall (see photo 11). It appears that there is capillary action that aggressively draws water up the separation between the epoxy and the individual glass fibers.

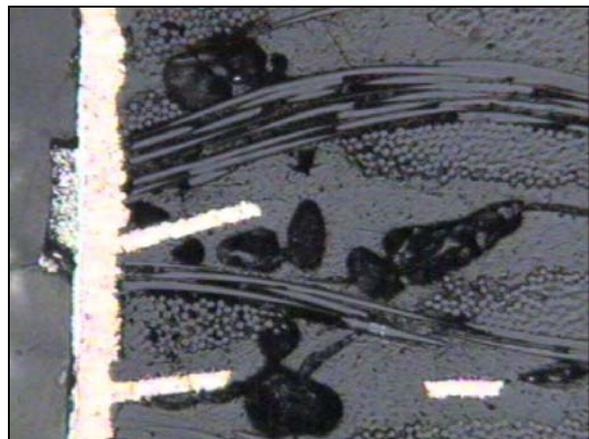
**Photo 12.** Example of Material Decomposition

Material decomposition is visually obvious in that it produces a blackening of the dielectric material and in extreme cases black balls of carbon on the surface of the PWB usually adjacent to holes. This occurs when one uses low end/cost material in a lead free application. This is a rare type of material damage. None of the materials in our study exhibited Material Decomposition.

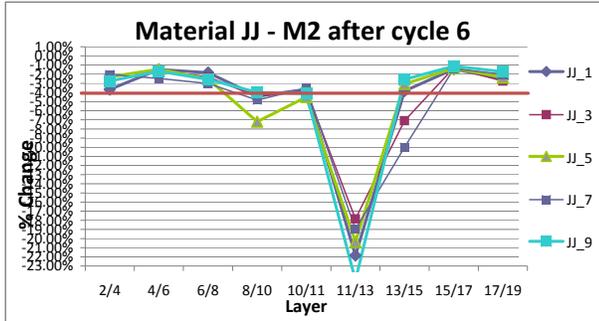
**Graph 3.** Plot of Capacitance by Layer for Material JJ

Graph 3 is a plot of capacitance percent change after 6X260°C preconditioning. Notice that on material “JJ” the majority of coupons measured material damage between layers 11/13.

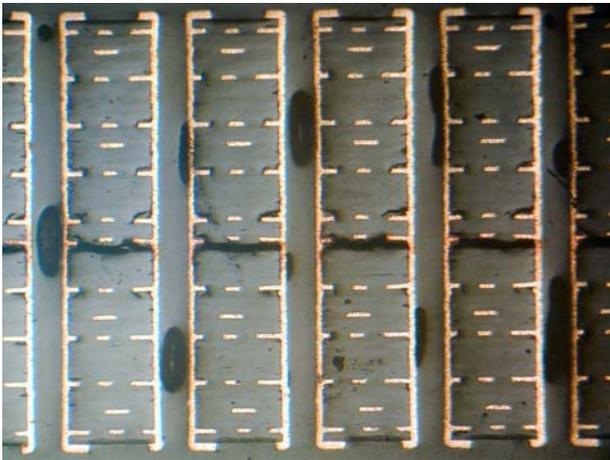
**Photo 13.** Material “JJ” cohesive failure

Photo 13 is a view of a number of holes with material damage visible for material “JJ”. The type of damage exhibited is most likely cohesive failure.

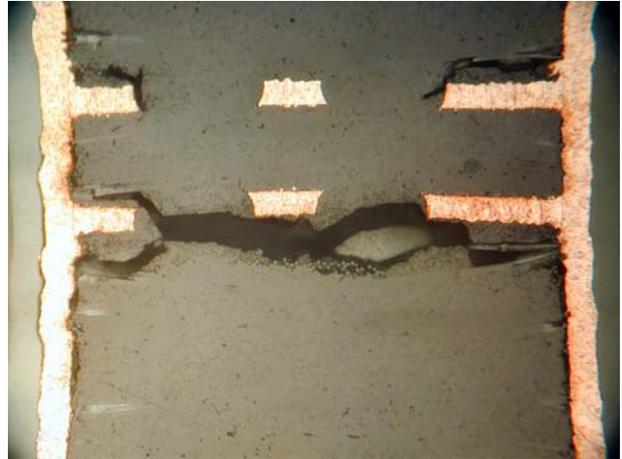
**Photo 14.** Material “C” cohesive failure

Photo 14 is a close up of cohesive failure found in material “JJ” coupon. Note that the material crack is not straight but branches on the left hand side and near the middle.
