Impact of Assembly Cycles on Copper Wrap Plating

Hardeep Heer, Ryan Wong, Bryan Clark - FTG Corporation
Bill Birch, Jason Furlong - PWB Interconnect Solutions Inc.

Abstract:

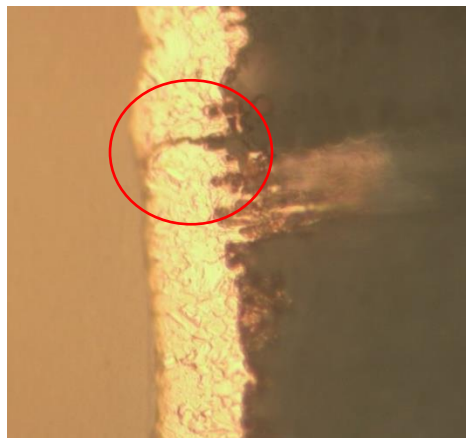
Figure 2 – After 417 cycles

Sections of the coupon that failed at 417 cycles showed that the failure was due to barrel cracking. No butt joint anomaly was observed (see Figure 2).

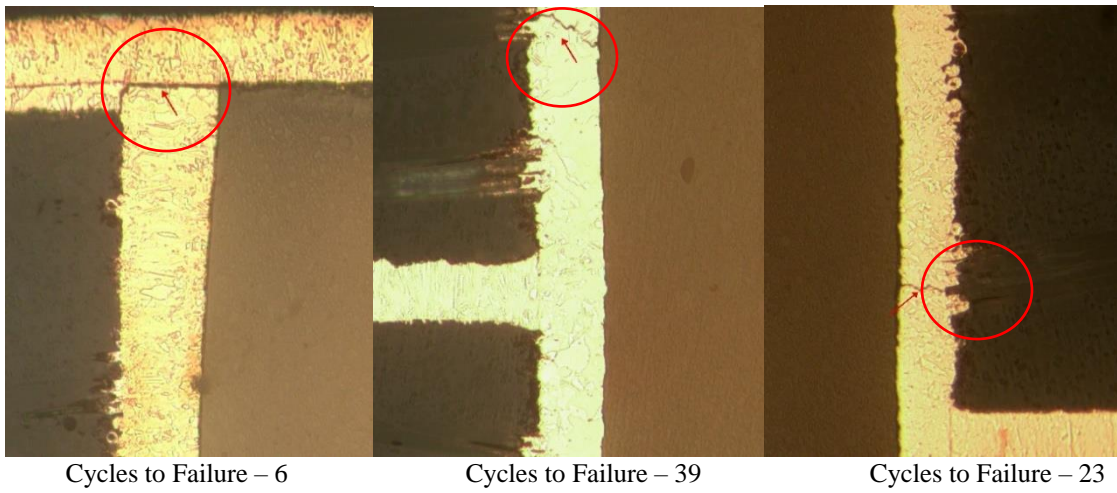
Figure6 – TV- No Wrap

Micro-sections were performed for all three types of wrap conditions for both through and buried vias. For each type the coupon with the lowest, mean and highest cycles to failure were selected. Micro-sections data was analyzed to confirm the Copper wrap plating thickness, failure mode and barrel copper plating thickness. Average wrap thickness for Class 2 was 8.38µm (0.00033”) and for Class 3 was 14.22µm (0.00056”). The coupons classified as no wrap did not have any copper wrap plating. Figures 6 to 11 are for the sections with no wrap, Class 2 wrap and Class 3 wrap. Predominately a butt joint type of failure was seen on coupons with no copper wrap plating with some having cracked barrel along with butt joint failure

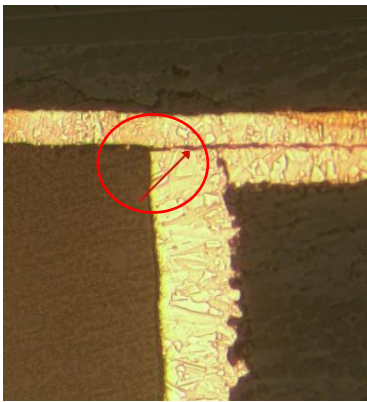
Figure9 - BV - No Wrap

Cycles to Failure - 15

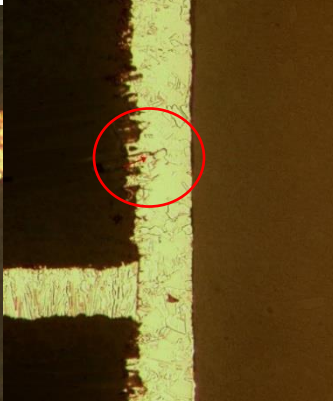
Figure10 - BV - Class 2 Wrap

Cycles to Failure - 57

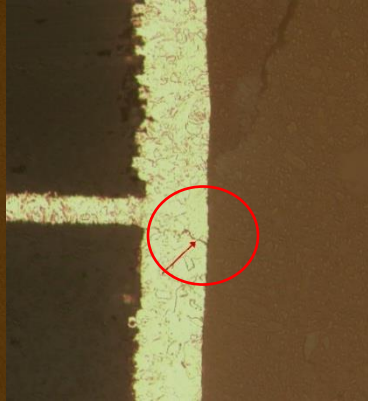
Figure 11 - Class 3 Wrap

Cycles to Failure - 63

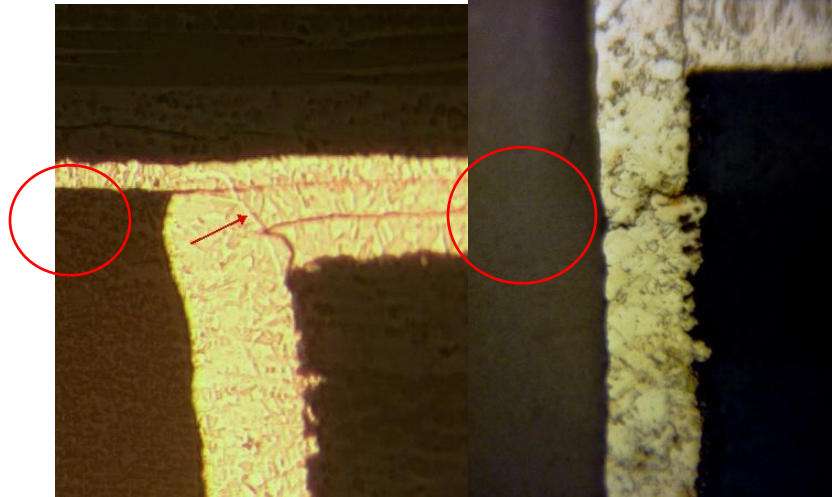
An initiation of a corner crack was seen on some of the Class 2 and Class 3 sections (see Figure 12). It needs to be noted that this section had gone through 29 lead-free assembly cycles and the section shows a complete barrel crack (see Figure 13).
