# INTERMITTENT CONNECTOR FAILURES IN ELECTRONIC ASSEMBLIES

Aravind Munukutla and Anil Kurella  
Intel Corporation  
Hillsboro, OR, USA  
aravind.munukutla@intel.com

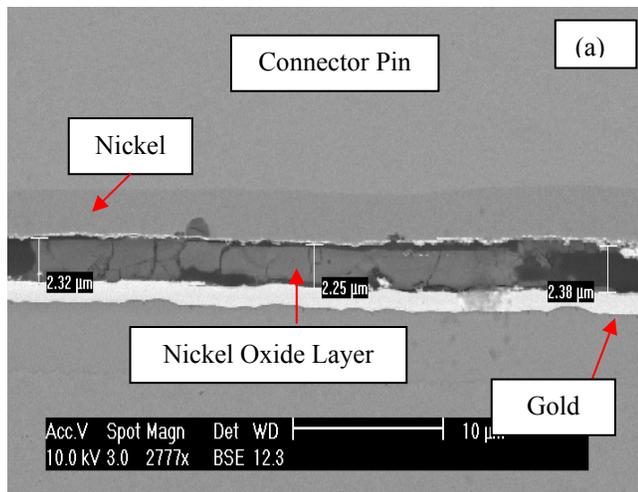
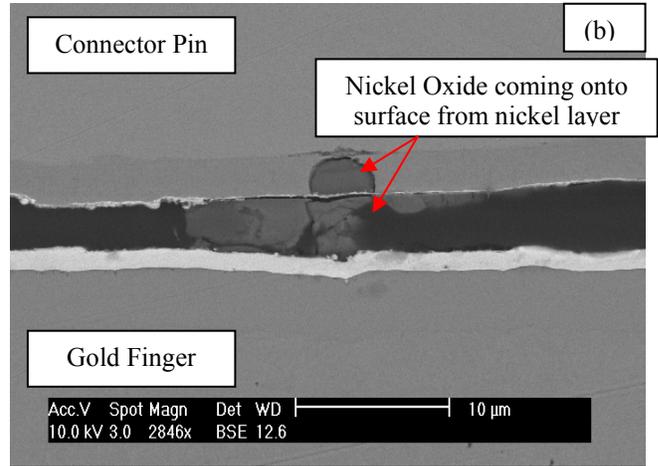
Cross section was then performed in a top down direction (memory inserted into connector) on the systems which had the failing pins isolated, to expose the area of contact. This was done very slowly in order to avoid missing the area of contact. At the area of contact there was a corrosion product which formed a layer between the two mating surfaces for the isolated pins. The corrosion product originated from the connector pin side for some systems and from the memory module gold finger side, in other systems. EDX (Energy-dispersive x-ray spectroscopy) dispersive analysis of the corrosion product shown in Figure 2(a) confirmed it to be nickel oxide along with possibly nickel sulphide as shown in Figure 3. Nickel oxide is not electrically conductive and so it leads to the degradation of contact resistance between the two mating surfaces. As seen in the figure 2(a) this layer is around 1-2 micron in thickness and spreads along the interface. This can cause a mechanical separation between the two mating surfaces by pushing them apart.

From figure 2 (b) it is observed that the oxide seems to be oozing out from the connector pin, starting from the nickel layer underneath the thin gold layer. The nickel layer is being attacked by oxygen and is providing a continuous supply of metal to form the thick oxide layer. As it forms

the thick nickel oxide layer, it appears that there is a separation caused between the nickel and phosphor bronze layer of the connector pin. This in turn lowers the normal force leading to higher contact resistance.

The thickness of the gold layer on the connector pin is small. Supplier data indicated this gold thickness ranged from 2-10 microinches and therefore be classified as flash gold. Flash gold is generally known to be porous based on where the thickness lies in the range provided. If it is in the lower end of the range, less than 5 microinches, then it could be porous, non- uniform and can easily be removed after a few insertion cycles leading to exposure of underlying nickel layer. Nickel diffusion to the surface through pores in the gold layer can lead to oxidation. It is known that environment plays a role on contact resistance. Figure1 shows the effect on contact resistance of the growth of oxides on nickel, copper and silver surfaces[1]. High pollution (corrosive gases like sulphur dioxide SO<sub>2</sub> and hydrogen sulphide H<sub>2</sub>S) coupled along with high humidity levels can increase the rate of corrosion of nickel. Synergistic chemical reactions between the base metals with the corrosive gases and water lead to the formation of solid corrosion products that grow and creep out of the pores and spread along the contact area surfaces [3]. At ordinary temperatures nickel is not affected by H<sub>2</sub>S, but SO<sub>2</sub> can affect it above certain relative humidity (RH) values. This RH level can be reduced by the presence of dust & other hygroscopic materials [4].

Figure 2(a) SEM image of the area of contact for one of the failing pins with Nickel Oxide layer between the mating surfaces. Thickness of oxide layer greater than two microns (b) High magnification SEM image of the area of contact for one of the failing pins with pore corrosion on the connector pin. Also note the separation in the intermetallic between nickel to phosphor bronze layer

The corrective actions for this case involved using 15 microinches of electroplated gold on the connector pins for better reliability in medium harsh environments. Supplier B for the memory modules was asked to improve process control over their nickel and gold plating.

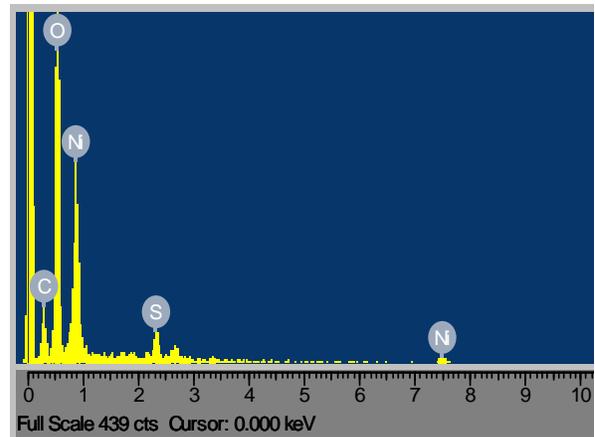
Figure 3. EDX spectra of the corrosion product between the mating surfaces indicating nickel oxide and possible sulphide.

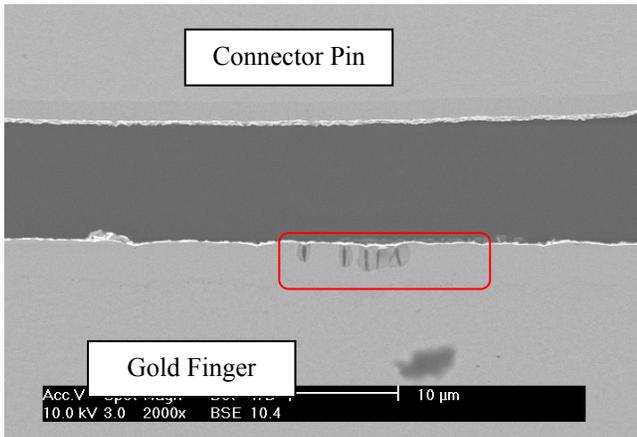
Figure 4 shows the corrosion product forming from the gold finger of the memory module at the contact area interface. Nickel oxide is forming and coming onto surface where there is hyper corrosion of gold as seen in figure 5.

**Figure 4.** SEM image near the area of contact for one of the failing pins on a different board with memory module from supplier B.

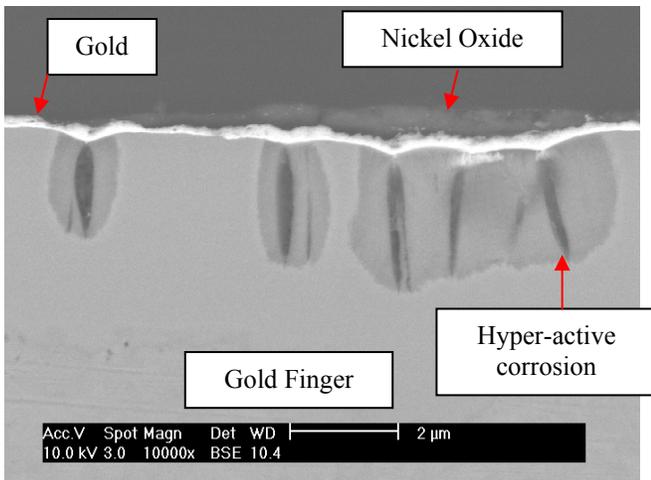
Hyper-active corrosion of gold is a phenomenon generally attributed to gold plating process on nickel plating with high phosphorous content. It causes non uniform plating and increases porosity locally at that location. The thickness of the gold layer on the gold fingers is less than or equal to one micron (~40 microinches). In order to check for porosity of the gold fingers, modules from both suppliers were subjected to five days Mixed Flow Gas (MFG) test. Post five days testing, the memory module from supplier B failed the porosity test as seen in Figure 6 whereas supplier A passed the test.

**Figure 5.** Hyper-corrosion of gold on the gold finger and Nickel oxide forming on the surface

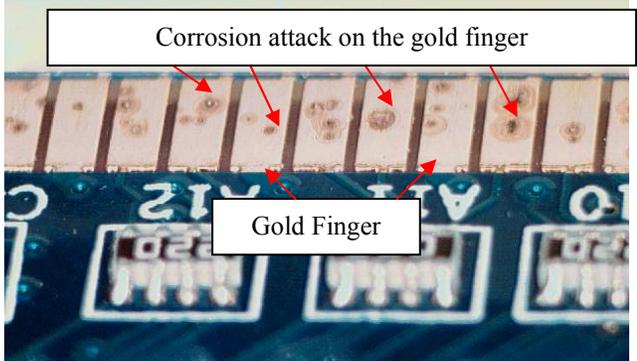
**Figure 6.** Optical image of gold fingers for memory module from Supplier B post 5 days MFG test showing a lot of pores

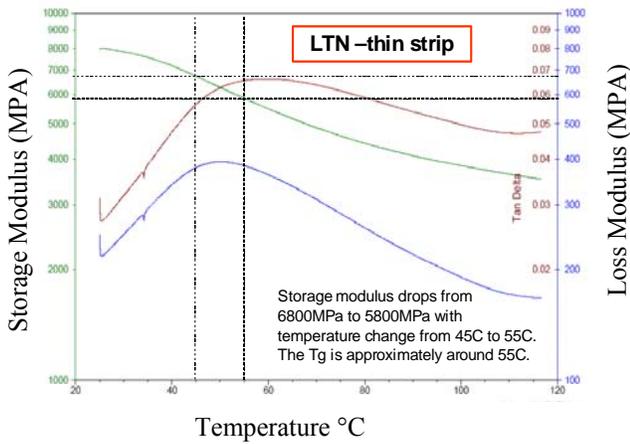
Figure 8 DMA data from LTN thin strip

Based on the type of LTN used it was recommended to use additional solderable reinforcements to prevent plastic deformation. It was also recommended to change the connector housing material from low temp nylon to high

temp nylon for heavier graphics cards and also for boards that were being used for extreme graphics like gaming applications.

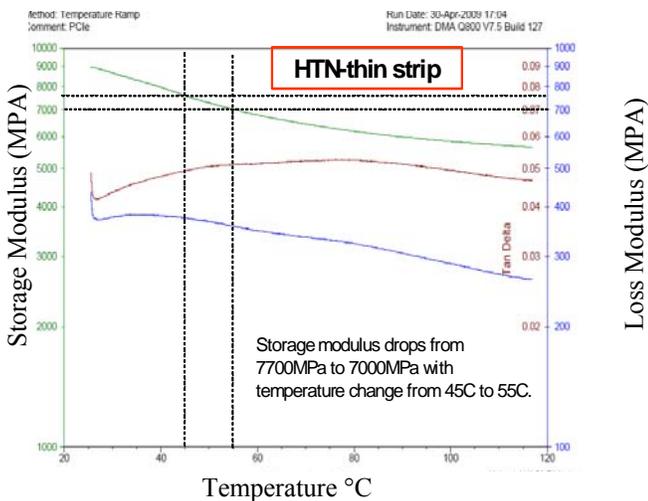
Figure 9 DMA data from HTN thin strip

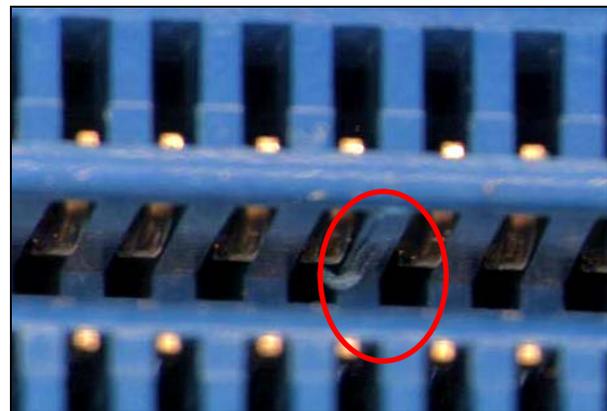
Visual inspection was performed on the memory modules and DIMM slots of the systems which lost the failure signature. Most of the connectors showed mechanical damage to the connector housing body as shown in Fig 11.

Figure 11. Optical microscope image of the connector showing scraping of the connector housing as indicated by the red circle above.

The corrective actions implemented for the issue was to have the factory follow the JEDEC specification to insert the memory modules straight down, factory to investigate getting modules with chamfer to reduce any further reliability risk.

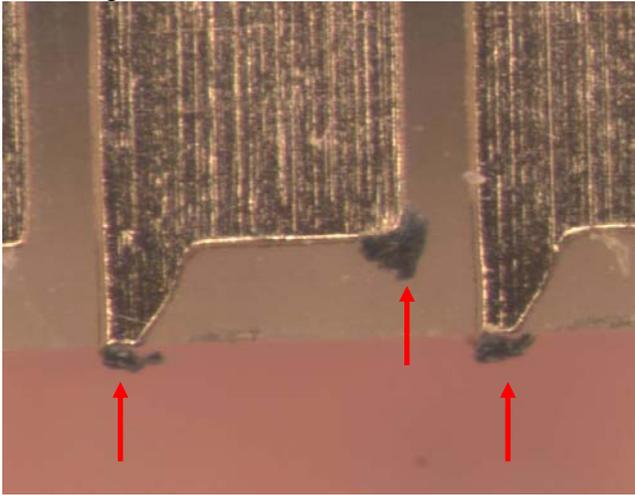
Inspection of the memory modules indicated deep wear marks and also connector housing debris at the bottom of the tie bar of the gold fingers on the memory modules as seen in Figure 12.

**Figure 12.** Optical microscope image showing connector housing debris on the memory module as indicated by the red arrows

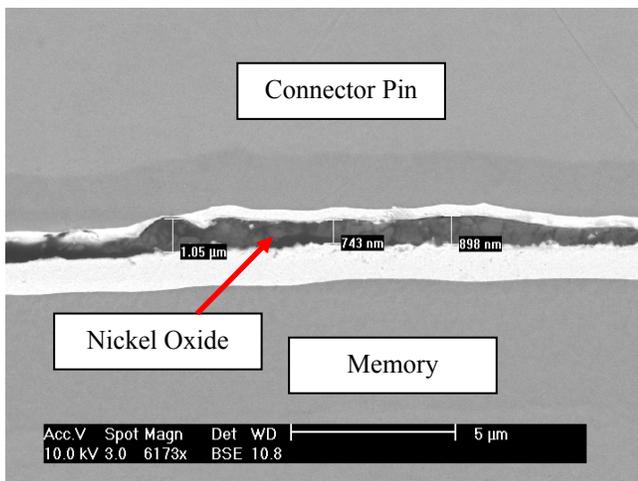
**Figure 13.** High magnification scanning electron microscopy image showing the presence of nickel oxide at the interface

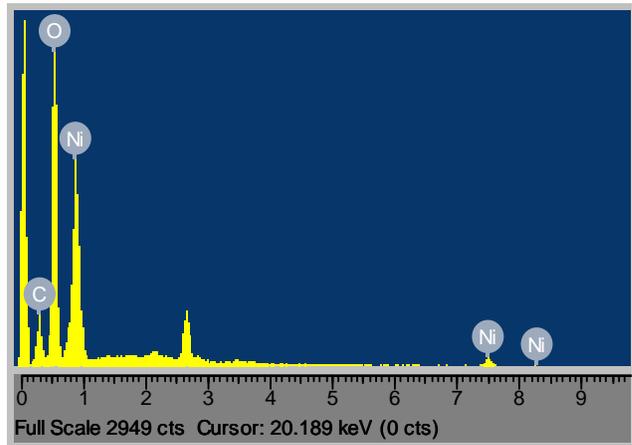
EDX analysis for the corrosion product indicated it was nickel oxide as shown in Figure 14.

**Figure 14 .** EDX data indicating the product at contact area is nickel oxide

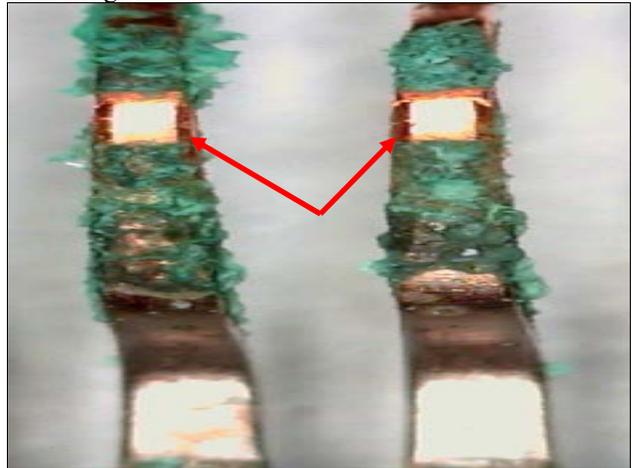
As the gold thickness on both mating surfaces looked acceptable, a nitric acid vapor porosity test as per EIA 364-53B was done on the connector pin to check for plating porosity. No porosity was found at the area of contact as seen in figure 15.

**Figure 15** Image showing the plating porosity test on the connector pins indicating no attack at the contact area

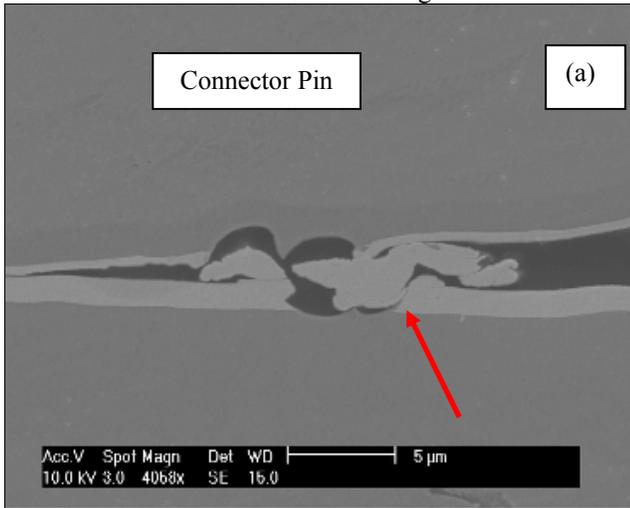
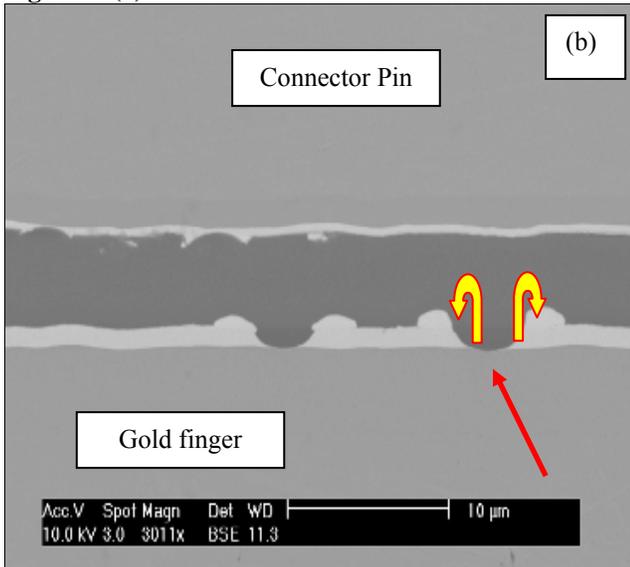
With less of a porosity concern, but deep insertion marks on gold fingers and connector debris on the tabs of the gold finger, the cross sections were inspected in detail to see for signs of any damage. As observed in Figure 16(a), (b), the gold was being displaced at the wear track region and pushed aside forming valleys and hills. Thus nickel exposure at those sites followed by oxide formation lead to the failure of the system. The connector pins of some of the recovered systems was inspected using SEM which indicated the wear mark was getting deeper as it went down from the top of the connector to the area of contact as seen in Figure 17(a), (b) below. Further investigation into the memory modules indicated the lack of a chamfer for the PCB (Printed Circuit Board) and so the gold or copper tabs were in direct contact with the connector housing and the connector pins. The next step was to understand how the memory modules in the systems were inserted into the DIMM connector. The factory indicated a manual process

for insertion. As there are 16 connectors close to each other, the memory modules would have been inserted in an angle thus having housing debris at bottom of the gold fingers and also the debris on the connector housing.

Figure 16(a). Scanning electron microscope image near the edge of contact area showing damage to the gold layer on both interfaces and the gold trapped in between.

(b) Scanning electron microscope image showing wear marks causing displacement of gold on both interfaces, making a hill and valley, thus exposing underlying nickel layer. The cross section is a top down one and so you are looking at the wear marks

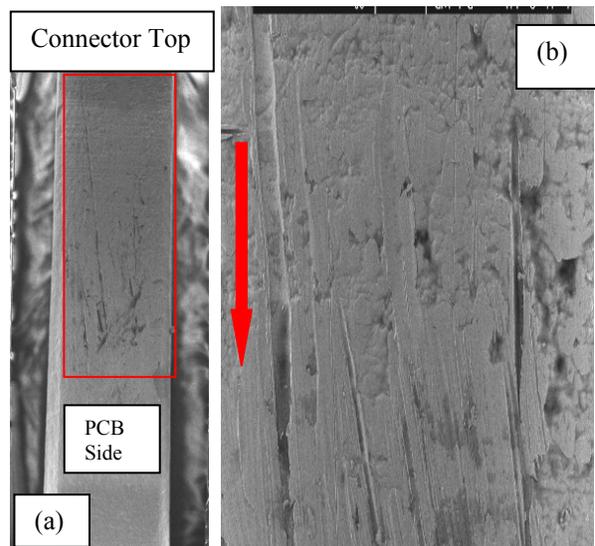
Figure17(a) Low magnification scanning electron microscope image of contact area for a pin. (b) High magnification scanning electron microscope image of the

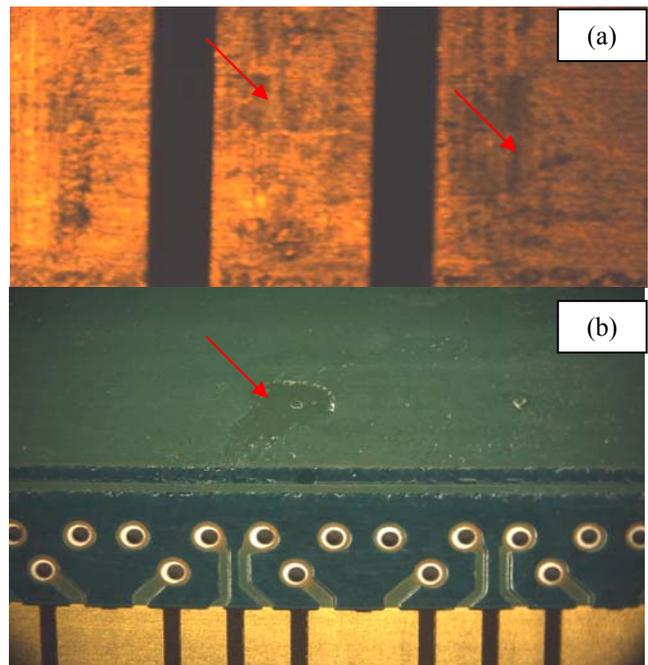
This section includes cases where the intermittent failures were found on systems in the line integration stage. These failures are mainly due to contamination on the riser card gold fingers during motherboard assembly process. The case involved no display during POST and boards would not boot up. Visual examination of the riser cards indicated some excess solder on the back of the boards with some contamination on the PCB surface and visual contamination on pins as shown in Figure 18(a) and 18(b).

Figure 18 (a). Optical image of the gold fingers on the riser card showing contamination. (b) Optical image of PCB surface with the contamination

The corrective action in this case was a detailed cleaning process for the gold fingers after assembly. Using tape on the gold fingers during soldering was recommended. The type of tape used should not leave any residue behind.

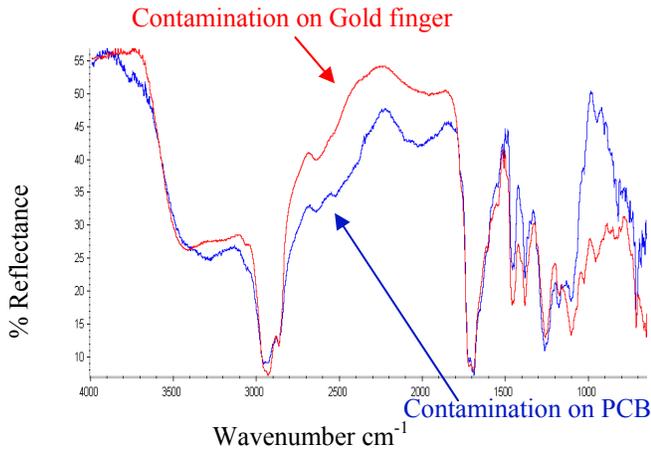
Upon cleaning the gold fingers the failure disappeared and the board became functional. Fourier transform infrared spectroscopy (FTIR) was used to analyze the contamination on both the printed circuit board and the gold fingers. The spectra for both the spots were collected and they matched very closely indicating the same contamination was present on both the locations as seen in Figure 19. The spectra were then compared to the flux spectra used in wave soldering for motherboard assembly.

**Figure 19.** Overlay of FTIR reflectance spectra of the gold finger contamination and contamination on PCB indicates it is the same contamination.

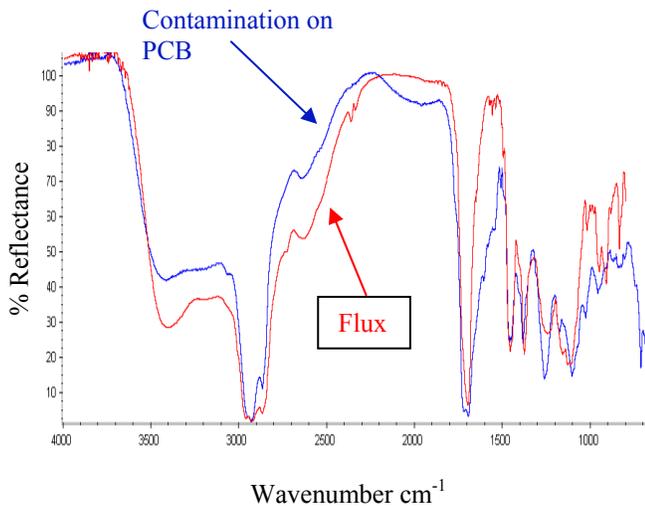
There is a decent match in the fingerprint region between the flux spectra and the contamination found on the board as seen in Figure 20

**Figure 20.** Overlay of FTIR reflectance spectra of the gold finger contamination and spectra of flux indicating a good match between the two in the fingerprint region
