## **“Metal Whiskers” Does Surface Contamination Have an Effect of Whisker Formation?**

**Terry Munson / Paco Solis**  
Foresite Inc.  
Kokomo Indiana

### **Abstract:**

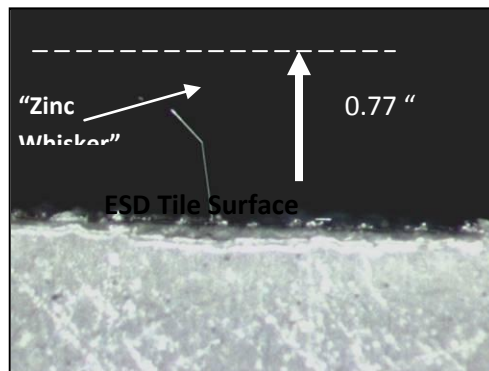
- ICT hardware on a raised ESD flooring system was found to have intermittent electrical issues with power supplies.
- Transformers and power busses were being shorted by an accumulation of zinc formations carried by cooling fans into system architectures.
- These issues were found to coincide with janitor mopping activity of the ESD floor.

**Figure 1 - Tin whisker on zinc alloy ESD floor tile**

- These whiskers are the result of a highly Sulfonated / Amine bearing mop water solution (validated by Ion Chromatography testing). ESD Soap!
- On tiles where these ionic residues have been removed by remedial cleaning and rinsing (with proper chemistries), the whisker formations are greatly retarded or completely eliminated.
- Contaminated tiles in our lab continue to produce whiskers to this day.

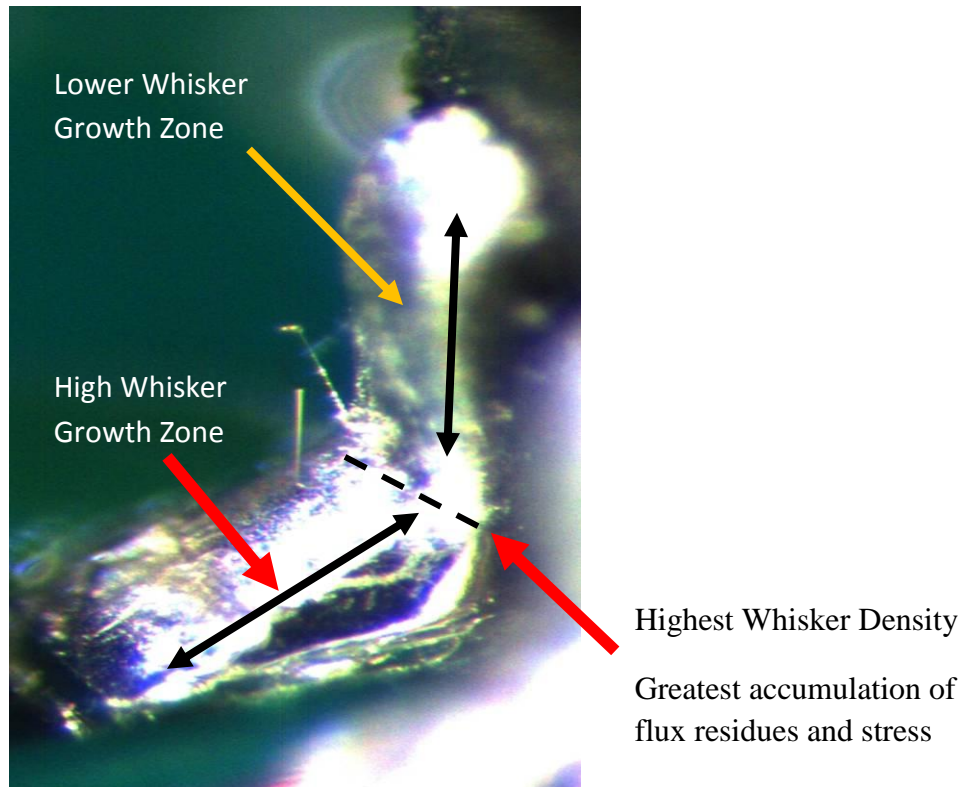
**Figure 2- Whiskers on SOT gull lead with SAC 304 alloy termination**

During reflow, high concentrations of flux residues flow up the termination and accumulate at the gull wing bend. Although solder reflow occurs from toe to shoulder, the flux accumulation settles at the lead bend. A second item noted was the discovery of nano-whiskers which form from the flux line extending over 200  $\mu\text{m}$  in serpentine length and under 1  $\mu\text{m}$  in width.

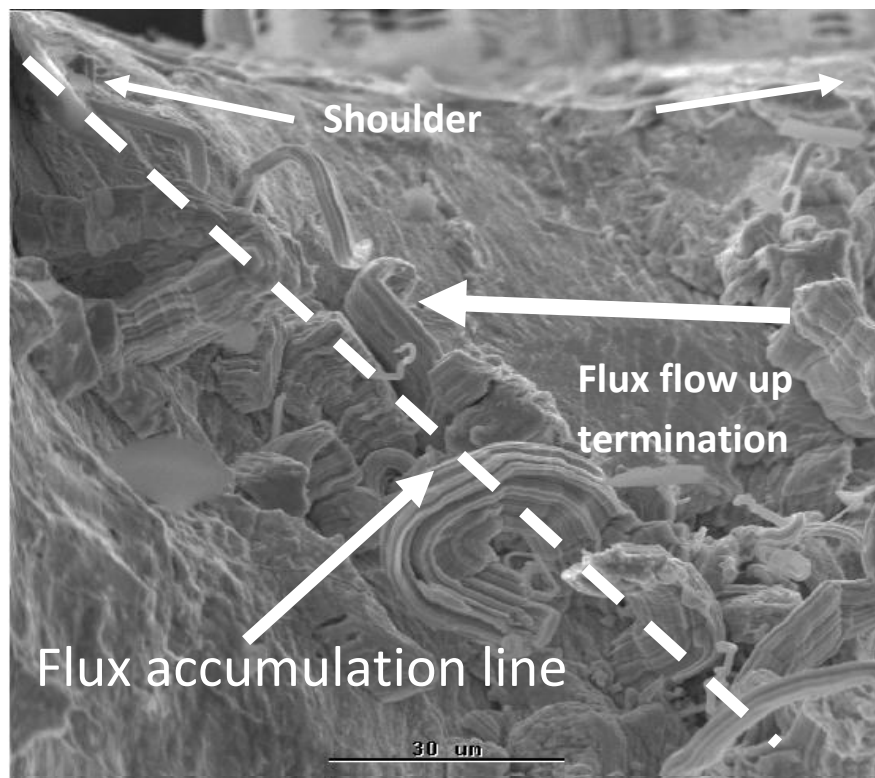
**Figure 3 - SEM Image of SOT gull wing termination**

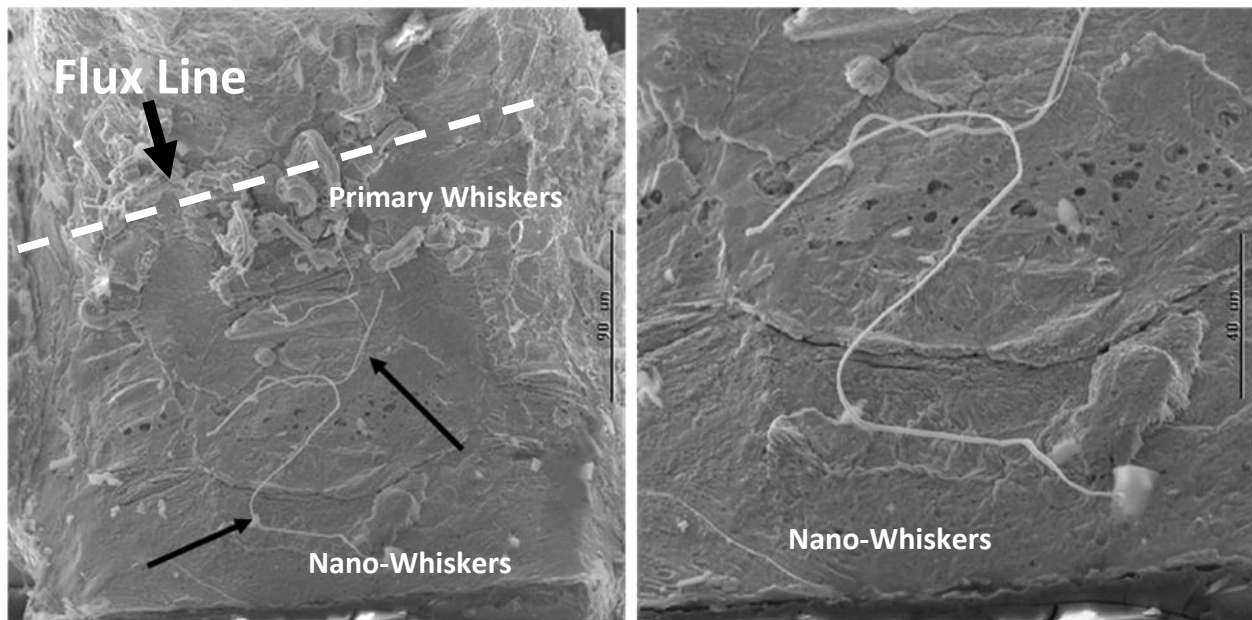
**Figure 4 & 5 - SEM Image of primary and Nano-Whiskers**

These nano-whiskers continuously extrude from the surface as well as from the larger primary whiskers. They settle on the surface and are freely fractured and fall away with little force.

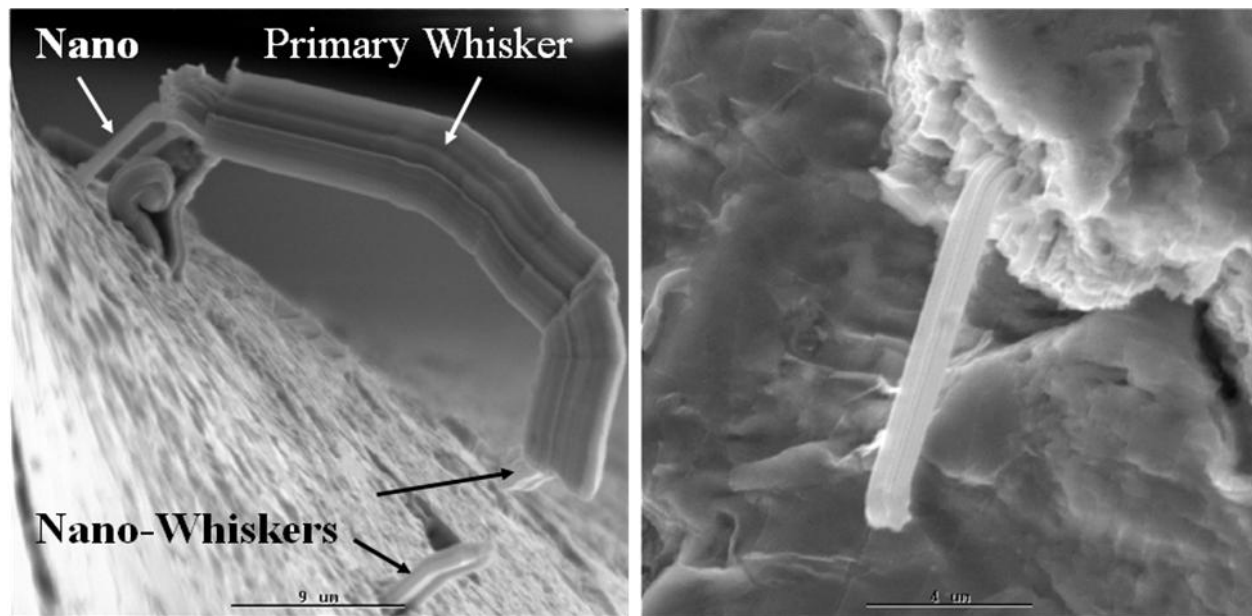
**Figure 6 & 7 - SEM Image of primary and Nano-Whiskers**

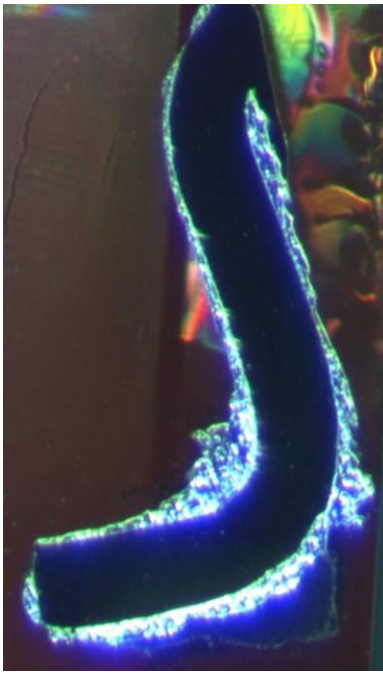
**Figure 8 – Optical Image of primary whisker in cross-section**

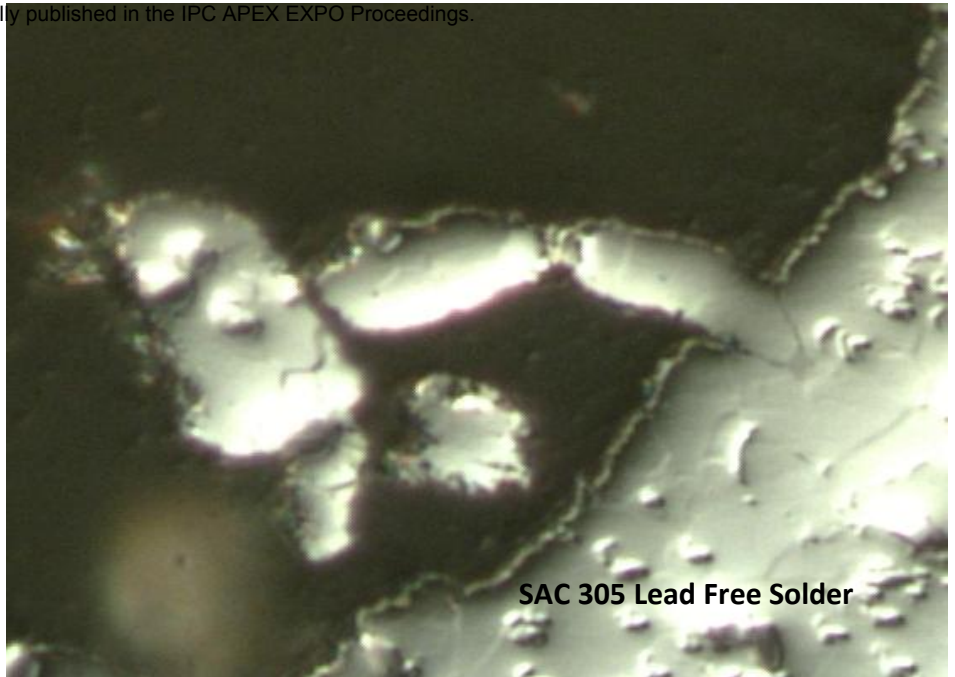
**Figure 9 – Optical Image primary whisker in cross-section at 1000X**

In cross-section a single grain dislocation can be seen at the whisker extrusion site. More samples like these are needed to further study this condition. This sample was prepared with pH 9 gamma colloidal silica slurry for grain delineation. The sample was unfortunately compromised before it was submitted to SEM analysis.

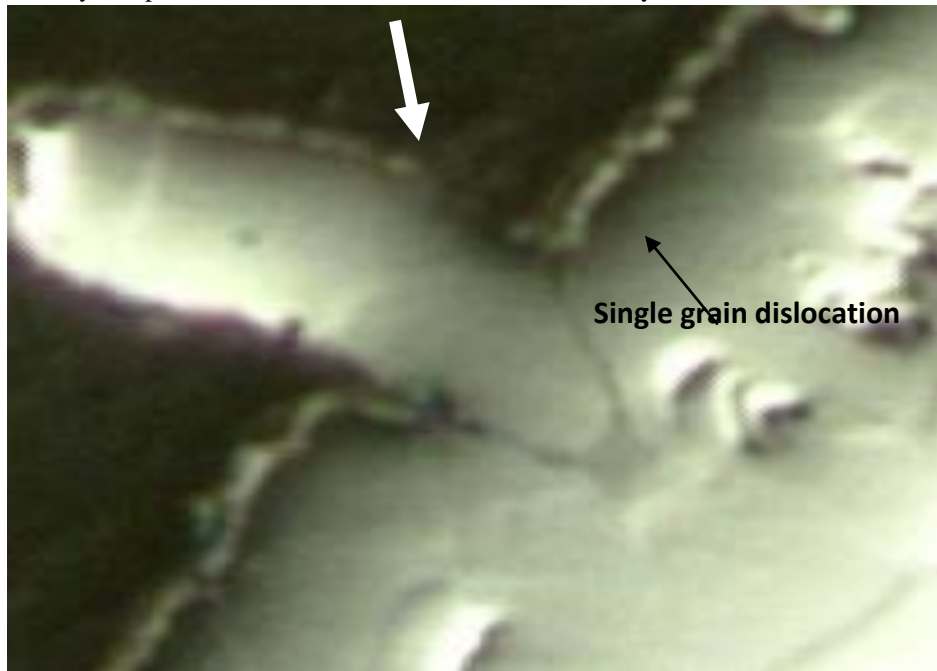
**Figure 10 – Optical Image of primary whisker in cross-section at 1000X (digitally magnified)**

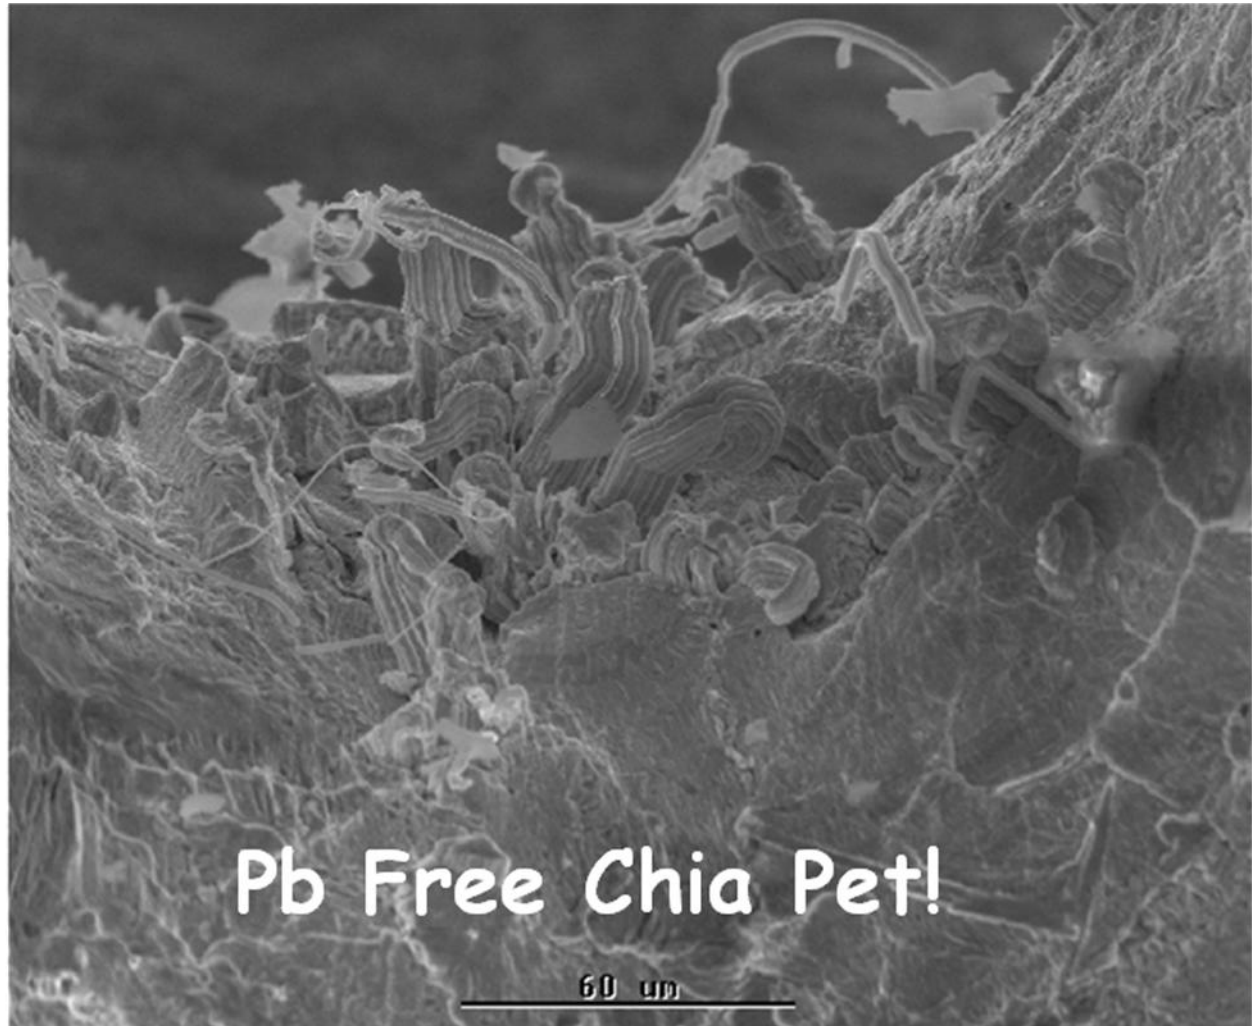
- Localized D.I. steam cleaning with a saponifier has proven effective at preventing reoccurrences when total ionic contamination has been reduced.
- Inversely - areas doped with high levels of ionic contamination show a significantly higher occurrence of whisker formations.

**Figure 16 – Results of accelerated whisker growth from select doping of terminations**

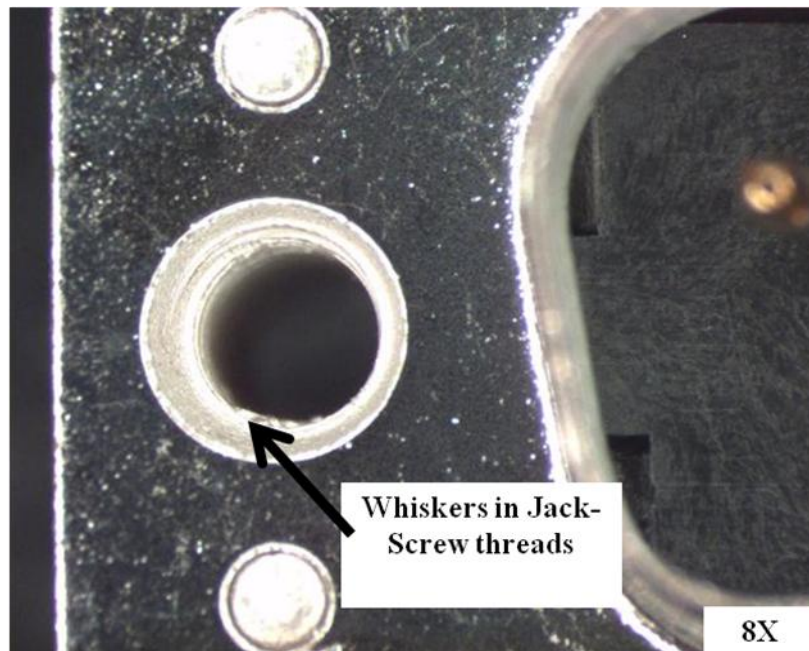
Whiskers are forming in the jack screws of lead free connectors. Preliminary data has shown high levels of Chlorides, Sulfates, and Amines are present in the Jack Screws. Analysis is ongoing to study the contamination effects in these locations and the retardation effects of cleaning. Data on this analysis is will published in updates to this paper.

Figure 17 – optical images of whiskers on jack screw threads

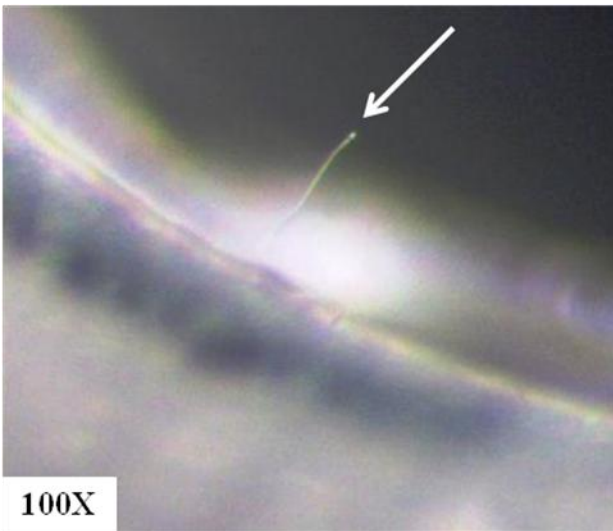
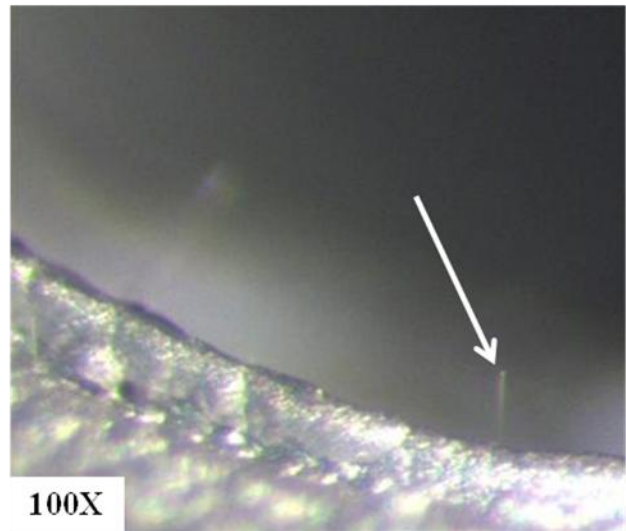
Figure 18 & 19 – optical images of whiskers on jack screw threads
