Reliability and Failure Mechanisms of Laminate Substrates in a Pb-free World

Kevin Knadle
Endicott Interconnect Technologies, Inc.
Endicott, NY

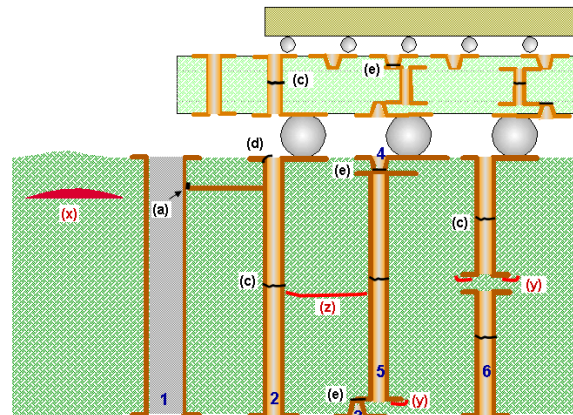
Figure 1—The “PTH” family and related failure mechanisms for today's boards and chip carriers.

The first significant change to the PTH occurred in the 1980-1990's with the advent of surface mount technology (SMT) where plated thru vias shrunk in diameter and were no longer solder filled, resulting in the “wiring via” (Figure 1 via 2). As

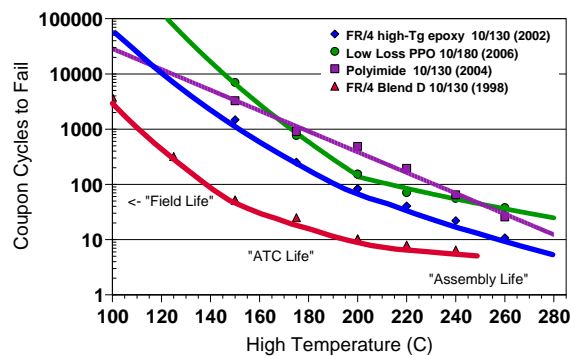
The place to start a discussion of today's PTH and laminate problems is with a review of the standard wiring thru via—barrel life as a function of temperature, and video clips of barrel and laminate deformed state at reflow temperatures. The "PTH life curve" has been used by the author for over 15 years to characterize new materials or PTH structures, and to calculate via life for any combination of temperatures^[1-4]. Figure 3 depicts some select recent and vintage life curves to review the problem that is behind all others—the CTE mismatch between copper barrel and the surrounding laminate at reflow temperatures can produce deformation of such magnitude that even well plated vias can survive only a handful of assembly passes without cracking. The 1998 red curve FR/4 (10 mil vias/130 mil thick PWB) is from a mixed resin system (note the 2 Tg deflection points in the curve) that is no longer commercially available, and which was the cause of several cases of PTH cracking based on industry discussions. The reason for such fails is clear from the curve at the "assembly" life end of the curve—well constructed coupons lasted less than 8 reflow cycles. Since 1-2 reflow cycles are required for SMT attach, and an additional 2 reflows for each rework (remove & replace), 8 reflow cycles to 220°C could be envisioned during assembly. But more importantly there is no "safety factor" in 8 reflows—any increase in thermal exposure, or any form of thin plate or defect in the vias could easily account for assembly driven cracks, as was confirmed by industry experience. Failure analysis of the 8 cycle 23-220°C CITC fails showed significant laminate and copper deformation. Note that if the same product could be shipped to the field without any reflow, it would survive (by extrapolation) over a million cycles of 23 to 75°C!

Figure 3-- Select CITC PTH life curves to illustrate challenge of unfilled wiring vias.

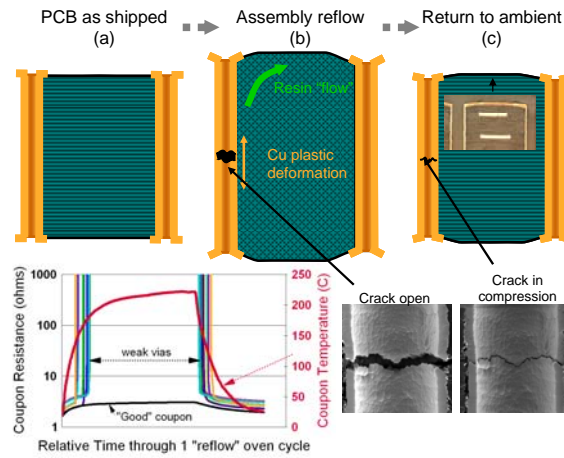
While Figure 3 shows the reason for assembly driven failed vias, Figure 4 illustrates why they can be a serious reliability concern as latent opens in the field. At reflow temperatures above the Tg of the laminate material, the z-axis expansion of the laminate is an order of magnitude much greater than that of the copper, which forces the copper in tension where it plastically deforms—i.e., the copper barrel becomes permanently longer than it was. Similarly, the laminate sees significant compressive forces in the zone around the PTH barrel because the barrel acts as a rivet to constrain it from expanding as it would away from the PTH. These considerable compressive forces create a pressure gradient that causes the laminate, now well above Tg, to "flow" away from the barrels. "Flow" is used in quotes because cross-linked thermoset polymers are not supposed to flow as other polymers, but some form of movement or reshaping is indicated by the permanent deformation seen in laminate x-sections after reflow or solder shock—the laminate is now longer between vias than in the zone directly next to them (Figure 4c). The combination of these permanent deformations (longer barrel, shorter laminate) means that any crack formed at the peak temperature will be forced in slight compression on return to room temperature. In addition to the illustration, figure 4 includes 1) ESEM photos of a barrel crack open at 230°C and the same crack closed tightly again after cooling to ambient, and 2) electrical measurements of 8 coupons (left axis) with intentionally very weak barrels through a single simulated reflow cycle in a convection oven showing them open completely during heating (temperature, red line and right axis) between T = 140-185°C, and close solidly to original resistance value starting between T=175-110°C.

Figure 4-- Illustration, electrical data, and ESEM photos of deformations on a wiring via during assembly cycle.

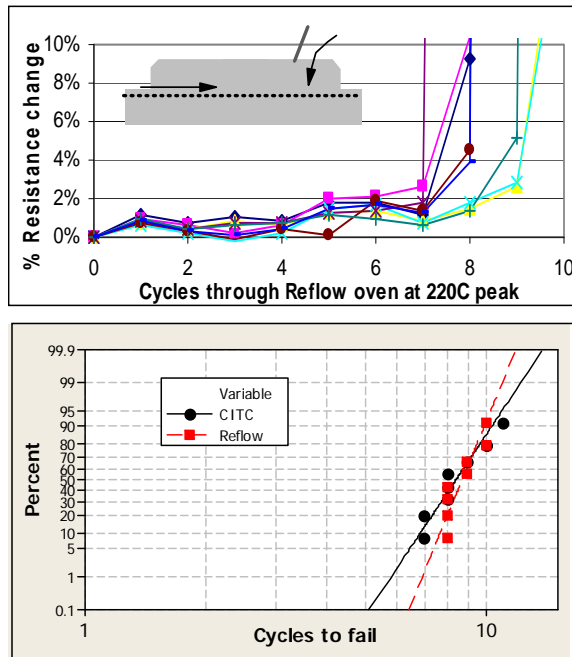
to allow hand probing of the coupons right after the heating peak. That is, at the correct point (by timing) of each pass, the panel was removed and the part quickly measured with 4 wire resistance while still hot. Before pass 1, the oven was profiled with an identical block to 220°C peak using the same timing and panel removal. The part was cooled to room temperature, and this process repeated up to 10 passes. Figure 5a plots the hot resistance by coupon and reflow cycle. A 3% failure criterion was used in this case, instead of 5 or 10%, because of the difficulty of reading all the coupons simultaneously while still hot, and because it appears to best fit the sharp slope change of the data. The final results are plotted in Figure 5b— the curve for cycles to fail from actual 220 reflow passes is almost identical to the 220°C CITC cycles to fail curve.

Figure 5-- -- Reflow verification for CITC data of Figure 3; (a) Coupon resistance vs. cycle measured inside reflow oven. (b) Probability plot showing identical cycles to failure between CITC and reflow.

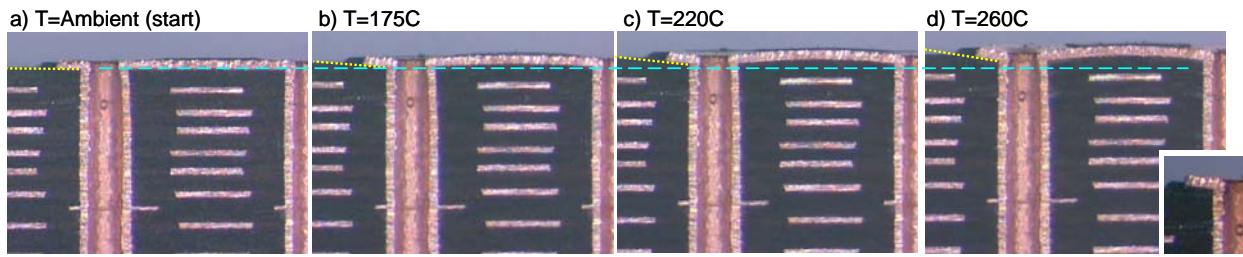
Figure 6-- Select frames from video of CIRC coupon cycled ambient to 260°C, 10mil via/180mil thick PWB.

The magnitude and slope of the PTH curve at Pb free temperatures, as well as the challenge of Pb free assembly in general, is further portrayed by real time video of a coupon cross-section during a Pb free reflow. Figure 6 shows four select frame captures from the video of a high T_g epoxy coupon similar to that of the blue curve (this one was 10 mil via on 180 mil thick board) in a simulated single cycle from room temperature to 260°C. Sample preparation and procedure was as shown earlier in Figure 2: sample was dry-sectioned to row 1, wired, and placed PTH-up in a glass frame under the camera. For this video, N₂ gas was leaked into the glass enclosure to limit oxidation of the copper during heating. The first observation from the figure is the significant deformation of the laminate, barrel, and lands at 260°C. The difference in the two center frames between Pb free 260 and conventional 220°C is staggering, but is consistent with the slope of the Figure 3 blue curve as discussed above, let alone general industry experience with Pb free assembly. The yellow dotted lines indicate measurements of the angle of deflection for the external lands: the lands deflected about 10 degrees at 260, 6.5 degrees at 220°C and 5 degrees at 175°C. The inset photo shows the permanent deflection of that same land (no longer adhered to the laminate) after on return to ambient after only a single 260°C cycle, measured at 7.7 degrees, suggestion significant plastic deformation of the rim copper. Additional cycles at 260°C are known to exaggerate the angle and/or protrusion of the land even further.

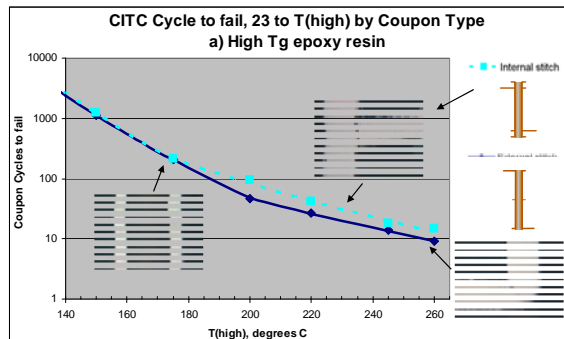
Finally, as if the Pb free situation was not complex enough, the magnitude of deformations at Pb free temperatures are so significant that they often trigger different and competing failure mechanisms along the life curve. While this fact does not invalidate the curves, it could have design implications, and it certainly sheds further light on the Pb free challenge. For example, Figure 7 is a life curve for a high T_g epoxy (more recent build than in Figure 3, though same aspect ratio) constructed with 2 different and independent CIRC coupons—one with the daisy chain stitch external (top and bottom surfaces) and one with the stitch on the nearest 2 internal planes, top and bottom. The two coupon types yield exactly the same cycles to failure at 150°C and 175°C, and the same failure mode (center barrel crack), but they diverge slightly at higher temperatures—the external coupon with lower life in this case, fails at the external rim, while the internal coupon lasts a little longer but fails at the inner plane connection, at least at 260°C. Note that inner plane fails observed at 260°C are not related to poor barrel to innerplane connection, but rather appear to be ripped apart in a bending mode due to the same laminate deformation that bends the lands (only a few mils above where the first innerplane connection is located) as seen in Figure 6. Of course, the rim crack mechanism that activates on the external coupon at 260°C in Figure 7 is similarly related to the same observations of Figure 6.

Figure 7—Failure mode shift vs. temperature for a High T_g epoxy resin, 10mil drill on 130mil thick board.

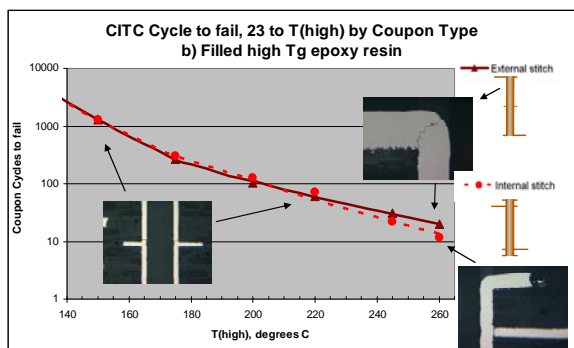
As a second example, Figure 8 compiles the results of the same experiment for a High T_g filled resin. The same 3 failure mechanisms “compete” again, this time with the inner plane failing slightly earlier than the rim at 260°C, but both different than the center barrel crack than at conventional reflow temperatures. Note that none of the curves differ significantly, and a repeat of either test could yield a different result by material depending on plating thicknesses, etc, but these examples are otherwise provided as one more case for the complexity of assuring laminate boards for Pb free assembly.

Figure 8—Failure mode shift vs. temperature for a High Tg filled epoxy, 10 mil drill on 130 mil thick board.

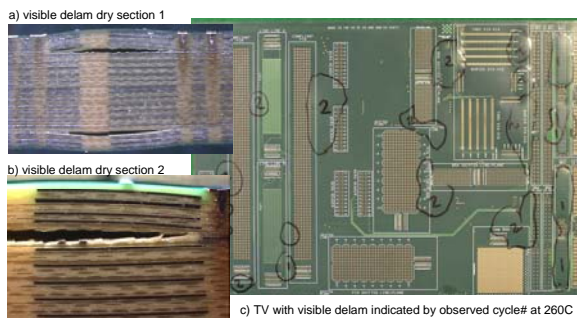
Thermally induced internal delamination is one of the original and ever-present failure mechanisms for laminate substrates and boards. The root cause is generally linked to the “explosive” vaporization of entrapped moisture at high temperatures, especially reflow. The alternate names of blistering or popcorning not only reflect the mechanism but also hint at another fortunate attribute— when they occur within laminates of any thickness they create a measureable opening within the substrate that is almost always visible at the surface as a raised and/or discolored area. “Visible delamination” as such is typically observed in open areas with few vias, and/or in regions surrounding vias such as is shown in Figure 9c for a 130 mil thick 10”x7” test vehicle (TV); cases of visible delamination on the TV are circled and numbered during reflow passes at 260°C . The number is the pass after which it was observed (i.e., “2” = delamination was observed by inspection immediately upon removing card from reflow pass 2 at 260°C). Note how the delamination rarely encroaches on via grids. The (a) and (b) insets show dry-section examples of visible delamination, typically cohesive within laminate material at glass to resin interfaces, near but not into vias seen further back in the section.

Figure 9-- "Visible Delamination" during Pb free reflows on a high Tg resin board.

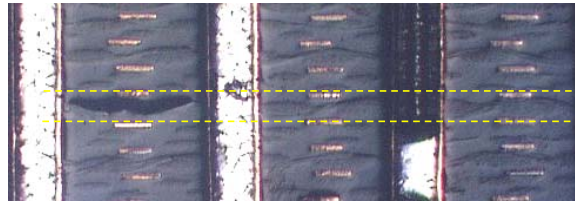
However, as Pb free evaluations continued, users and suppliers began to discover another form of delamination with clear distinctions from this classic visible form— the new type appears only between vias, not open areas; it occurs within resin

not at glass interfaces, and is highly dependent on the aspect ratio and grid of those vias. That is, for any given board thickness the mechanism would trigger above a certain hole density (below a certain grid), and usually near the center of the board^[13]. The author prefers to call this new form after its most pragmatic difference and challenge—the significant void or hole it creates in the board, often spanning entire vias, is completely invisible from the surfaces. And except in a specially designed coupon where it can be detected as a capacitance change, it can only be found by x-sectioning. That is, there is no visible difference between a board module site that has this delamination versus one that does not. While most believe that at the very root both mechanisms are due to expansion/vaporization of trapped moisture with temperature, the unique nature of “invisible delamination” is so striking as to demand a greater understanding. Figure 10 shows a unique photo of invisible delamination found by x-section (in this case induced by solder shock, but otherwise the same as that found with oven reflows, and not a time-0 condition) that vividly answers why this mechanism is invisible— despite the large rupture between the two vias, there is otherwise little or no change to the surrounding material, planes, or dimensions. But this answer only raises new questions—how does the material within the rupture disappear as if to violate “conservation of mass”, and how does this happen with little affect to surrounding laminate?

Figure 10—“Conservation of mass” dilemma with Invisible delamination—where does the material go?

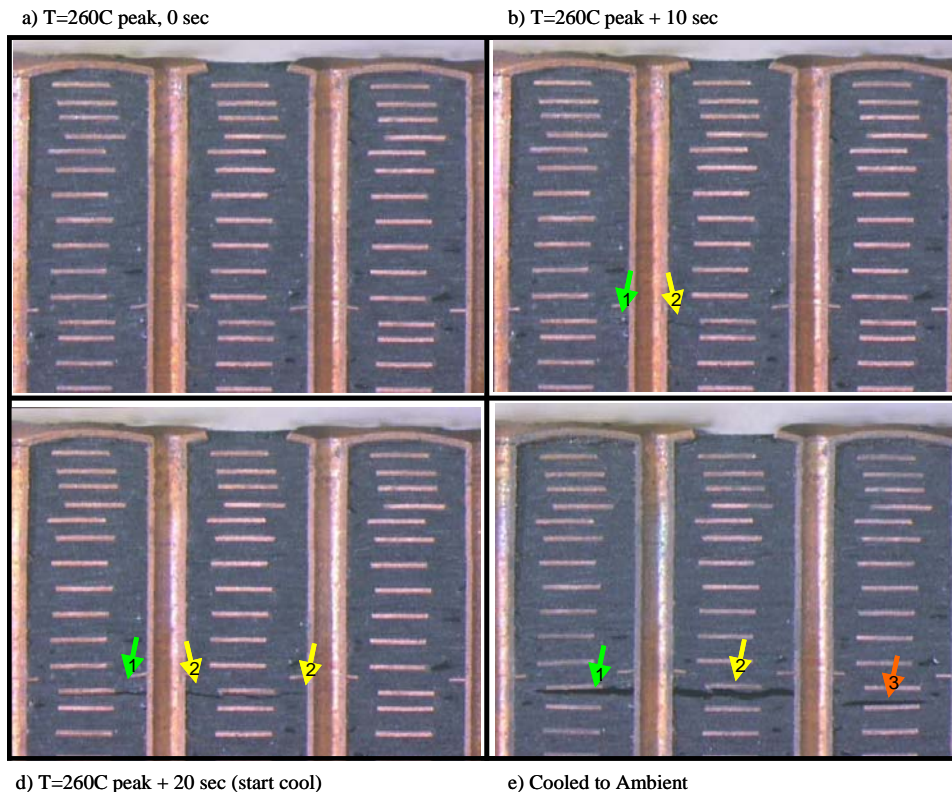
To help answer these questions and further explore the root mechanism, the CIRC video technique (Figures 2 and 6) was again employed in an attempt to record the formation of invisible delamination. The same type of coupon and setup was used except that the camera view must include the center of sample and more than a single cycle from 23 to 260°C was required to activate the mechanism. During the peak dwell of the 7th cycle delamination was observed about 10 seconds after stable dwell at 260°C, as shown by some frame captures in Figure 11. At point “2” in the figure, a sharp crack grew more than half way across the span quickly, within a second. At the same time a small crack grew on the other side at point “1”. By 20 seconds, just before cooling was started, both cracks had grown, especially “2” which now spanned the distance between PTH’s. As cooling started (fans), the cracks progressively opened until they appeared as the typical wide ruptures at ambient,

Figure 11--Frame capture from video showing formation of Invisible delamination.

as shown in the 4th frame of Figure 11. At the same time, a new rupture at point 3 appeared during cooling; apparently it also was created during the dwell, but not visible until cooling. The other randomly shaped small black spots in the laminate are artifacts of the dry section polishing, and should be ignored except that it is interesting to note that they shrink somewhat with cooling, as expected, unlike the cracks formed by this mechanism. Also note the significant permanent deformation of the copper and laminate even after cooling, as discussed in the previous section.

1. The pressure of expanding vaporized internal moisture and pressure from the compressive forces from the via are “additive”, creating an extremely high pressure on the polymer matrix of the resin, or otherwise “complementary”—the compressive pressure accelerates both microcracking of the resin and the diffusion of moisture into the microcracks.
2. the “explosive” rupture that results when this pressure exceeds some level for that resin will locally deform (crush) the polymer above and below the rupture, especially given its highly softened, rubbery state at such high temperatures,

While a crack formed under tension will contract when the tension is removed, a crack formed under compression will open when the compression is removed—thus, at room temperature these cracks appear as large voids of missing material with little change to the surrounding structure or geometry outside a very local area.

Whatever the root cause, the most important question is how to control by design, evaluate with testing, and otherwise mitigate this unique Pb free failure mechanism given that its occurrence and severity is a strong function of: material, peak reflow temperature, board thickness, hole size, hole grid, process history including moisture content, and board construction (power vs. signal connections). Clearly, such a multi-dimensional problem demands an evaluation approach that is also multi-dimensional. That is, classifying a material as Pb free compatible or not based on a single coupon at 5x 260°C reflow test is no longer viable as it may have been with solder shock of PIH technology. The author recommends a coupon approach such as is shown in Figure 12; at 1” wide by 5” long, the EI delam coupon is small enough to fit on the kerf of most production boards, and therefore reflect the design features of that board, but can also include enough design space variations to better answer the “Pb free or not” question for a particular material and construction. The coupon version shown has 7 different grids including 8 mil vias on 0.8 mm grid, 10 mil vias on 0.8 mm grid, 10mil vias on 1 mm grid, 12 mil vias on 50 mil grid, etc. The coupon also includes nets for measurement of internal capacitance and 4-wire resistance of IP connections.

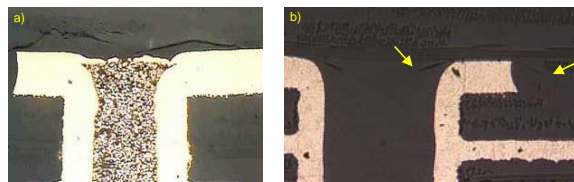
As discussed earlier around Figure 1, HDI technology has introduced several new via structures and via-induced failure mechanisms to laminate packaging. One of the most interesting though elusive HDI failure mechanisms is the eyebrow crack, as shown by a couple examples in Figure 13. Though the origin of the name is unknown, the name becomes self evident to all who observe them. Eyebrow cracks form above, below, and between buried vias of sufficient size whether they are filled, capped, or not. The cause of eyebrow cracks is best understood by referring (once again) to the significant deformations involving and surrounding wiring vias, as illustrated in Figure 4 and video captured by Figures 6 and 11. If such thru-via related deformations can cause so many problems— PTH life reduction, lifted lands, IP cracks, and invisible delamination— then placing such structures inside a PWB is an example of how one cannot simply “bury his problems”. At least in Figures 4, 6, and 11 the only stress on the surrounding laminate is compressive. But when thru vias become buried vias, laminated inside a composite structure, the same deformations result and can lead to tensile zones in the resin directly above and below the vias.

Figure 13-- Classic examples of eyebrow cracks after assembly

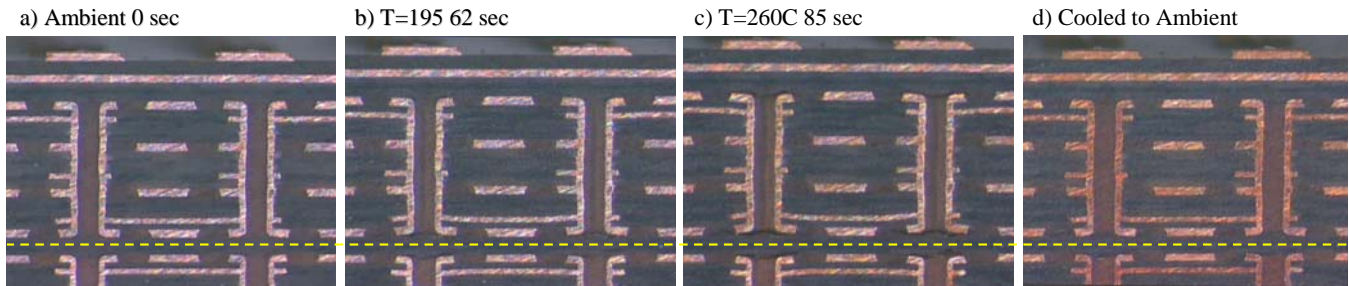
To illustrate, the CITC test is again used to capture with video the formation of eyebrow cracks in a worst case double subcomposite structure with a full grid of top and bottom buried vias. Figure 14 shows a macro view of 4 frame captures starting and ending with ambient; note that N₂ was not used in the glass enclosure, therefore copper will appear oxidized after the peak temperature exposure. Figure 14 includes a frame at 195°C when the eyebrow cracks (4 total, above and below yellow center line) were fully formed, and a frame at 260°C peak where they are more evident, somewhat longer, and more numerous (note 2 more at the top of the vias). But here, the difference between 260°C and 195°C is not as striking as with the prior mechanisms, which is consistent with industry experience that eyebrow cracks are by no means exclusively a Pb free problem, but can happen with any reflow. In fact, they may be as much a function of time as of temperature—the author has delaminated an entire module site due to interconnected eyebrow cracks simply by baking for several hours at 195°C.

Figure 14-- Frame captures from video of eyebrow crack formation in a double subcomposite board.

3 and 4 show a somewhat different formation path and look. Crack 3 simply becomes more visible with temperature, without the propagation of 1 and 2. Crack 4 starts as two separate cracks which apparently start far enough apart that, though they grow toward the center, they never join together. All the cracks close back up on return to ambient and are no longer visible, at least at this magnification.

Note the thermal induced deformation of the vias, lands, traces, and laminate in the middle 2 frames of Figure 14, compared to the ambient frames—the magnitude of the deformation is scaled down with aspect ratio, but the same shape as is observed as with thru-vias of Figure 6. But in the case of buried vias observe how the deformed shape, especially the land deflection, would create a tensile zone in the joining resin just above the lands and vias. Resins can withstand reasonable tensile forces below T_g , but above their T_g they tear easily when pulled in tension. This root cause of the eyebrow crack is further illustrated in Figure 16, which is a close-up of the left most via pair in the above Figures at ambient, and at a peak of 245°C . To better compare relative shape and deformation, the 245°C image is shown flipped 180 degrees vertically. Dotted reference lines are drawn at the indicated locations a, b, and c for both temperatures. Note the distinct tensile zone visible in the region of the via rims (at arrows), exactly where the eyebrow cracks were seen to start and grow in the above Figures.

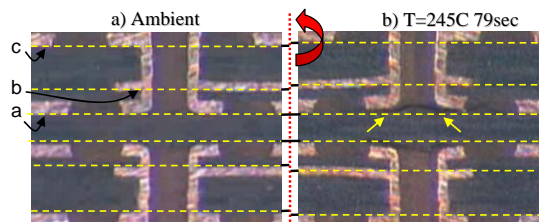
Figure 16— Comparison of $T=245^{\circ}\text{C}$ versus ambient frames to illustrate tensile zone that causes eyebrow cracks.

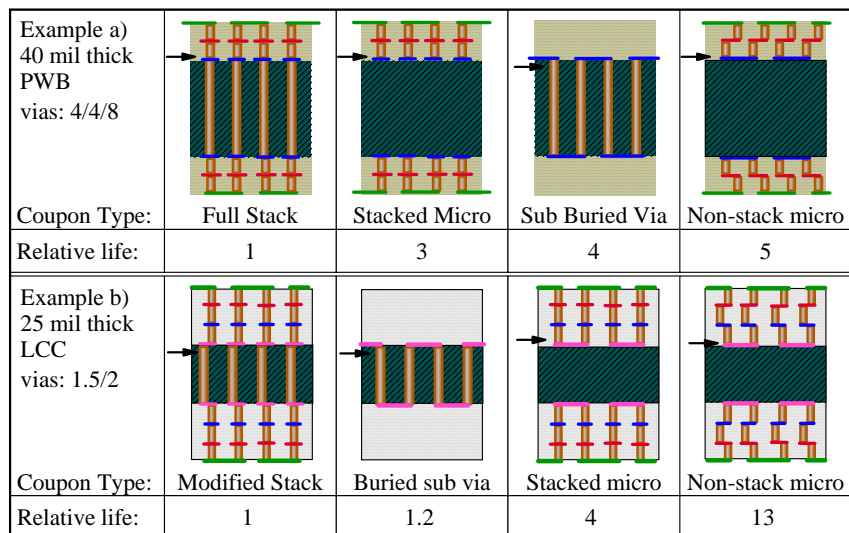
Figure 17 compiles relative via life for 2 different HDI products, one PWB and one dense LCC substrate. Each product had individual CITC coupons covering the 4 different via constructions shown. Relative life is calculated by testing all coupons to fail at CITC 23-220C, and then comparing N50's with a lognormal probability plot. The coupon with the lowest N50 is listed first and defined as with base life =1. In both cases, the first coupon is that structure which most closely resembles a “thru via”, which becomes the first rule of thumb—thru vias or any facsimile see the full force of the Z-axis CTE mismatch as demonstrated by data and photos earlier. That is, the full stack of example a is expected to have about the same via life, and the same propensity for thru via related laminate failure mechanisms if present (e.g. invisible delamination), as would be the equivalent thru via. Therefore in the first example, the full stack structure had the same failure location (indicated with arrows based on failure analysis x-sections) as the next 2 structures, but with cycles to fail 1/3 and 1/4 the values, respectively.

In example b, the first structure is a modified full stack, most similar to a thru via of the four coupons but lacking the full “rivet” nature of a thru via or full stack. Note that though this modified stack is still the first to fail and with the same failure mode as the second coupon, the margin is much closer attributed to the fact that structurally they are more similar than in the first example.

Figure 17-- Relative life by structure for two HDI examples, PWB and LCC.

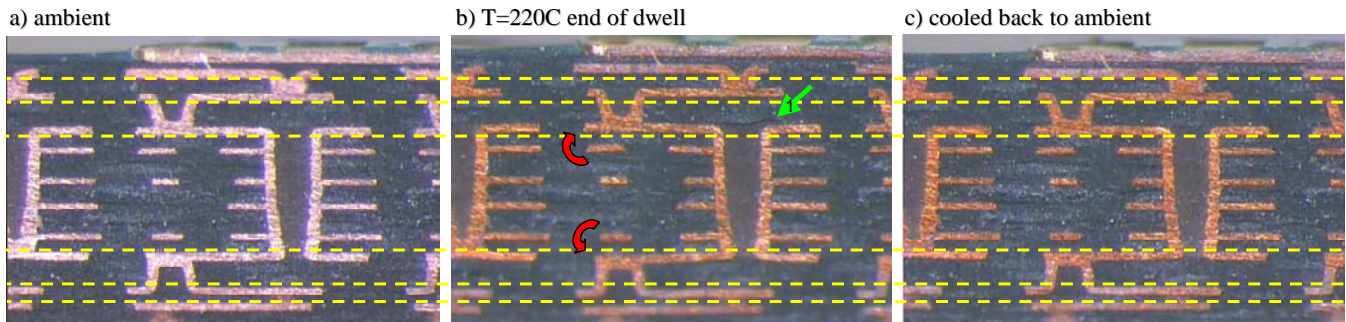
Figure 18-- Frame captures from HDI reflow cycle video

Interestingly, this first rule of thumb also applies similarly on a small scale to microvias. In both examples of Figure 17 the microvias had excellent life, but stacked microvias fail before unstacked microvias, with all else held constant—this is because they are locally more “thru-via” like in geometry and stress state, while the unstacked microvias have an additional degree of freedom in which to flex, reducing the stress on the copper. This situation is illustrated by a final video in Figure 18 for a substrate with 3+3 microvias on a buried via subcomposite. The substrate is cycled from ambient to 220°C and back again (no N₂). The yellow dotted lines are drawn from the build-up layers at ambient to help show both the Z-axis expansion, and more importantly, the flexing of the non-stacked microvias that occurs at °C (red arrows). It is clear how this flexing can reduce the stress on the microvia itself, and explains how unstacked microvias last longer than the stacked microvias, which like small “thru vias” are not able to flex. Note however that an eyebrow crack was formed at the green arrow during dwell at 220°C, which becomes a “reality check” reminder that at least one more rule of thumb is needed: the reduced stress on copper via interconnections in a “less thru-via-like” design comes with a price— possibility of tensile stresses in the resin, and therefore greater risk of eyebrow cracks. Or stated in more general terms, different HDI structures may trade one failure mechanism for another, once again reiterating the need for smart design and evaluations.
