# RESTORATION OF MICROSTRUCTURE AND MECHANICAL PROPERTIES OF LEAD-FREE BISMUTH CONTAINING SOLDER JOINTS AFTER ACCELERATED RELIABILITY TESTING USING A THERMAL TREATMENT

André M. Delhaise<sup>1,2,a</sup>, Mikaella Brillantes<sup>2</sup>, Ivan Tan<sup>1</sup>, Polina Snugovsky<sup>1</sup>, Jeff Kennedy<sup>1</sup>, David Hillman<sup>3</sup>, Stephan Meschter<sup>4</sup>, David Adams<sup>3</sup>, Milea Kammer<sup>5</sup>, Ivan Straznický<sup>6</sup>, Doug D. Perovic<sup>2</sup>

<sup>1</sup>Celestica, <sup>2</sup>Department of Materials Science & Engineering, University of Toronto, <sup>3</sup>Rockwell-Collins, <sup>4</sup>BAE Systems, <sup>5</sup>Honeywell Aerospace, <sup>6</sup>Curtiss-Wright  
adelhais@celestica.com

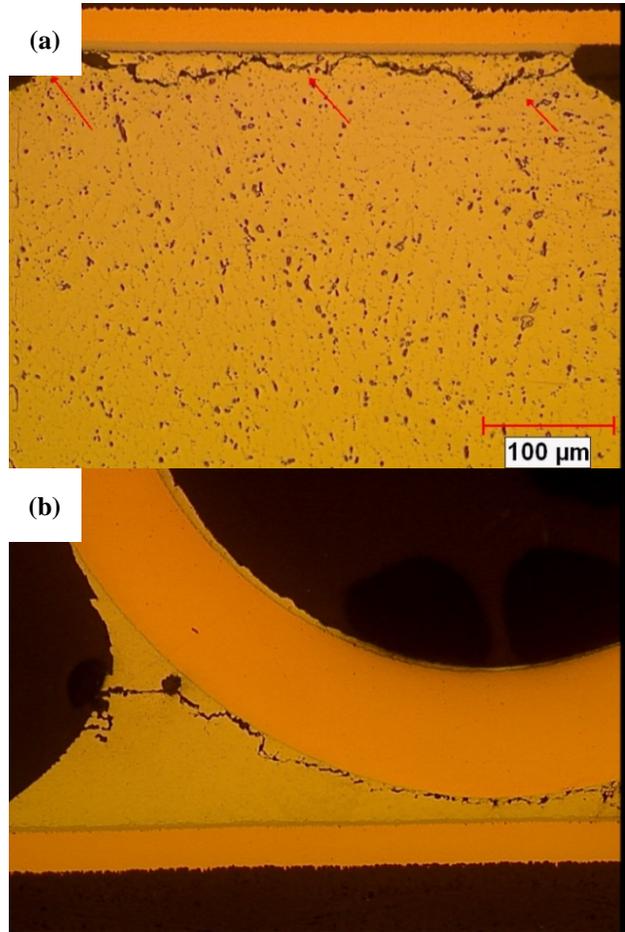
The vast majority of parts (including QFNs) failed in the bulk solder (**Figure 7**), at the component side in the case of the BGA joints.

**Figure 7:** Optical micrographs of solder joints after combined environment exposure. Violet BGA (U1), Joint AP17 (a); SAC 305 PLCC (U109), Pin 1 (b).

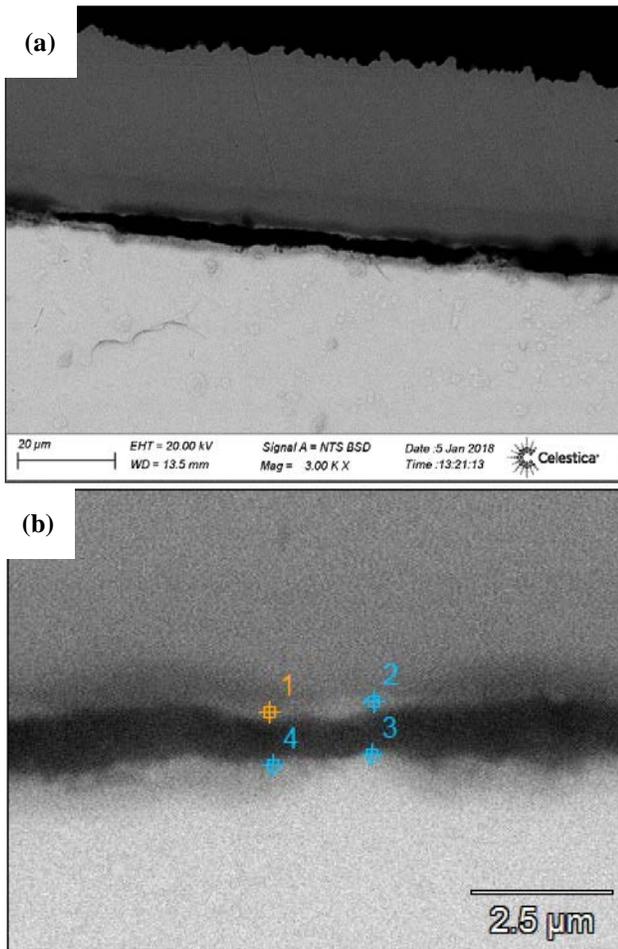
One notable exception was on the Violet BGA (U101, joints A18 and A21), in which the failure appeared to occur in the component side IMC layer. SEM and EDX were performed on these joints (**Figure 8** and **Table 5**) to verify the failure mode. The samples were coated in a conductive Au layer prior to SEM/EDX analysis, which produced Au peaks in the EDX scans. The EDX results indicate that the separation occurred through the intermetallic layer, indicating that a mixed mode interfacial fracture occurred between the intermetallic and the solder/Ni. The Sn and Ni found on both sides of the separation indicate that both sides are part of the IMC layer. It is possible this failure caused the U101 part to fail earlier than the other BGA on the Violet card (U1) and this is an example of an outlier whose failure mode deviates from the rest of the population.

**Figure 8 (starting on previous page):** SEM micrographs of Interfacial Fracture in Violet U101 BGA, Joint A21, low magnification (a); high magnification, showing EDX point scan locations in Table 5 (b).

In addition, EDX was performed on the bulk Ni layer on these joints as well as joints not exhibiting this failure mode, to determine whether high phosphorous content is responsible for the interfacial failure (**Table 6**). It was found that the amount of phosphorous is negligible in both samples, which is expected in typical electrolytic Ni plating.

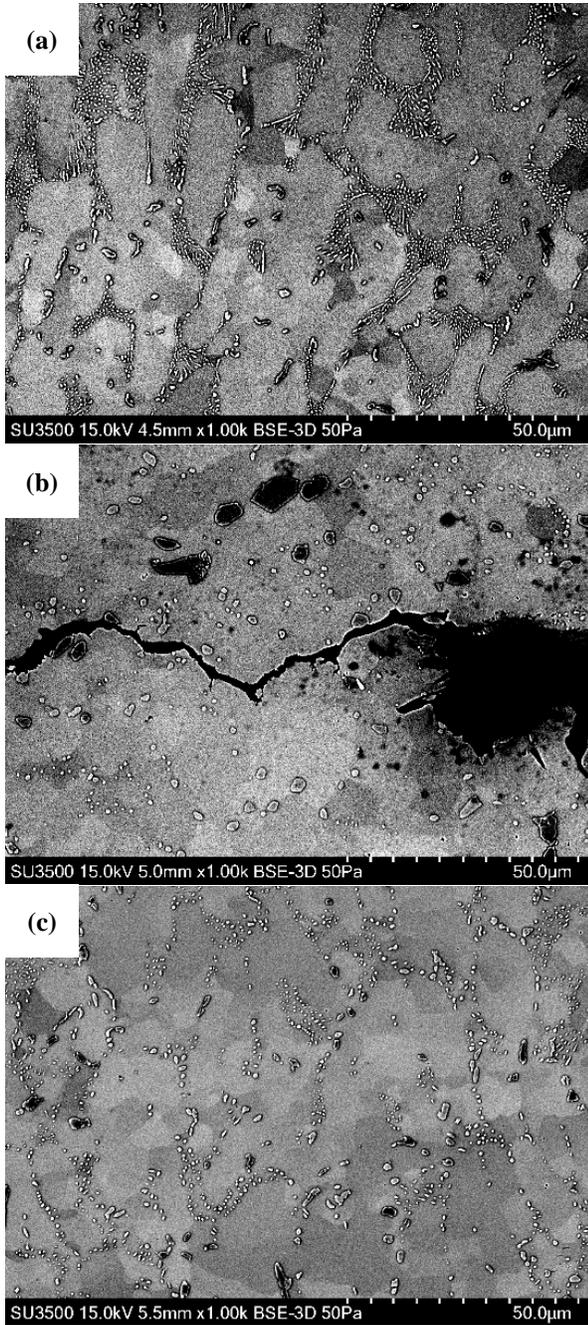
The SAC 305 PLCC joints display typical dendritic microstructure at T0 (**Figure 9a**), with slight coarsening of the IMCs after preconditioning. This structure is no longer present after reliability testing (**Figure 9b**), with significant coarsening of  $\text{Ag}_3\text{Sn}$  and  $\text{Cu}_6\text{Sn}_5$  IMCs. No difference is observed after the restoration treatment, likely because the duration of the treatment is insignificant compared with the duration of the test.

After extensive RT aging, the dendritic structure persists, with coarser IMCs than at T0, but not as coarse as after reliability testing (**Figure 9c**). Once again the restoration treatment has negligible, if any, effect on the microstructure, because of the same reason discussed above. EBSD (not shown) revealed a coarse grain structure for all conditions, comparable to our earlier work<sup>10</sup>, with Sn recrystallizing at the crack front, indicative of damage accumulation during reliability testing.

**Figure 9:** Select SEM images from SAC PLCC joints. T0 (a); Reliability tested (b); RT aged (c).

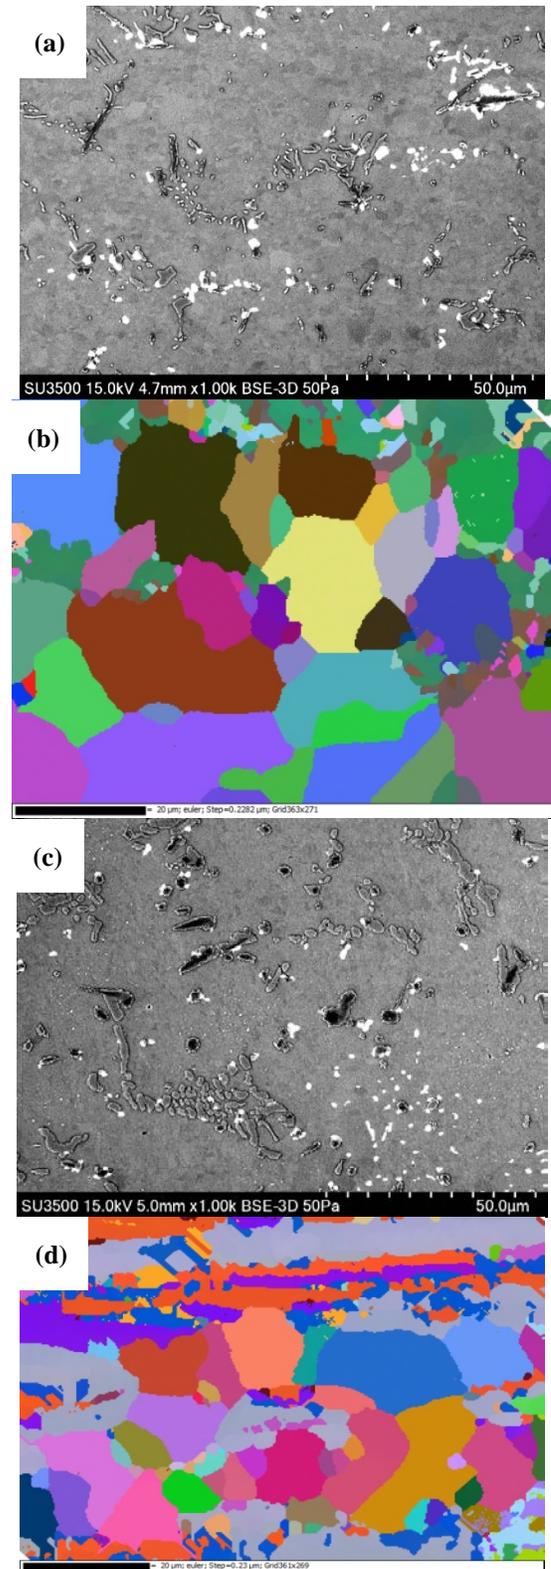
The Violet PLCC joints also solidified in a dendritic structure, with wider dendrite arm spacing than SAC. Bi precipitates were clustered in the interdendritic spaces (**Figure 10a**), and the grain structure was coarse (**Figure 10b**) with localized recrystallization near Bi precipitates. It is likely, since T0 samples were aged at RT for several months, that some particle coarsening occurred. Some Bi appeared to migrate into the Sn dendrites after preconditioning (**Figure 10c**), and the grain structure is

slightly refined due to more uniform Bi precipitation (**Figure 10d**) than at T0.

**Figure 10:** Select SEM images and EBSD maps from Violet PLCC joints. T0, SEM (a) and EBSD (b); Preconditioned, SEM (c) and EBSD (d).

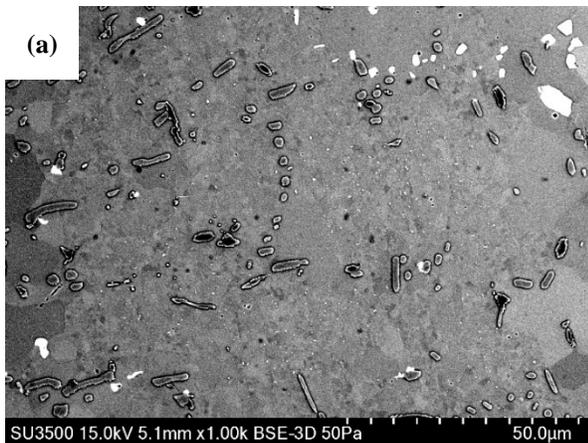
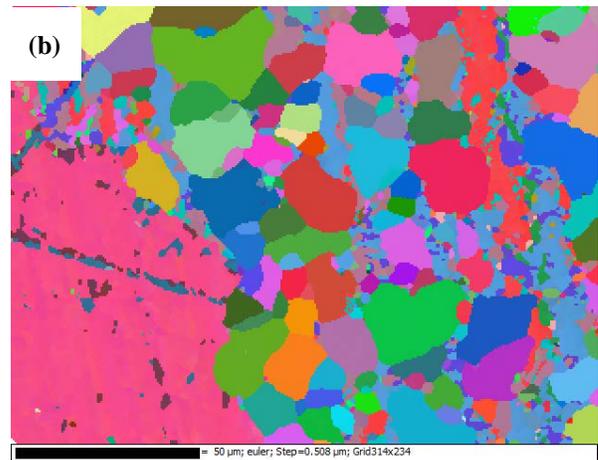
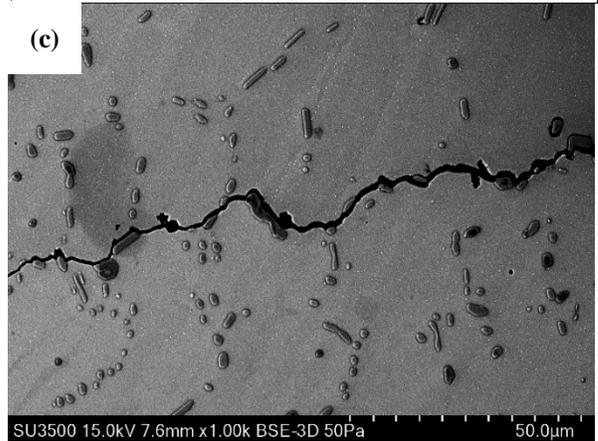
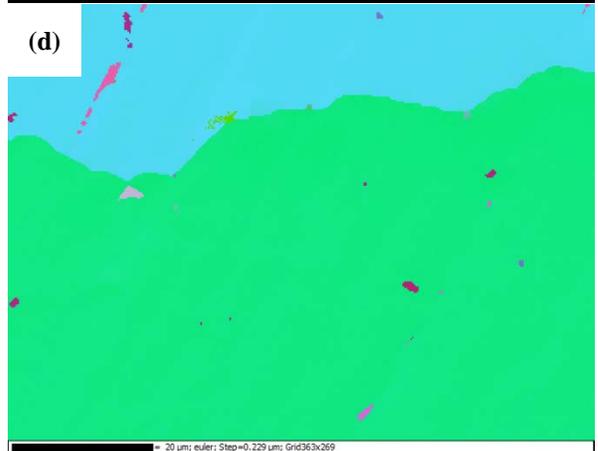
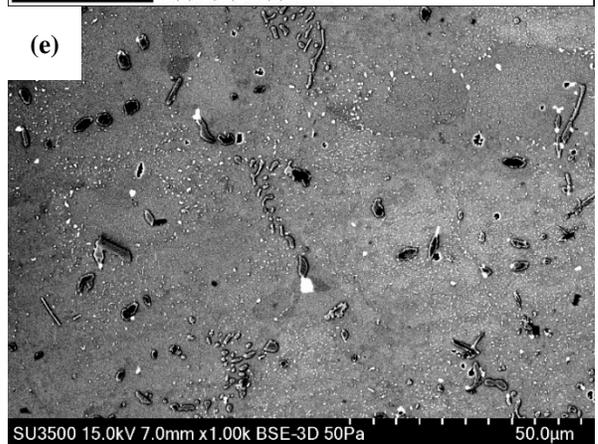
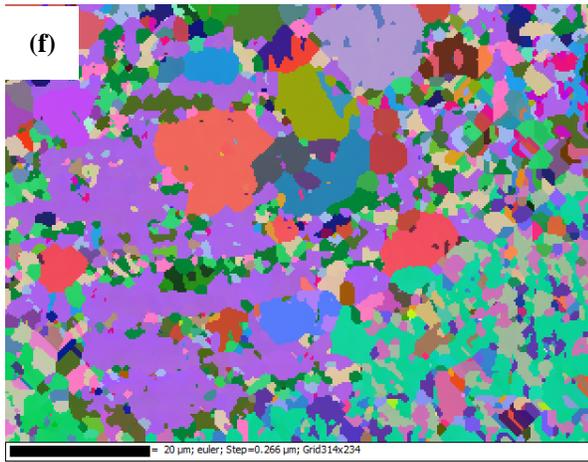
After reliability testing, the dendritic structure was lost (**Figure 11a**) and a lower area fraction of Bi precipitates was observed in cross-section, suggesting Bi may have been forced into a supersaturated solid solution. Extensive recrystallization of the Sn matrix occurred (**Figure 11b**). After restoration, submicron Bi precipitates are evenly dispersed throughout the Sn matrix, with no coarsened particles (**Figure 11c**). The Sn grain structure coarsened drastically (**Figure 11d**); a very different result than expected. It was previously observed, in Bi-bearing solder alloys, that recrystallization of the Sn matrix occurs after aging<sup>10</sup>. This is surmised to be caused by density and lattice structure mismatch between Sn and Bi as the latter comes out of solid solution during cooling, stressing the Sn matrix. This is known as Particle Stimulated Nucleation (PSN). Theory of this phenomenon<sup>17</sup> suggests that submicron particles may fail to induce matrix recrystallization – this may explain the coarsened structure observed in these restored samples.

After RT aging, the microstructure of the Violet PLCC joints is comparable to that of the T0 joints. After the restoration treatment, Bi precipitates became more evenly dispersed into the Sn matrix (**Figure 11e**) and are a little coarser than those present in the joints restored after reliability testing. This is accompanied by significant recrystallization of the Sn matrix, producing a fine grain structure (**Figure 11f**).

The restoration treatment produced very different microstructures between the reliability tested and RT aged joints. It is possible that during reliability testing, Bi undergoes more dissolution and diffusion in the Sn matrix at the higher dwell temperature and becomes more distributed than after isothermal aging at ambient temperature. After restoration, the Bi precipitates become finer and more uniformly distributed in the reliability tested samples compared with the RT aged samples. The particle size in the latter is therefore sufficiently large to induce PSN of the surrounding Sn matrix.

**Figure 11:** Select SEM images and EBSD maps from Violet PLCC joints that had experienced simulated service life. Reliability tested, SEM (a) and EBSD (b); Restored after reliability testing, SEM (c) and EBSD (d); Restored after RT aging, SEM (e) and EBSD (f).

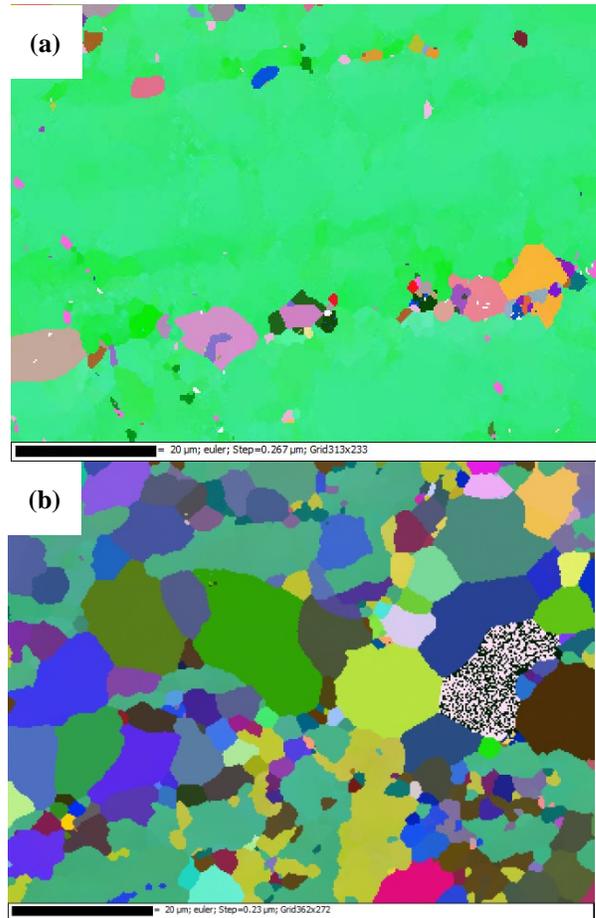
The microstructure and grain structure of the Violet BGA joints closely resembled that of the SAC PLCC joints, with a dendritic structure and very coarse grains (**Figure 12a**). This is likely the result of the BGA ball being composed of SAC 305. Very few Bi precipitates were observed, which is to be expected given the mixed metallurgy of the joint. No observable changes occurred after preconditioning. After reliability testing, the dendritic structure was lost, IMCs underwent coarsening, and some recrystallization was observed, likely caused by damage accumulation during testing (**Figure 12b**). The microstructure after RT aging was very similar to that at T0. No observable changes were observed in either reliability tested or RT aged samples after restoration treatments. Overall, less coarsening of the IMCs occurred than in the SAC PLCCs; this suggests that Bi in solid solution may provide a stabilization effect to the alloy microstructure over time.

**Figure 12:** Select EBSD maps from Violet BGA joints. T0 (a) and reliability tested (b).

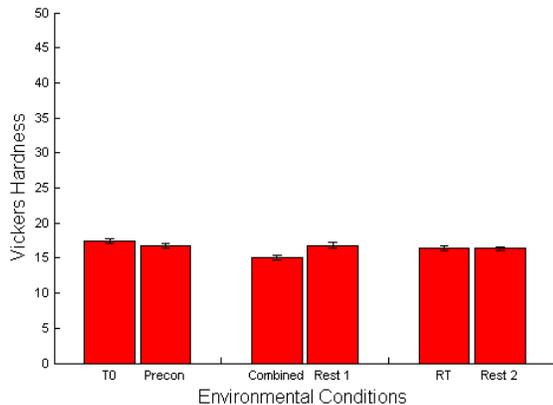
For the SAC 305 PLCC joints (**Figure 13**), all environmental conditions yield comparable hardness values with low standard error; this was observed in the microstructure. For SAC 305, hardness typically decreases after aging, however only a slight decrease was observed after preconditioning. This is probably because the T0 joints had been aged at RT for seven months and further aging above solvus did not degrade microstructure significantly further. The same logic can be applied to RT samples compared to the corresponding restored samples. The

hardness of T0 and RT joints were nearly identical - it is possible that seven months of aging is sufficient to minimize the hardness of the alloy and level off, as seen in previous aging studies<sup>2</sup>. As observed above, the coarsening of microstructure was comparable between these two conditions. The hardness of the reliability tested joints was noticeably lower than T0 joints; this is indicative of the damage incurred during testing. Finally, the hardness of the reliability tested joints increased slightly after restoration – this is not expected for SAC and is likely the result of variations in hardness between individual joints, each with different Sn grain orientation.

**Figure 13:** Hardness of SAC 305 PLCC joints after environmental exposure and heat treatment.

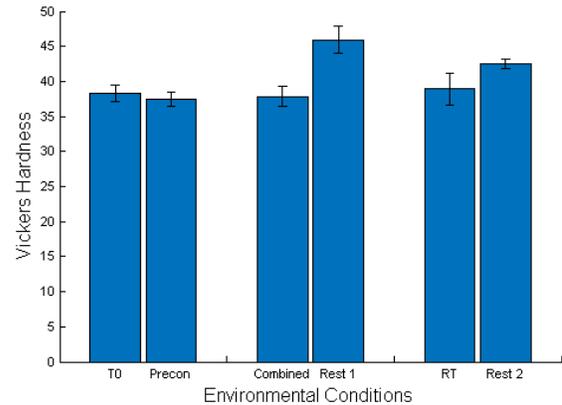
The Violet PLCC joints (**Figure 14**) demonstrated higher hardness values than their SAC 305 counterparts, likely caused by Bi present in solid solution and as second phase precipitates. The standard error is higher; this may be because there are more second phase particles in the microstructure, resulting in a higher likelihood for the indenter head to contact IMCs and/or Bi precipitates.

All three assembly conditions (T0, reliability tested, and RT aged) show comparable hardness; each had experienced some long-term storage / simulated usage and the degree of microstructure evolution was comparable. The reliability tested samples, however, contained a much sparser distribution of Bi precipitates and it is possible the Sn matrix may be supersaturated with Bi. Preconditioning did not change hardness after T0 statistically; this agrees with results from our prior studies<sup>2</sup> and with the microstructures shown in **Figure 11**.

The hardness of joints that had undergone reliability testing increased appreciably after restoration treatment, indicating the treatment ‘healed’ the microstructure. As observed in **Figure 11c**, Bi precipitates are very fine and evenly dispersed in the Sn matrix, which likely contributes to this improvement in hardness. A similar, but smaller increase in hardness is observed in joints that had experienced long-term isothermal storage – as shown in **Figure 11e**, precipitates are slightly coarser and less dispersed than those

restored after reliability testing. These improvements are likely caused by dissolution of coarse Bi precipitates; these are less effective at strengthening the alloy.

**Figure 14:** Hardness of Violet PLCC joints after environmental exposure and heat treatment.

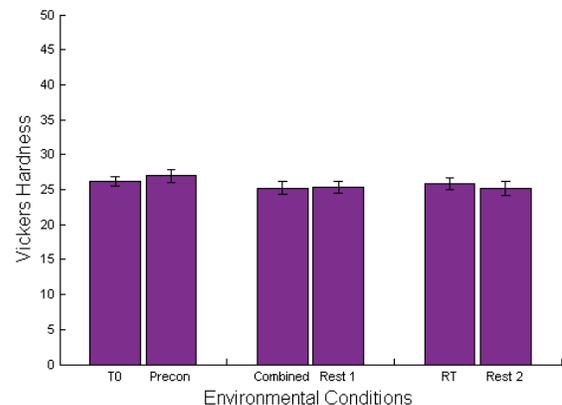
The Violet BGA joints (**Figure 15**) demonstrated hardness values and standard error intermediate to those of the SAC PLCC and Violet PLCC joints, due to the mixed metallurgy. The three assembly conditions again show comparable hardness, likely due to the same reasons explained above. Similar to the SAC PLCC joints, Violet BGA joints that had been reliability tested show slightly lower hardness than T0 and RT aged joints – this is correlated with slight coarsening of IMCs. The difference is less than that for SAC PLCC, indicating that Bi may mitigate damage accumulation and IMC coarsening. All heat treatment conditions show no statistical difference in hardness from their original assembly conditions, which again can be explained by comparable microstructures. As these joints are mixed metallurgy, few to no Bi precipitates are present in these joints and thus little to no Ostwald ripening is expected. This is a different result from the Violet PLCC joints and indicates the heat treatment may be more beneficial if Bi precipitates are present in the microstructure.

**Figure 15:** Hardness of Violet BGA joints after environmental exposure and heat treatment.
