## USE OF COMBINATION 2D AND CT SCAN X-RAY IMAGING FOR SOLDER JOINT INSPECTION

Nandu Ranadive  
IBM Corporation  
Poughkeepsie, NY, USA

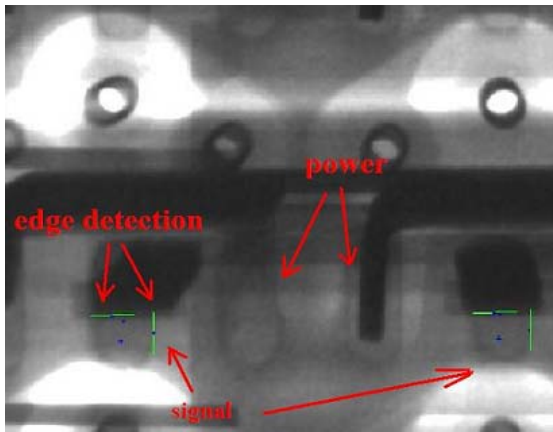
**Figure 1b:** Lead geometry and connection points

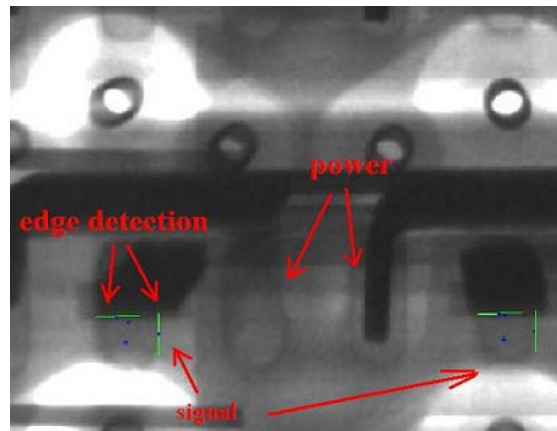
**Figure 2a:** Program execution initial stage showing vertical and horizontal edge detection

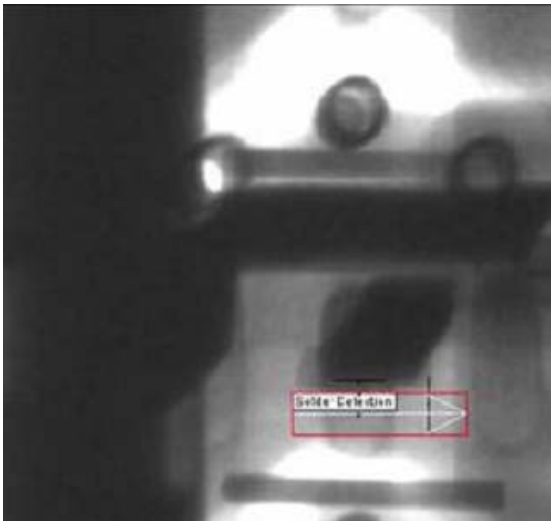
**Figure 2b:** Program conclusion showing stripe failure at vertical edge

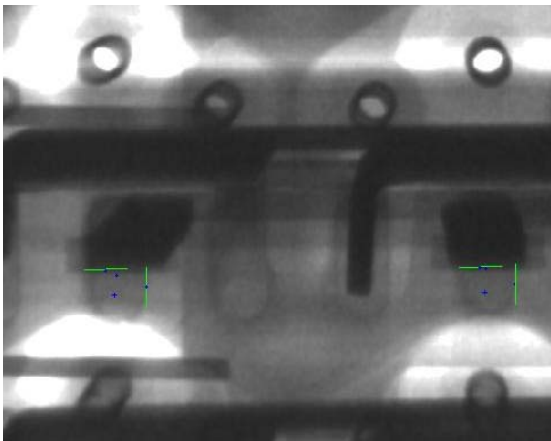
**Figure 3:** A typical inspection sequence showing acceptable solder joint quality

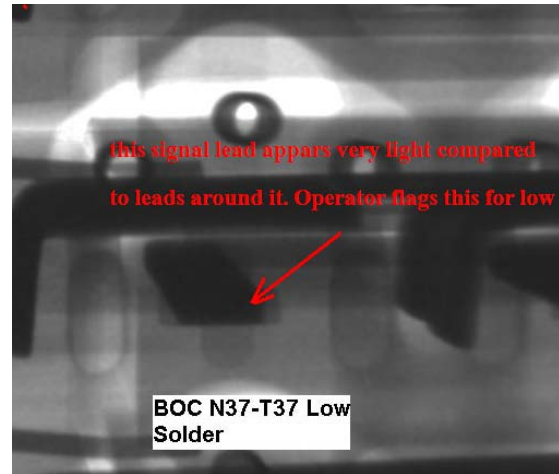
**Figure 4:** Shows a potential defect flagged by 2D inspection as low solder. Note that the area of the lead does not show any edges

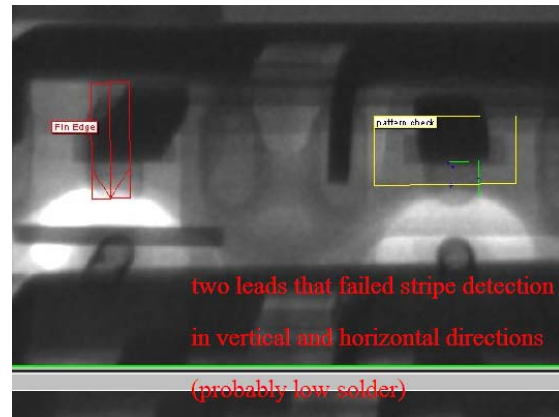
**Figure 5:** A combination fail. One lead failed for vertical stripe detection, the other failed for solder compare

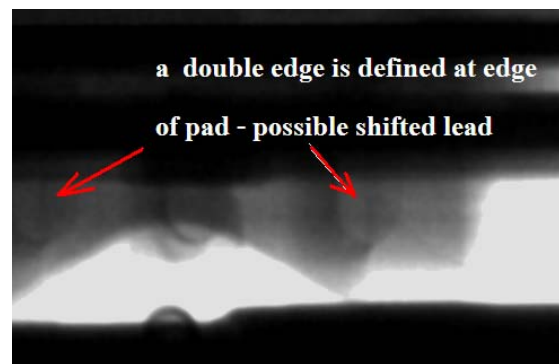
**Figure 6:** Leads that appear to be shifted at least 50% off the pads were flagged by the algorithm

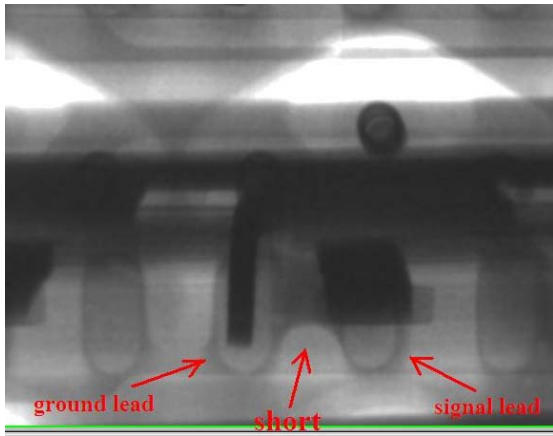
**Figure 8:** An example of solder short that was caused due excess paste deposition

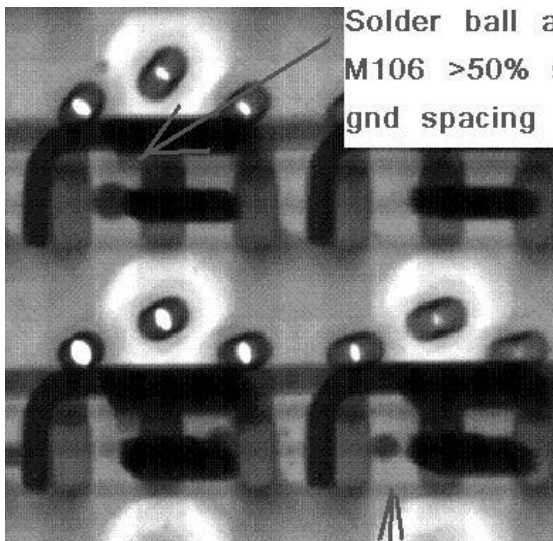
**Figure 9:** Example of solder balls that span about 50% lead to lead spacing

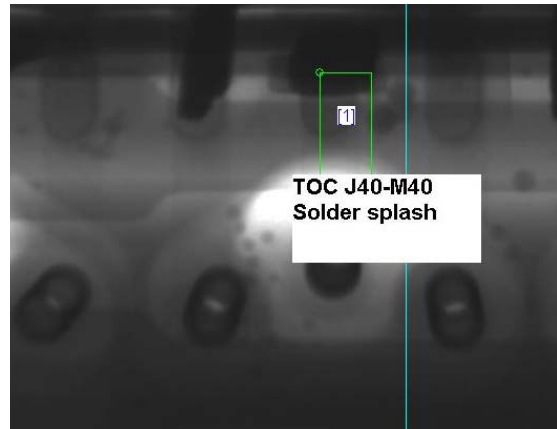
**Figure 10:** Typical example of solder splash showing numerous tiny solder balls, dispersed in the footprint

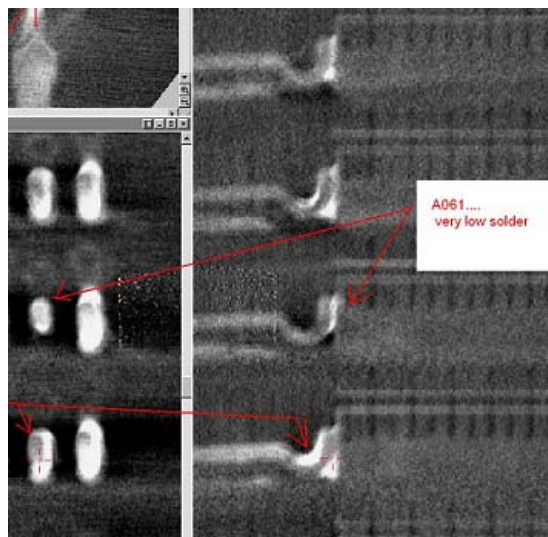
**Figure 12:** A typical low solder volume defect detected by CT scan showing planar and side views of the same lead

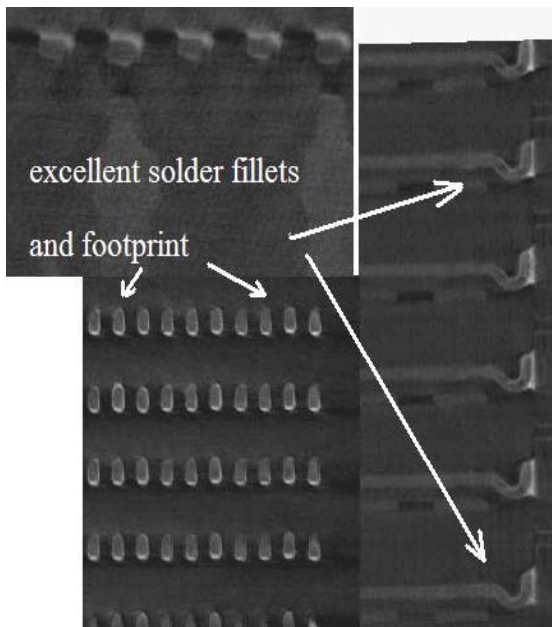
**Figure 13:** A Typical good solder connection. The fillets are nicely formed, joint thickness is uniform and footprint shows good coverage

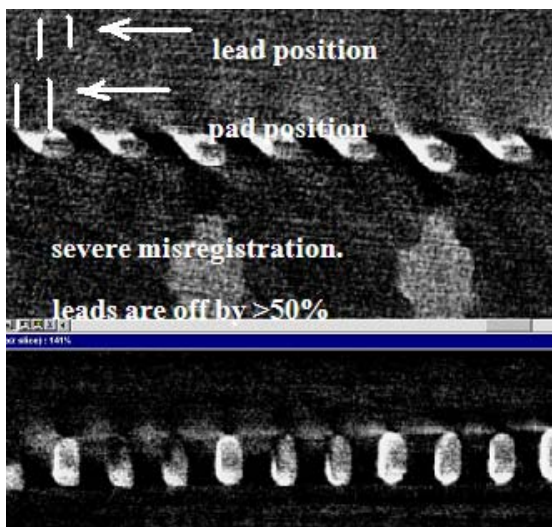
**Figure 14:** Typical frontal view of a mis-registered lead. The relative position of the lead is off by more than 50%

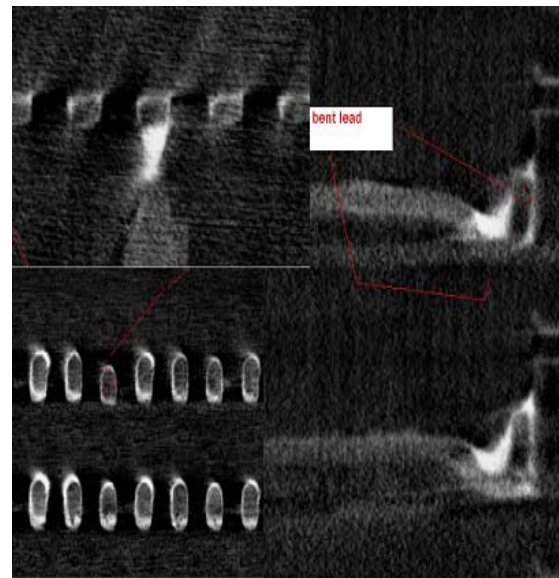
**Figure 15:** Solder Climb defect that has resulted in smaller footprint (bottom right), indicating that there is now less solder in the joint

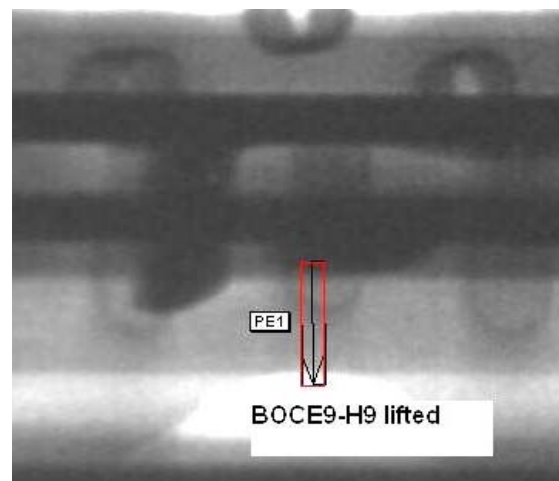
**Figure 16:** A bent lead detected by 2D inspection algorithm. Lead position is slightly shifted up

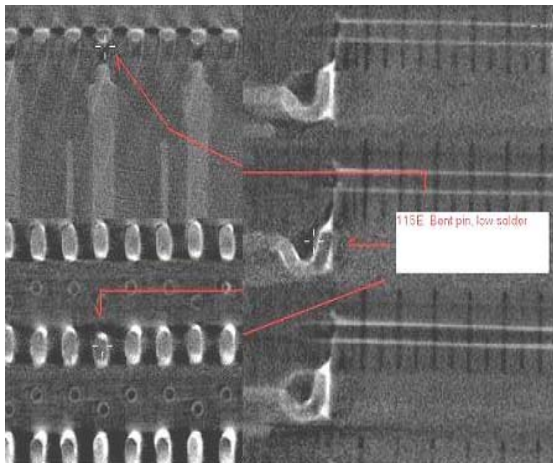
**Figure 17:** A bent lead defect flagged by 2D is easily validated by 3D. The center lead is bent differently

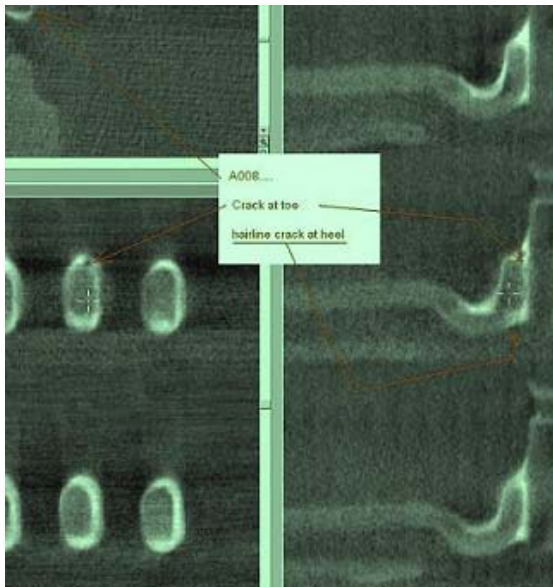
**Figure 18:** Connector lead in the center shows an evidence of a stress crack near the toe
