A Method to Investigate Printed Circuit Board Supplier Rework Processes and Best Practices

Hailey Jordan¹, Wade Goldman P.E.¹, Curtis Leonard¹,
Edward Arthur²

¹The Charles Stark Draper Laboratory, Inc., Cambridge, Massachusetts

Abstract

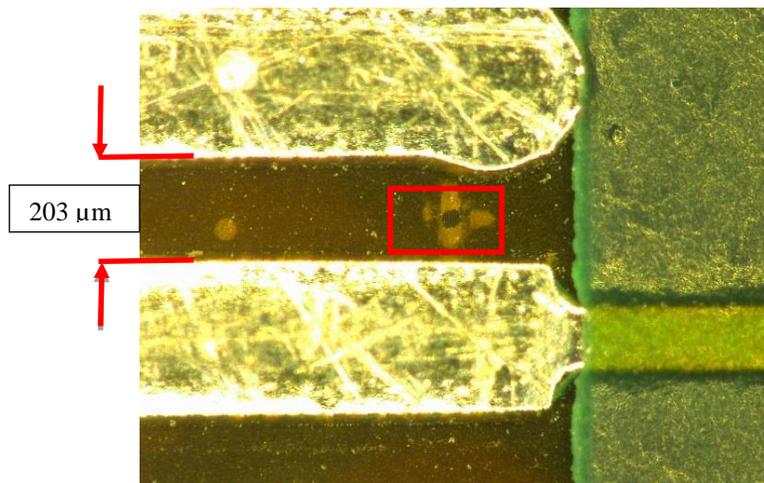
In the instance of weave exposure that the team was reviewing, the concern was raised that the exposed weave condition could potentially reduce the minimum electrical spacing between conductors (especially tightly pitched component leads). Typically for this board design, the minimum conductor clearance is 127 μ m (0.005 in.). Several unassembled PCBs were provided for evaluation. During the initial visual inspection using standard magnification, it was unclear if the weave condition was weave texture or weave exposure. As a result, higher magnification was needed to accurately identify the condition. Very high magnification (200X and 400X) was used to view the weave exposure, and it was determined that the weave exposure condition was in violation of minimum conductor spacing requirements. See Figures 1 and 2 for examples of the exposed we've seen.

Figure 1: Exposed weave between connector lead pads.

The investigation into the root cause of exposed weave, including a thorough review of the manufacturing process traveler and accompanying documentation, for the manufacturing lot in question led to the following information (Goldman, et al., 2018). The boards were reworked by stripping cured soldermask (and cured epoxy ink marking) in accordance with an in-house approved procedure which specified using a caustic stripper and then using a pumice scrubber as part of the wash down procedure. This process was conducted while the boards were full up panels. With a high level of confidence, it is believed that the result of this process which attacked the resin on top of the glass fibers, resulting in weave texture and weave exposure. The chemical stripper employed was an aggressively caustic solution using dipropylene glycol monomethyl ether as a water-soluble solvent.

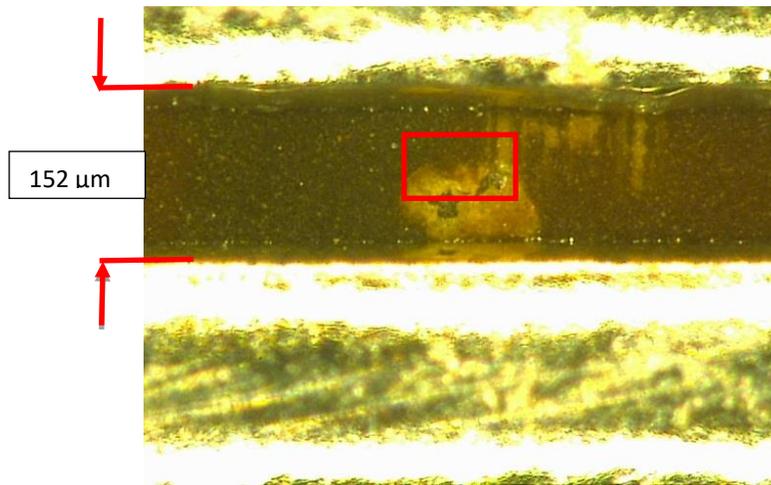
Figure 2: Exposed weave between component lead pads.

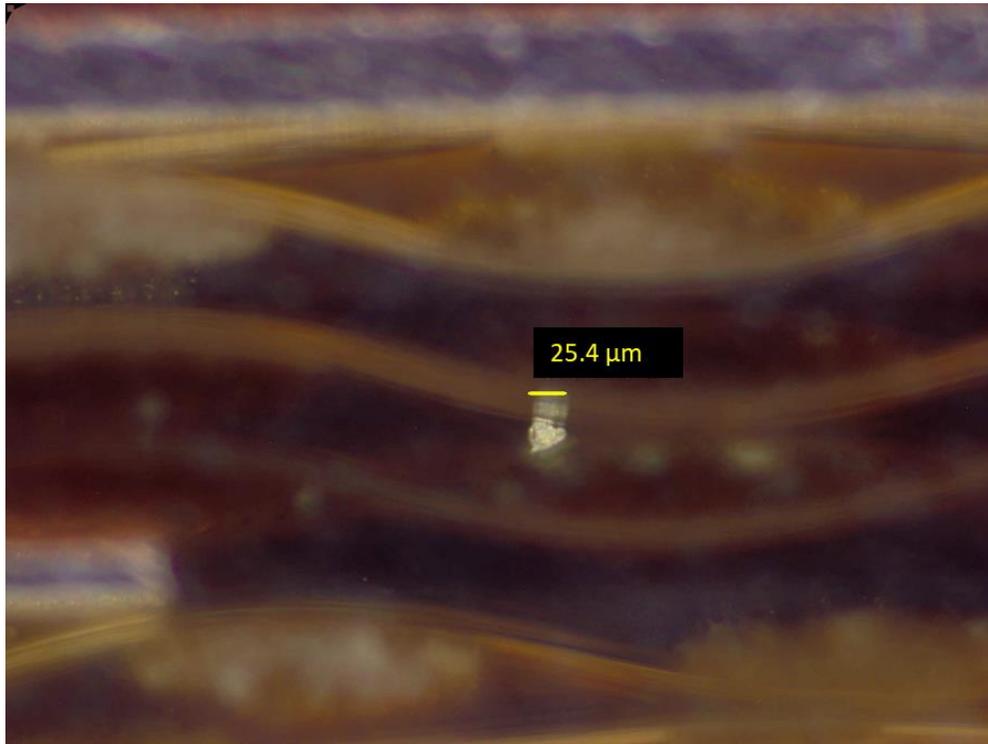
The second item that contributed to the need to review rework processes and best practices at PCB suppliers was a system failure investigation. The root cause was determined to be FOD which promoted a CAF failure. There was no direct evidence of CAF due to the PCB destruction in the vicinity of the failure site. However, there is circumstantial evidence based on FOD discovered in an adjacent location in the PWB in proximity of the burnt failure site. The PCBs are built up into a complex system, and defects at the PCB level can result in system failures. This investigation started at the PCA level and resulted in a detailed destructive physical analysis of the PCB. Some examples of relevant FOD can be seen in Figures 3 and 4.

Figure 3: Example of Metallic FOD, seen at magnification of 125X in Dark Field inspection.

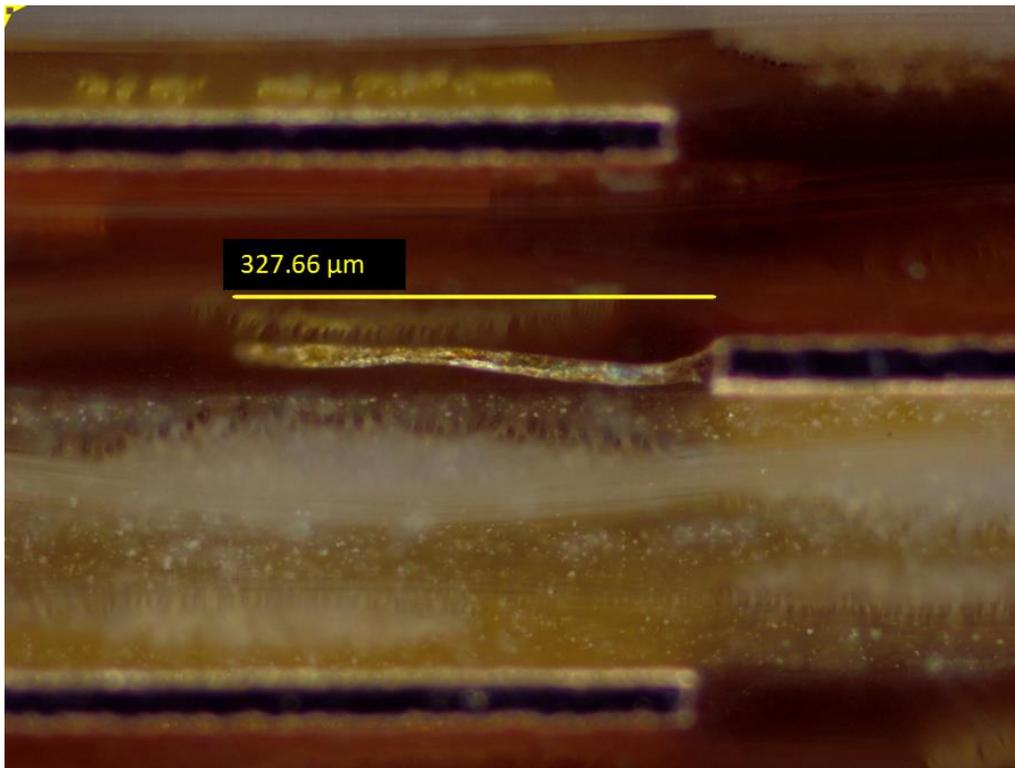
Figure 4: Example of Non-Metallic FOD, seen at magnification of 125X in Dark Field inspection

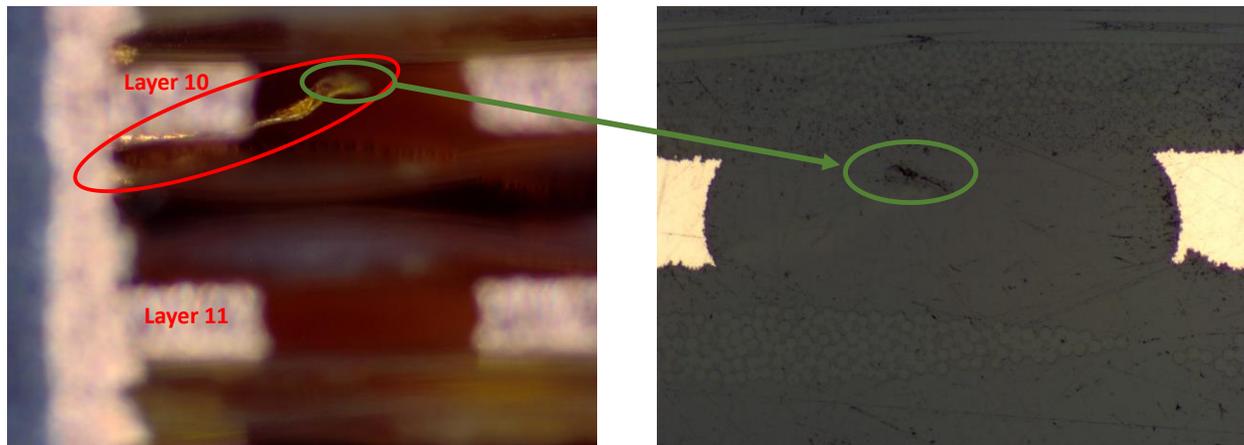
conformance coupons within the same manufacturing lot. As a result of the failure analysis, evidence led the team to the conclusion that the mechanism causing the failure of the system was a foreign inclusion, which acted as a catalyst in propagating a crack, thereby providing a pathway for copper plating and plating residue to travel up the crack. This condition reduced the design clearance distance between a buried via (which is signal GND) and layer 11 plane (which is a 3.3V plane). This reduced distance had been breached by a conductive filament growth facilitated by plating residues over time.

Once the short was established, the heat generated by the short caused burning and melting of the dielectric material, creating carbonization (electrically conductive), which further propagated the short. The electrical short measured in the failure site coupon mount was the result of the carbonized material in the PCB (Goldman, Grubbs, & Arthur, 2016). A photo of one of the lot conformance coupons with a foreign inclusion can be seen below, in Figure 5.

Figure 5: PCB Acceptance Coupon with FOD (Dark Field on Left, Bright Field on Right).
