# COLLABORATION BETWEEN OEM AND EMS TO COMBAT HEAD ON PILLOWING DEFECTS: PART 1 – AXI CAPABILITY FOR HOP DETECTION

## ABSTRACT

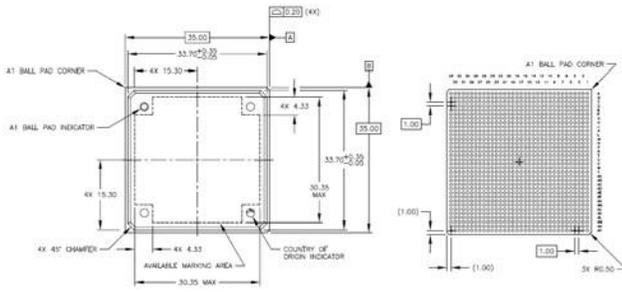
**Figure 5:** 35x35mm PBGA with HoP defects

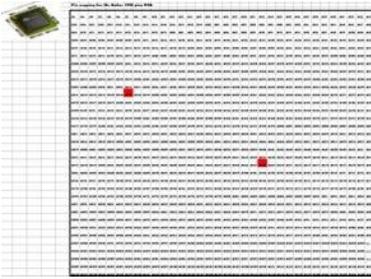
The tedious process of cross-sectioning each device row by row was used in order to observe any potential HoP defect that may have escaped both electrical probing and AXI. As expected by the team, the HoP defects identified were more toward the center rather than in the corners of the PBGAs, owing to the device warpage which is described as concave down during reflow. As shown in Figure 5, the pin map shows the locations of the two defects from part ID 10 and 23.

**Figure 5:** Pin map of the two failing pins on the part ID 10 on board SN8 and 23 on board SN11

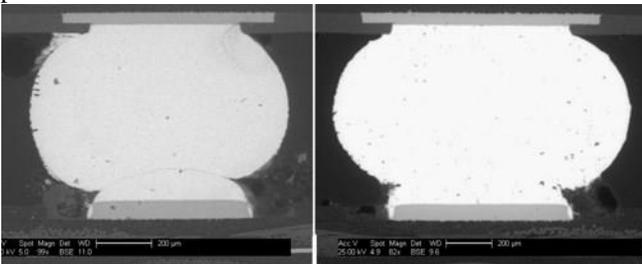
Images of the two HoP defects from part ID 10 on board #8 and part ID 23 on board #11 are shown in Figure 6. As described in Coyle’s paper [2], some HoP failures might even pass electrical testing depending on the HoP joint type and how it was formed. From an inspection and statistical point of view, this may not be a big concern because a small percentage of defects are expected to escape any algorithm that is not yet completely mature. However, from a product point of view, this type of one pin defect escaping inspection is the worst enemy of the OEM as it is expected to fail after a period of time in the field.

**Figure 6:** The single HoP defect of the part ID 10 from board SN8 on the left, and the part ID 23 from board SN11 on the right

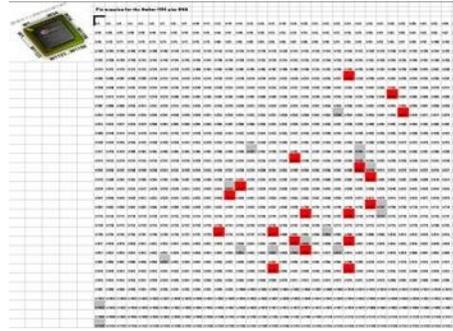
Finally, the focus turned to part ID 1 on board #8 as the last part for cross-sectioning in this program and the pin map of HoP is shown in Figure 7. This part ID had a large number of HoP reports by each EMS site. In addition, the results from the different sites varied quite a bit between the number of escape calls (defined as a real defect that was not caught by the inspection) versus the number of false calls (defined as a good joint reported as a defect by the AXI). For part ID 1 board #8, cross-sectioning shown in Figure 8, was performed row by row and the pin map diagram shown in Figure 7 illustrates where the defects were located on the part. All the pins highlighted in **RED** are those that were confirmed by cross-section and are considered to be real defects. All the pins highlighted in **GREY** are those that have been confirmed as false calls from one or multiple machines.

**Figure 7:** Pin map of HoP on part ID 1 on board SN8

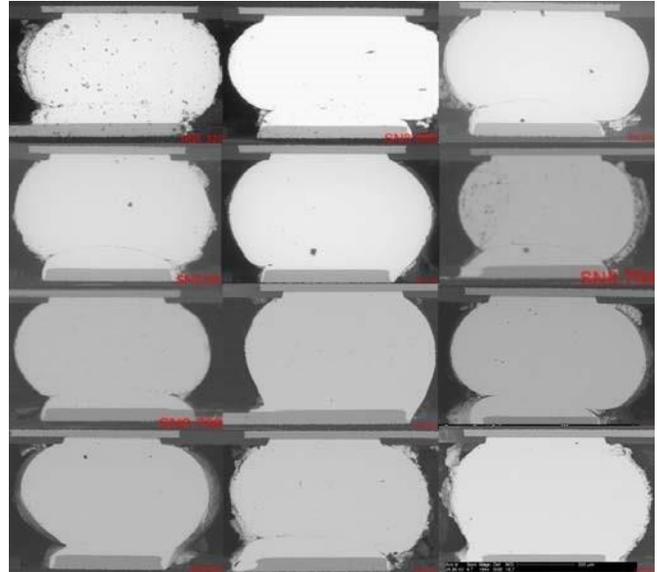
**Figure 8:** HoP images of different pins from part ID 1 on board SN8
