# Effects of Dielectric Material, Aspect Ratio and Copper Plating on Microvia Reliability

Thomas Lesniewski

Northrop Grumman Corp, San Diego, CA

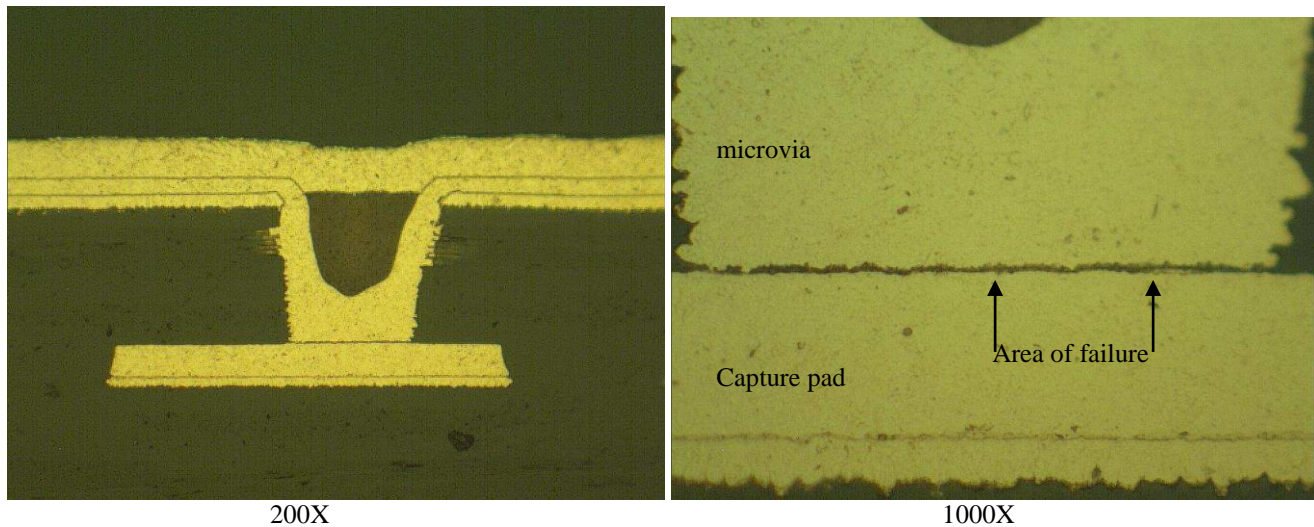
Board and coupon failures were isolated to discontinuities across microvias. Failed microvias were analyzed by cross section, FIB and SEM to determine the failure mechanism. In this study, all failures occurred at the interface between the microvia and the capture pad, as illustrated in Figure 3. In some cases, it was easy to see separation under a microscope, for example in Figure 3. However, in other cases, such as Figure 4, there was a line of demarcation at the base of the microvia but it was hard to tell at 1000X magnification whether or not there was separation between the microvia and capture pad. In those cases, cracks became visible 10,000X magnification, after the interface had been smoothed by Focused Ion Beam (FIB).

Figure 3. Cross section images of failed microvia.

The FIB/SEM images showed separation within the electroless copper layer at the base of the microvia. The images led to these conclusions:

- Failure mechanism was brittle fracture of electroless copper. The most likely cause was fatigue stress brought about by the differential expansion and contraction between the dielectric and copper.
- Failures were cohesive rather than adhesive.
- Failures were not the result of residues or incomplete cleaning of the capture pad.
- Besides the microvia failures, there was evidence of thermal stress in the PWBs, but no evidence of thermal overstress.
- Any variation in the quality of electroless plating, such as voids or low density, weakened the copper and contributed to fractures.
- In some cases (discussed below), there was minimal electrolytic copper cap on the target pad at the base of failed microvias.

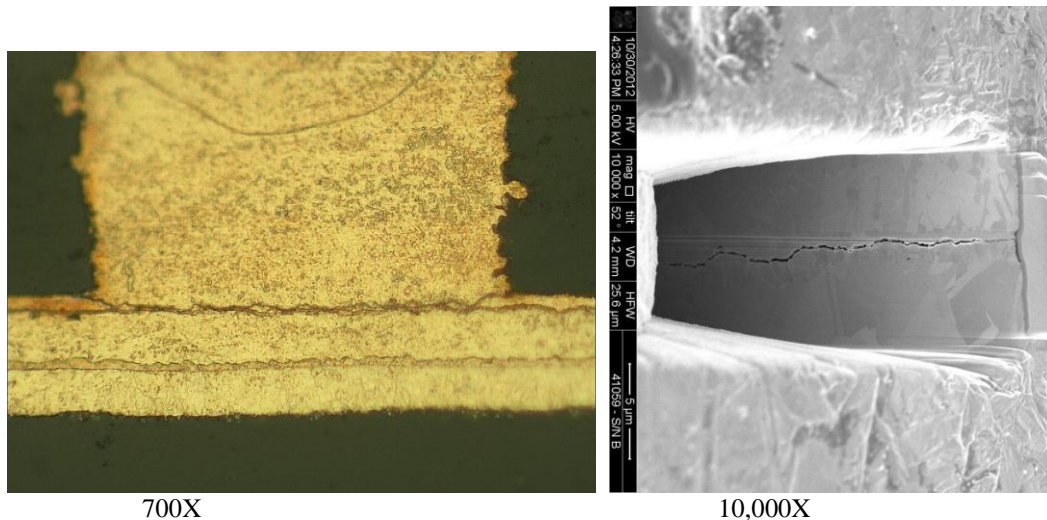
Figure 4. Cross section and SEM images of failed microvia

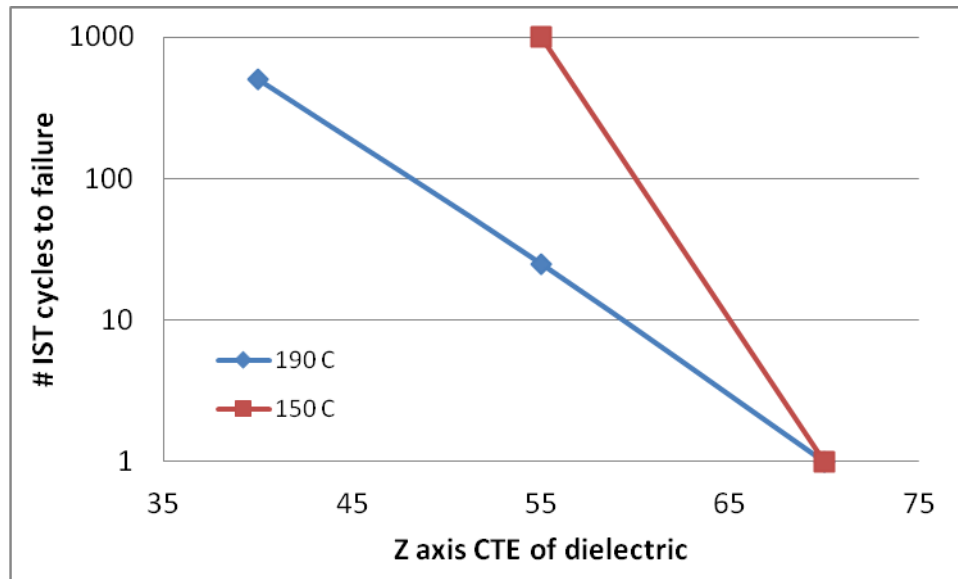
Most of the microvias that failed in test showed acceptable plating quality, and would not have been flagged during final PWB fabrication inspection. Detachment of the microvias from the capture pad suggests a strong z-axis effect which explained the trends with different materials. Material A, with the highest z-axis CTE, showed the most defects in thermal stress testing, while Material C had the lowest CTE and failure rates. Figure 5 illustrates the strong effect of the dielectric material on microvia reliability in IST.

**Figure 5. Effect of Z axis CTE on microvia IST reliability, for aspect ratio 1:1. The two lines represent IST peak temperatures, either 190°C or 150°C.**

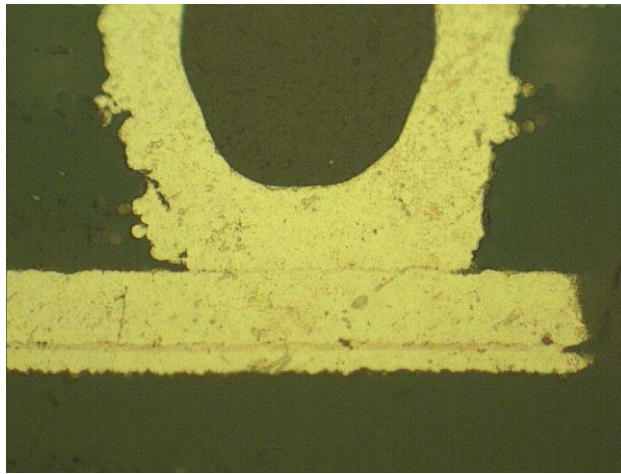
Figures 6 and 7 contrast a microvia deposited on a thick layer of electrolytic copper, and a microvia deposited on thin electrolytic copper. If the amount of electrolytic copper on the capture pad is thin to begin with, the resulting microvia will be susceptible to reliability issues. Laser drill and/or cleaning processes may further deplete the electrolytic copper, leaving behind an underlying layer of electroless copper, on which the microvia “seed” layer is deposited. The results of this study clearly showed that microvias with electroless-to-electroless connections failed at a higher rate than microvias on which the electroless copper was deposited onto a thick cap layer of electrolytic copper—see Figure 8.

Figure 6. Microvia deposited on capture pad with 1 mil of electrolytic copper.

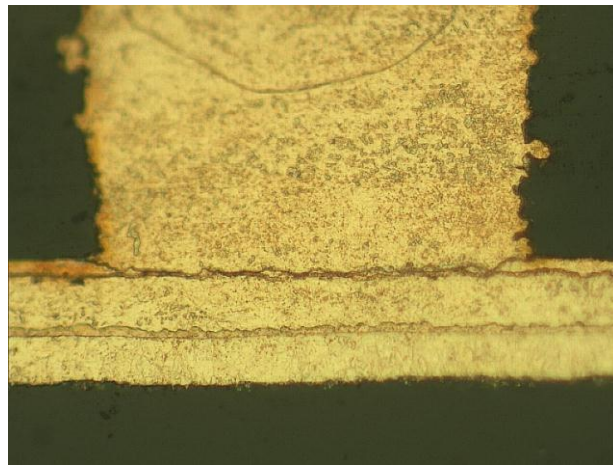
Another important factor in the failed microvias was the nature of the copper at the capture pad. References 7 and 8 cite thin copper at the capture pad as a problem with high aspect ratio (>1:1) microvias, but this study showed that under certain circumstances it can be a problem even with lower aspect ratios.

Figure 7. Microvia deposited on capture pad with minimal electrolytic copper cap.

- Capture pad copper composition. Processes that result in an electroless-on-electroless base layer for microvias is prone to premature brittle failure. 0.0003" minimum of electrolytic copper is recommended at the microvia capture pad.

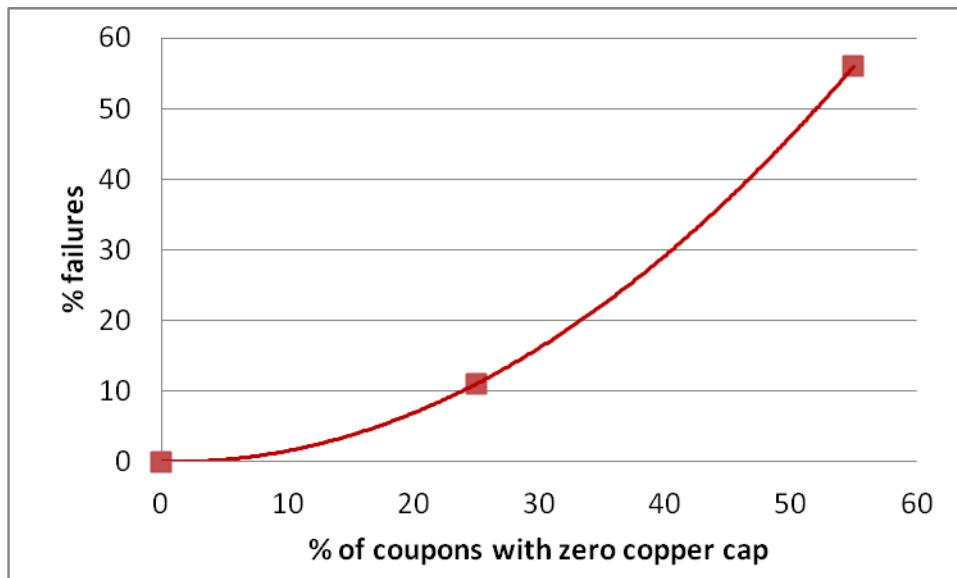
Figure 8. Microvia failure rate trend with copper cap thickness. As the number of samples with no electrolytic copper cap at the capture pad increased within a lot, the failure rate increased steeply. The trend illustrates that an electroless-to-electroless copper interface is less reliable than electroless-to-electrolytic.
