FALSE TIN WHISKERS: MASQUERADING TIN COPPER INTERMETALLICS

David Hillman
Rockwell Collins Inc.
Cedar Rapids, IA, USA
ddhillma@rockwellcollins.com

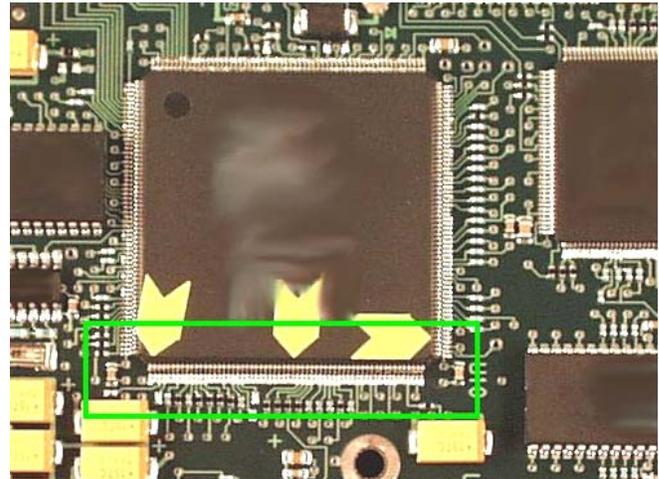
In March of 2007, a Rockwell Collins assembly auditor notified a process industrial engineer of whisker-like anomalies on a Quad Flat Pack (QFP) component. Figure 1 illustrates the printed wiring assembly and QFP component. Optical inspection of the QFP component revealed a large quantity of anomalies that appeared to be tin whiskers. Figure 2 illustrates the anomalies observed during the inspection.

Figure 1. Printed Wiring Assembly and Anomaly Location on QFP

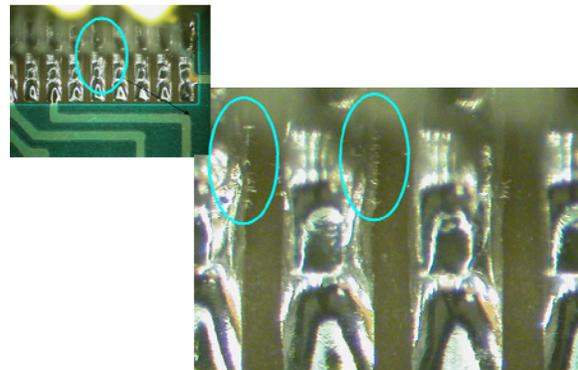
Figure 2. Anomalies Observed During Optical Inspection of QFP (Top); Magnified Optical View of Anomalies (Bottom)

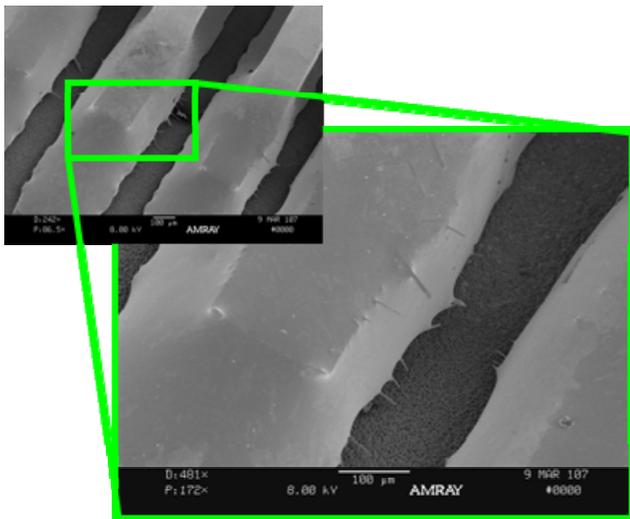
Photodocumentation of the printed wiring assembly was completed and the QFP component carefully removed for Scanning Electron Microscopy (SEM) analysis. The QFP solder joints showed good solder joint wetting and acceptable solder joint geometries. The identified anomalies were predominately located at the specific features associated with the solder joint (i.e. the component lead and the printed wiring board pad). Figure 3 shows the anomalies protruding from the upper edge of the QFP lead and in the region of the printed wiring board pad.

Figure 3. Anomaly Observations during SEM Analysis

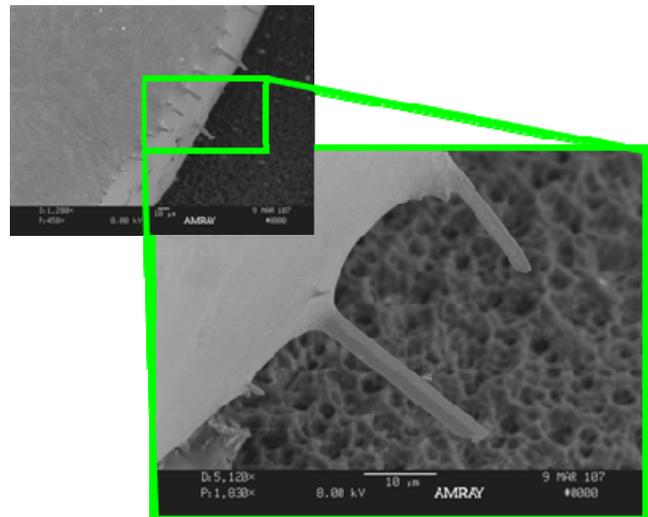
Figure 4 illustrates additional anomalies observed during the SEM analysis. The whisker-like protrusion in Figure 5 shows a hexagonal cross-section, ordered spacing and surface wetting at the anomaly base near the tin/lead solder. Several of the anomalies were observed to be hollow and filled with tin/lead solder (Figure 6).

Figure 4. SEM Images of Whisker-like Anomalies (Top); Magnified View of Anomaly (Bottom)

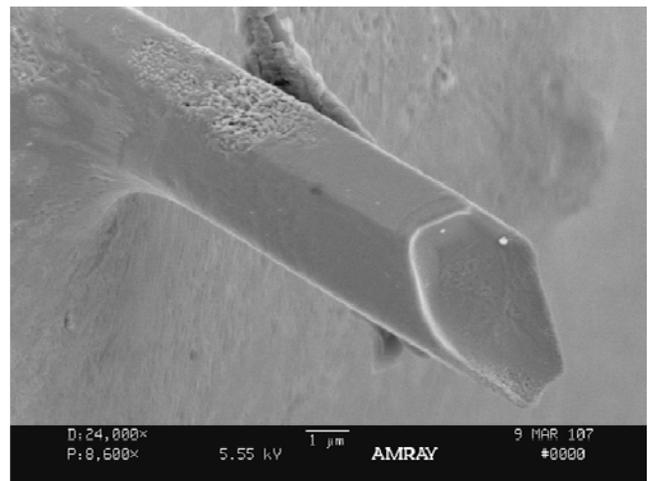
Figure 5. SEM Image of Whisker-like Anomaly

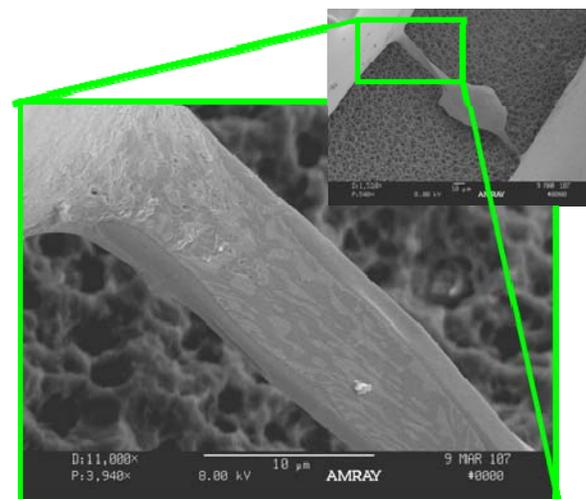
Figure 6. SEM Image of Anomaly Filled with Tin/Lead Solder

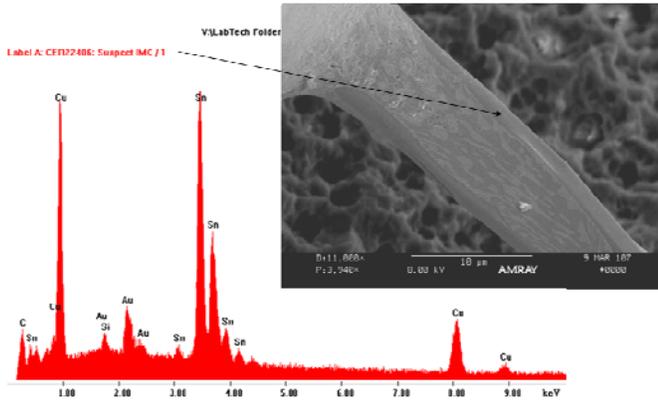
determine their elemental composition. The outer shell of the anomalies was determined to be a tin/copper alloy with a rough element ratio of six parts copper to five parts tin (Figure 7). The material contained within the anomaly was determined to be tin/lead solder from the soldering process thus demonstrating that the anomaly was a hollow structure (Figure 8). The gold indications shown in the SEM EDS measurements is an artifact of the gold sputter coating applied to the QFP as part of SEM analysis preparation.

Figure 7. SEM EDS of Whisker-like Anomaly Outer Shell

The SEM analysis results revealed the true identity of the whisker-like anomalies observed on the printed wiring assembly. The SEM EDS results show the copper/tin element ratio of the anomalies to be approximately six parts copper to five parts tin which would correspond to the Cu_6Sn_5 tin/copper intermetallic (IMC) phase [8]. The Cu_6Sn_5 tin/copper IMC phase forms in a needle morphology as the copper content of the solder begins to exceed approximately 0.3% [9, 10]. The Cu_6Sn_5 intermetallic needles often form and grow preferentially from component lead and/or printed wiring pad edges. The SEM analysis shows the same behavior for the whisker-like anomalies on the QFP component. The formation and observation of Cu_6Sn_5 intermetallic needles solder joint microstructure is a typical occurrence. Figure 14 illustrates Cu_6Sn_5 IMC needles produced in a typical wave solder process solder joint. Additionally, the Cu_6Sn_5 intermetallic needles have a hollow, hexagonal geometry in contrast to tin whiskers which are solid striated structures that often have bends or kinks. Figure 15 illustrates a typical tin whisker compared to the Cu_6Sn_5 intermetallic needles observed in the investigation. Tin whiskers form and grow in random, not in an ordered orientation to each other. The typical length of the observed Cu_6Sn_5 IMC needles was 0.001 inches. The Cu_6Sn_5 IMC needles are a fixed length and do not increase over time as tin whiskers have been observed. The Cu_6Sn_5 IMC needles pose a minimal electrical shorting risk that would be identified during product quality testing prior to product shipment.

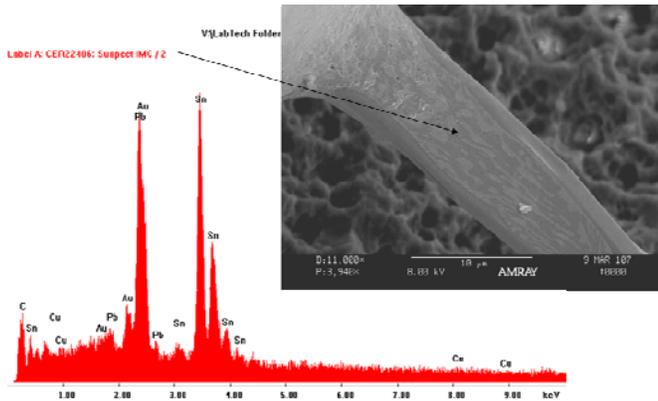
Figure 8. SEM EDS of Whisker-like Anomaly Fill Material

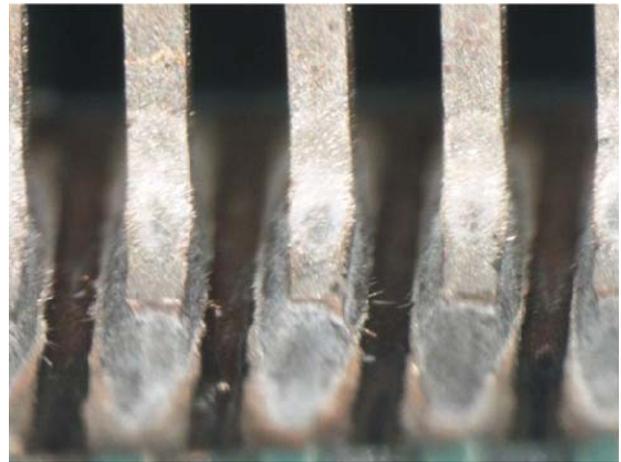
The QFP SEM sample was subjected to a 10% hydrofluoric acid/ 90% ethanol etching solution to remove the tin/lead solder but leave the whisker-like anomalies intact. The sample was immersed in the etchant solution for two minute intervals, carefully rinsed in deionized water and optically examined for the extent of the tin/lead solder removal. After eight minutes, a sufficient amount of solder had been removed to expose the anomalies and the etching process was halted. Optical examination and SEM analysis was conducted after etching. Figure 9 shows an optical view of the QFP sample after completing the etching process.

Figure 9. QFP Sample after Completing Etching Process

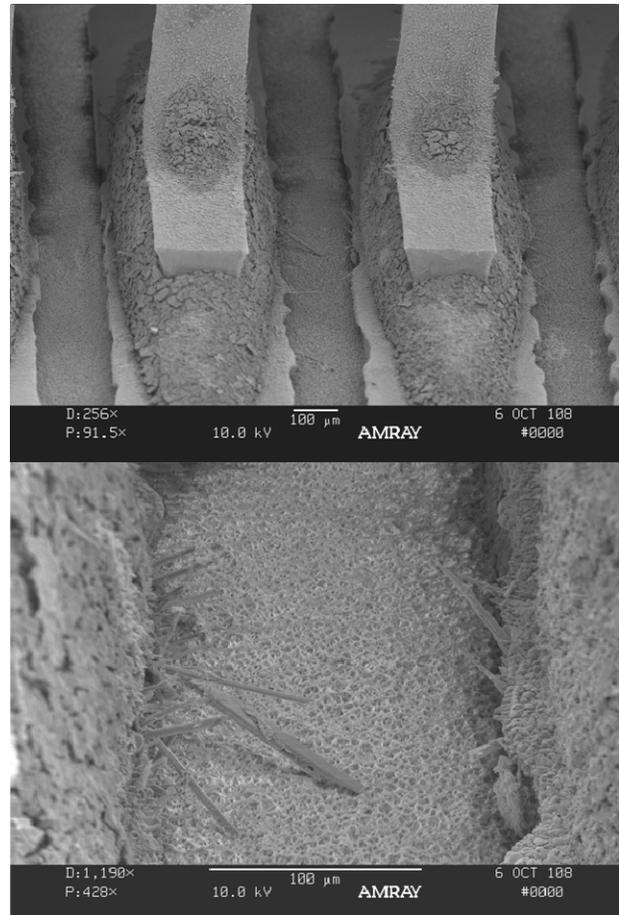
SEM analysis of the etched sample revealed that the anomalies were originating from both the QFP lead and the printed wiring board pad. The predominate anomaly shape was a hexagonal geometry with several of the structures observed to be hollow. Figure 10 through Figure 13 illustrate anomalies observed on the etched QFP during the SEM analysis.

Figure 10. SEM Images of the Anomalies on the Etched QFP Sample

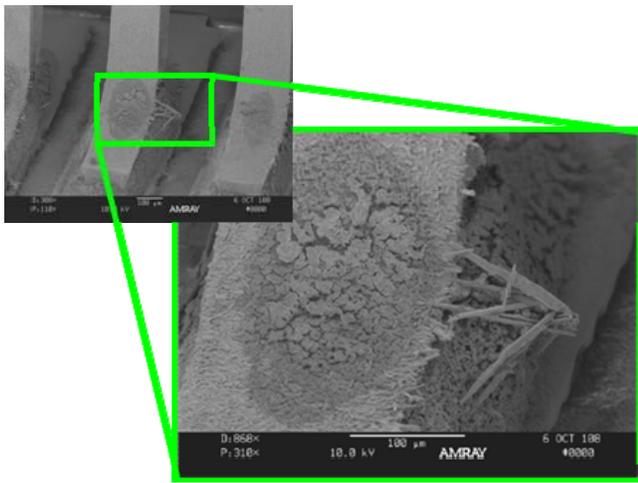
Figure 11. SEM Images of the Anomalies on the Etched QFP Sample

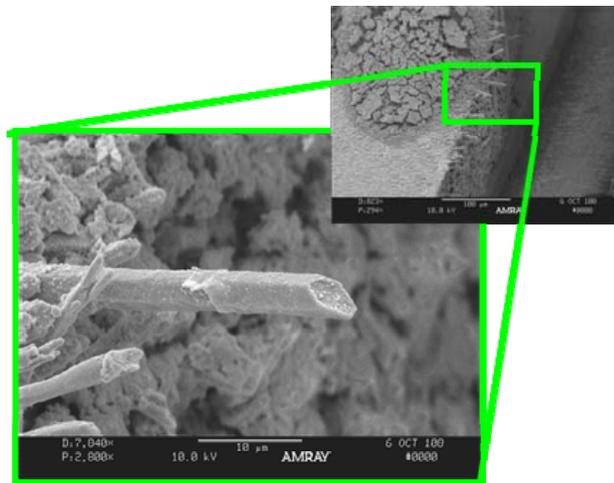
Figure 12. SEM Images of the Anomalies on the Etched QFP Sample

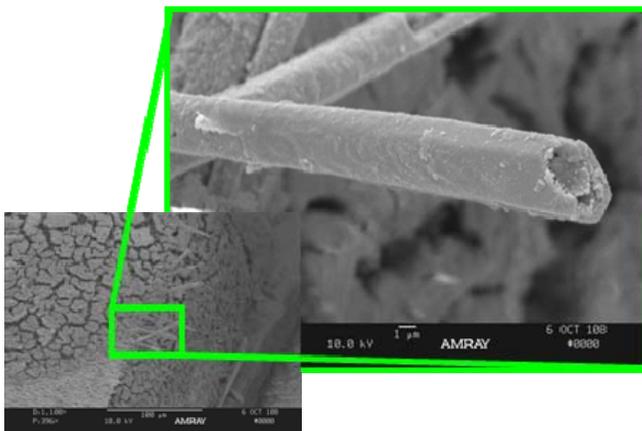
Figure 13. SEM Images of the Anomalies on the Etched QFP Sample

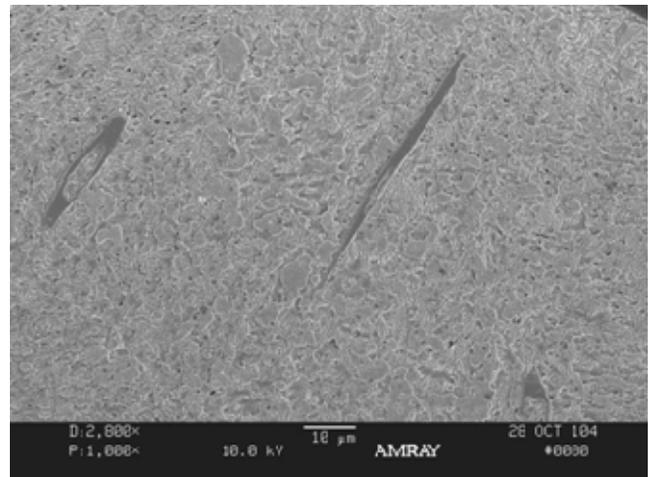
Figure 14. Typical Cu_6Sn_5 Intermetallic Needles Located in the Solder Joint Microstructure

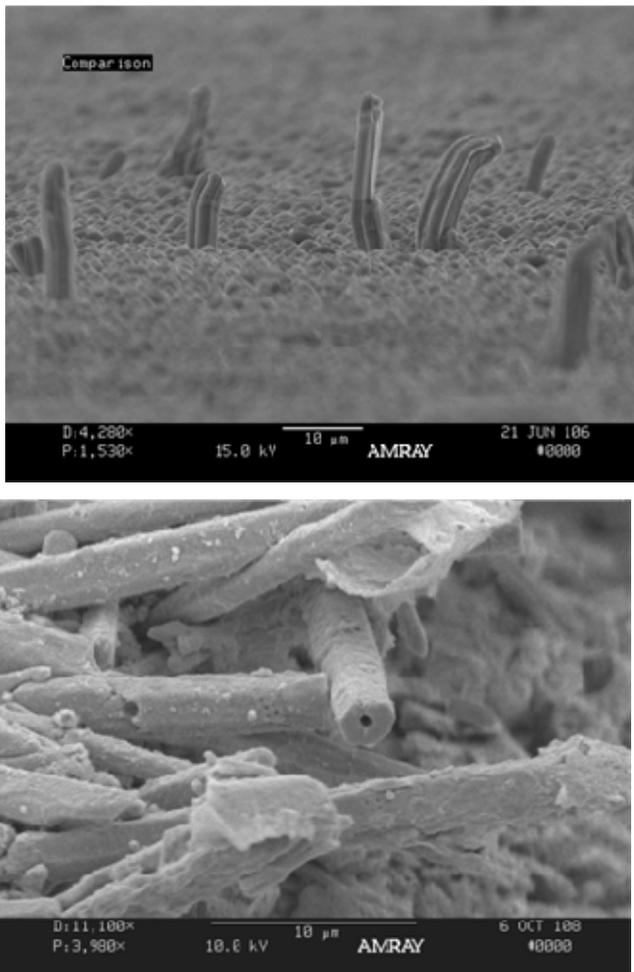
Figure 15. Comparison of Tin Whiskers (top) and Cu_6Sn_5 Tin/Copper IMC Needles (bottom)
