“Metal Whiskers”

Does Surface Contamination Have an Effect of Whisker Formation?

Terry Munson / Paco Solis
Foresite Inc.
Kokomo Indiana

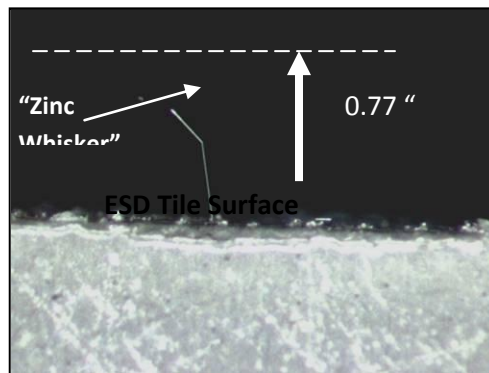
- ICT hardware on a raised ESD flooring system was found to have intermittent electrical issues with power supplies.
- Transformers and power busses were being shorted by an accumulation of zinc formations carried by cooling fans into system architectures.
- These issues were found to coincide with janitor mopping activity of the ESD floor.

Figure 1 - Tin whisker on zinc alloy ESD floor tile

- These whiskers are the result of a highly Sulfonated / Amine bearing mop water solution (validated by Ion Chromatography testing). ESD Soap!
- On tiles where these ionic residues have been removed by remedial cleaning and rinsing (with proper chemistries), the whisker formations are greatly retarded or completely eliminated.
- Contaminated tiles in our lab continue to produce whiskers to this day.

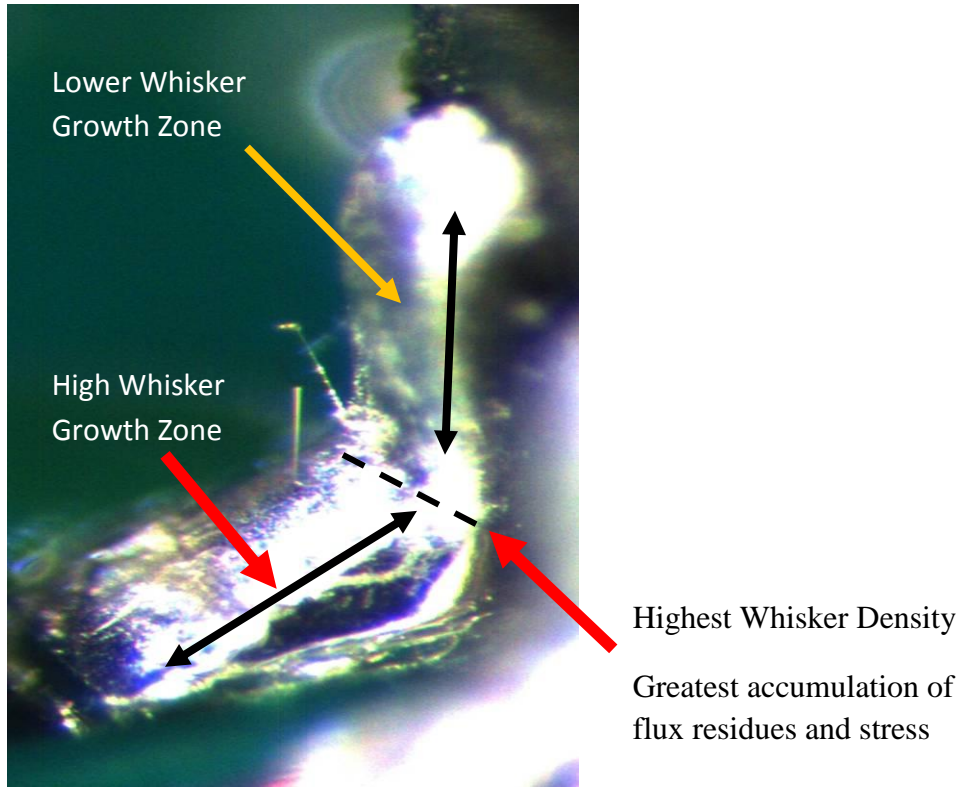
- SOT Device in high density SMT PCA
- SAC304 Alloy
- Dry Warm Conditions
- Formation in 2-3 weeks

Figure 2- Whiskers on SOT gull lead with SAC 304 alloy termination

During reflow, high concentrations of flux residues flow up the termination and accumulate at the gull wing bend. Although solder reflow occurs from toe to shoulder, the flux accumulation settles at the lead bend. A second item noted was the discovery of nano-whiskers which form from the flux line extending over 200 μm in serpentine length and under 1 μm in width.

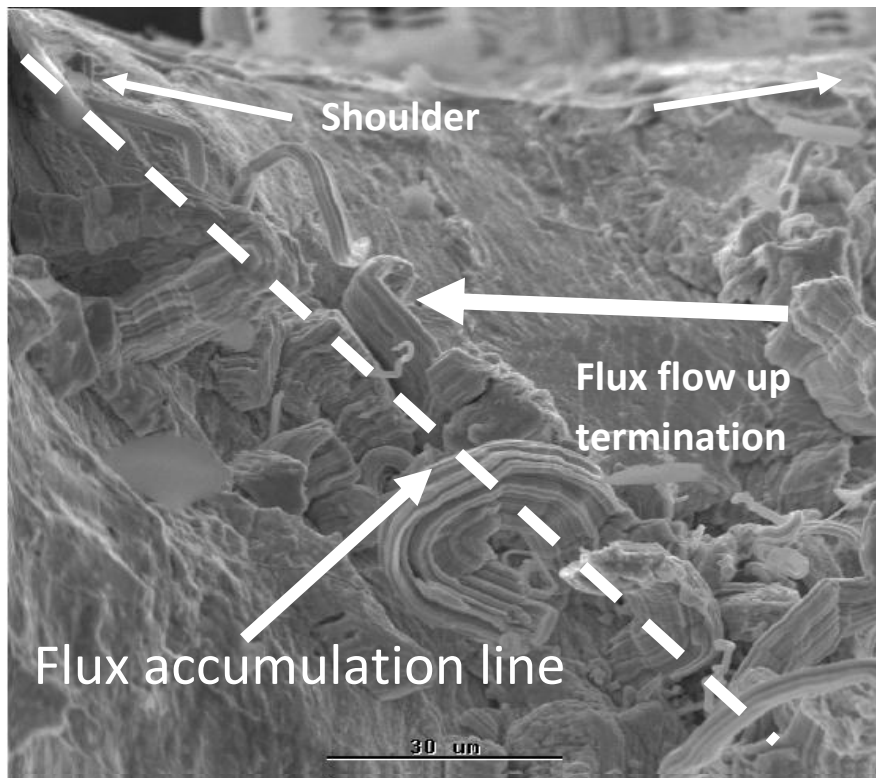
Figure 3 - SEM Image of SOT gull wing termination

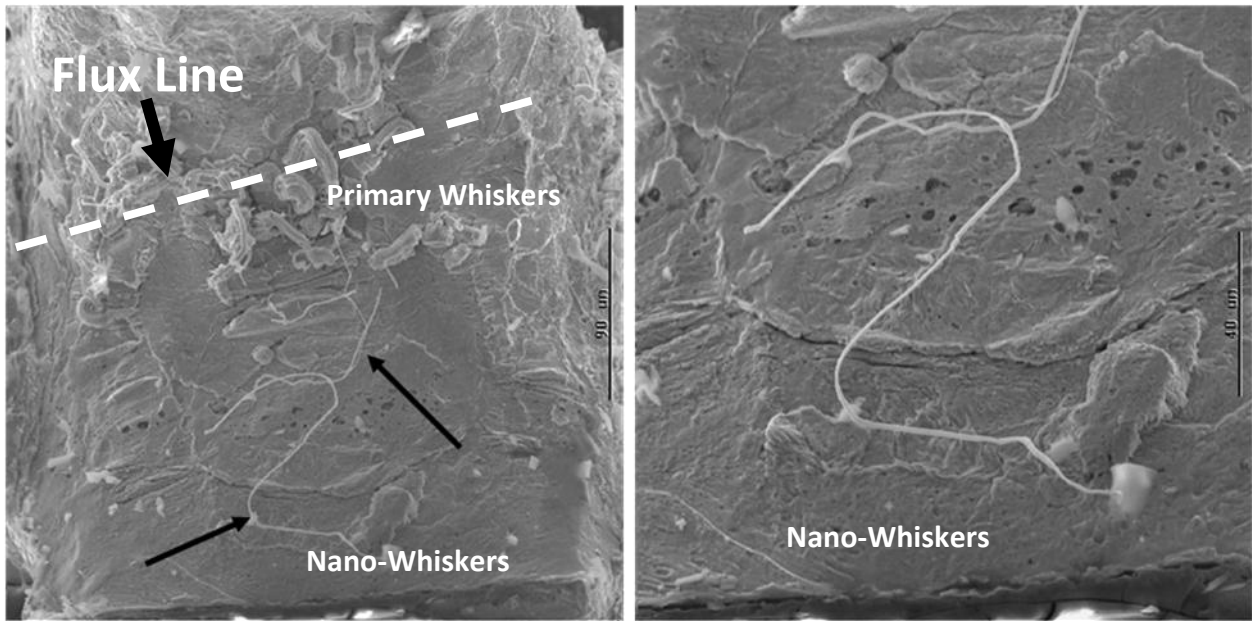
Figure 4 & 5 - SEM Image of primary and Nano-Whiskers

These nano-whiskers continuously extrude from the surface as well as from the larger primary whiskers. They settle on the surface and are freely fractured and fall away with little force.

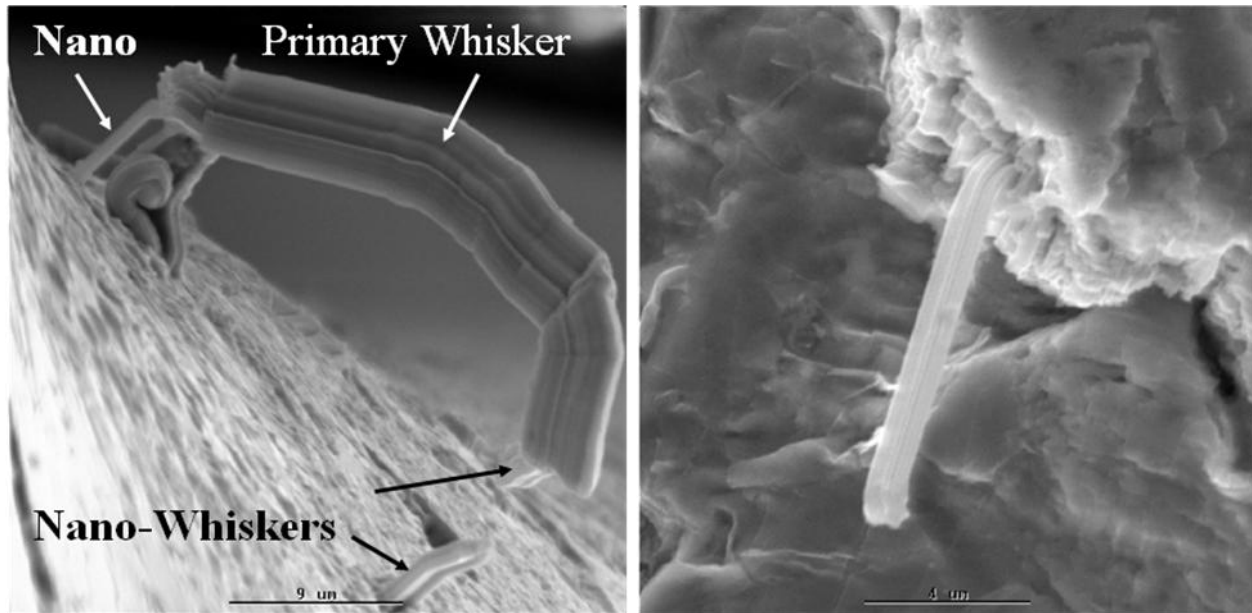
Figure 6 & 7 - SEM Image of primary and Nano-Whiskers

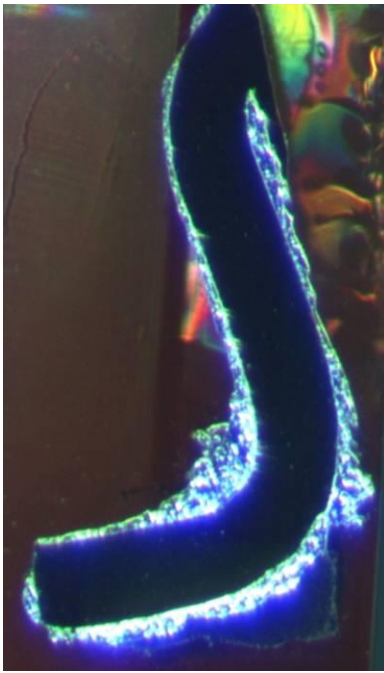
Figure 8 – Optical Image of primary whisker in cross-section

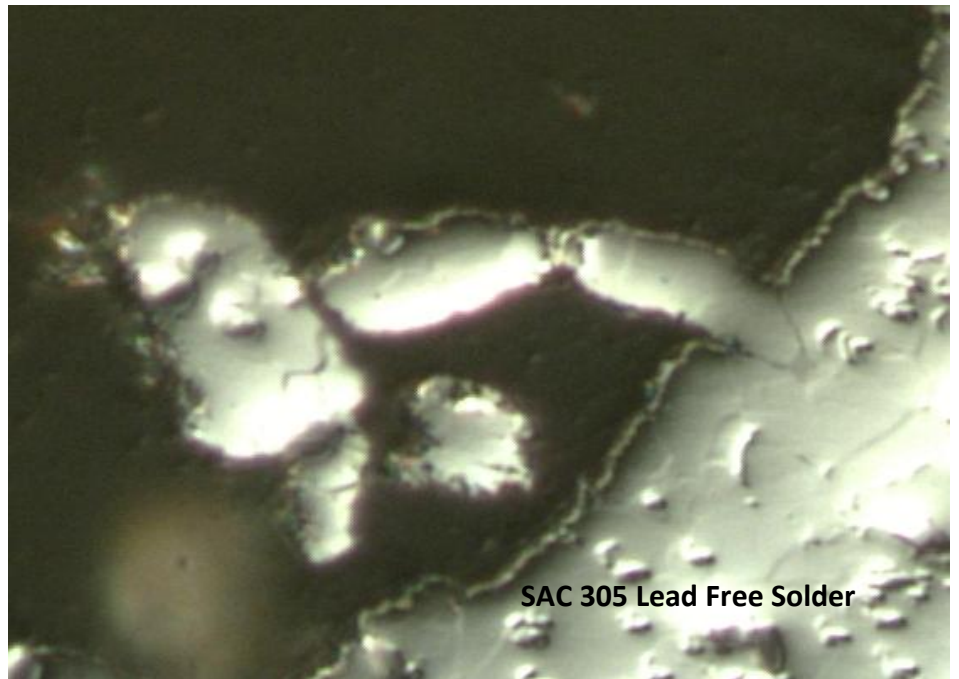
Figure 9 – Optical Image primary whisker in cross-section at 1000X

In cross-section a single grain dislocation can be seen at the whisker extrusion site. More samples like these are needed to further study this condition. This sample was prepared with pH 9 gamma colloidal silica slurry for grain delineation. The sample was unfortunately compromised before it was submitted to SEM analysis.

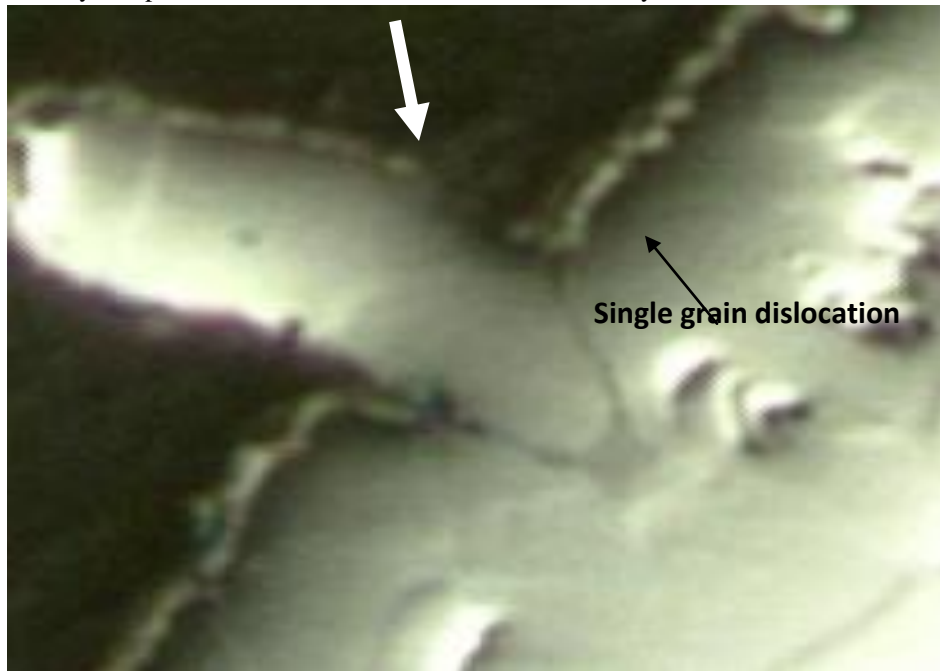
Figure 10 – Optical Image of primary whisker in cross-section at 1000X (digitally magnified)

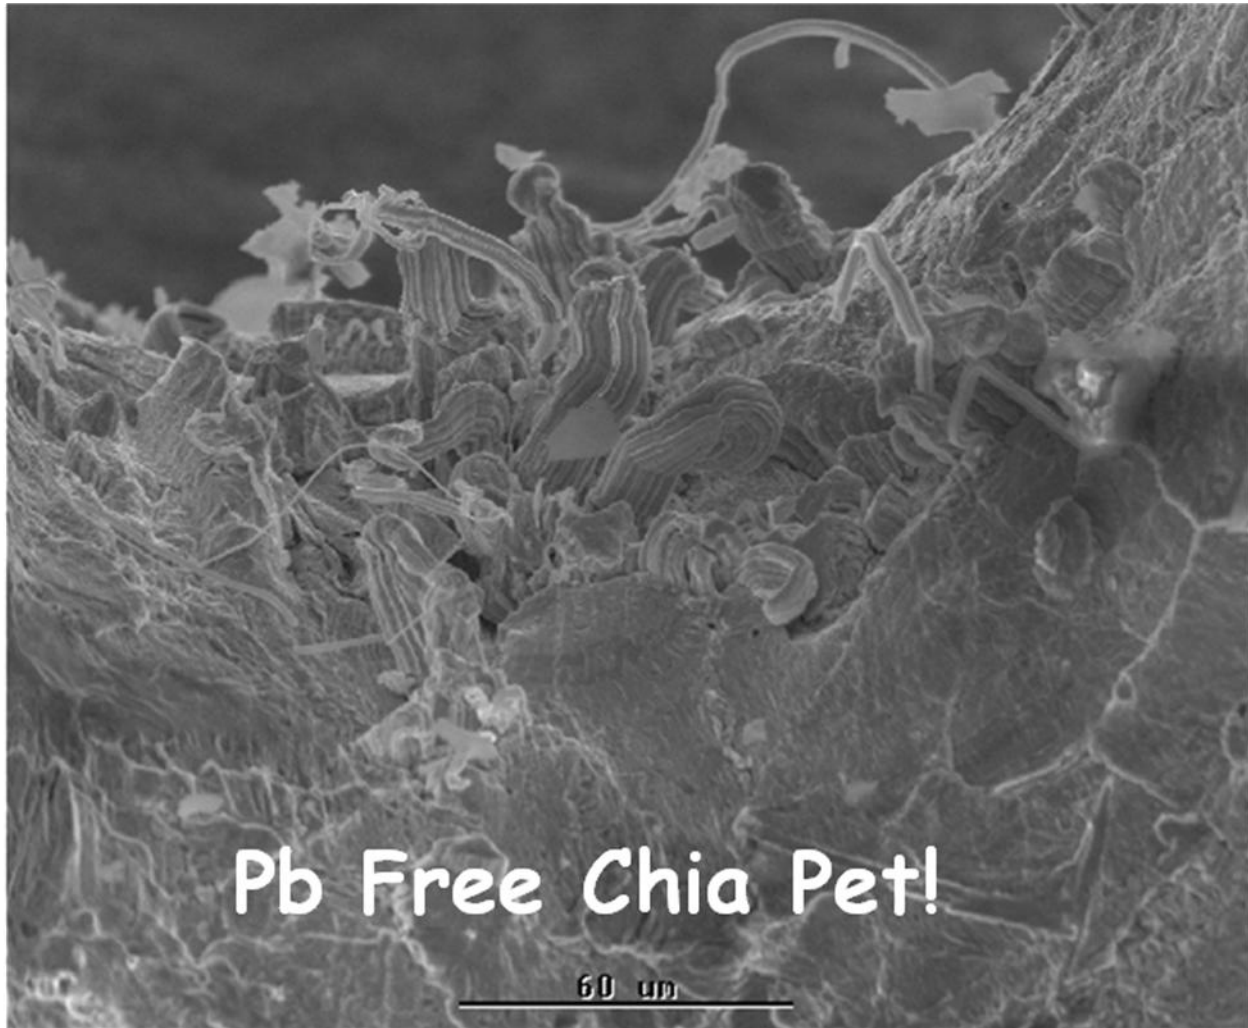
- Localized D.I. steam cleaning with a saponifier has proven effective at preventing reoccurrences when total ionic contamination has been reduced.
- Inversely - areas doped with high levels of ionic contamination show a significantly higher occurrence of whisker formations.

Figure 16 – Results of accelerated whisker growth from select doping of terminations

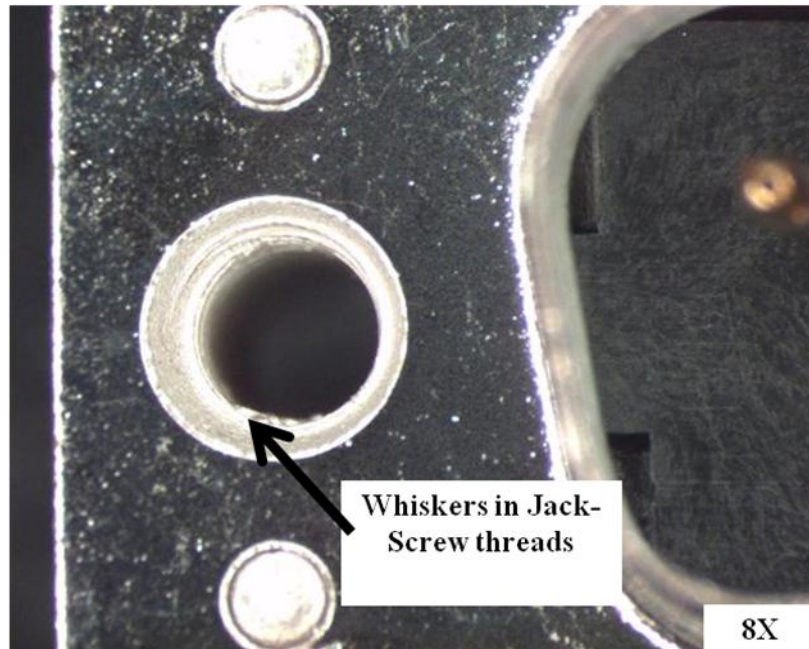
Whiskers are forming in the jack screws of lead free connectors. Preliminary data has shown high levels of Chlorides, Sulfates, and Amines are present in the Jack Screws. Analysis is ongoing to study the contamination effects in these locations and the retardation effects of cleaning. Data on this analysis is will published in updates to this paper.

Figure 17 – optical images of whiskers on jack screw threads

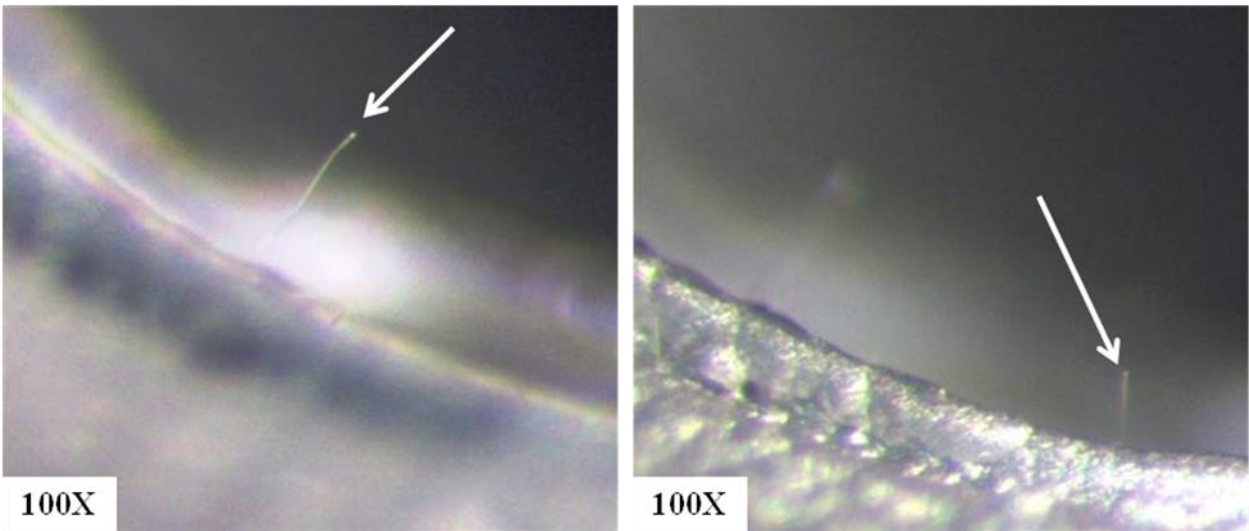
Figure 18 & 19 – optical images of whiskers on jack screw threads
