THE QUANTITATIVE ASSESSMENT OF MIXED BGA JOINT WITH THE ELIMINATION OF LOW-MELTING POINT ALLOY RE-MELTING PROCESS

Hongqin Wang, Guanghui He and Daojun Luo
China Electronic Product Reliability and Environmental Testing Institute
Guangzhou, China
wanghongqin2013@163.com

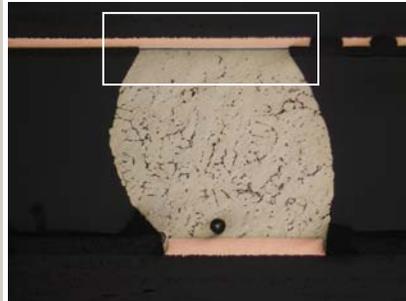
the pad of the PBGA component. The cross section image of the PBGA solder joints clearly showed that the SAC balls have only partially reacted with the solder paste and two evidently separated zones can be observed in the Figure 2. No traces of Pb were found in the zone of the top of the SAC ball. No crack was in the specimen S1 solder joints.

Figure 2. Cross-section optical image of specimen S1

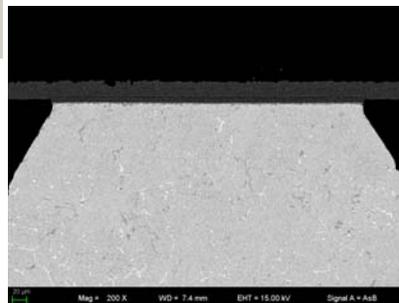
Figure 3. Enlarged image of a selected area of specimen S1 in Figure 2

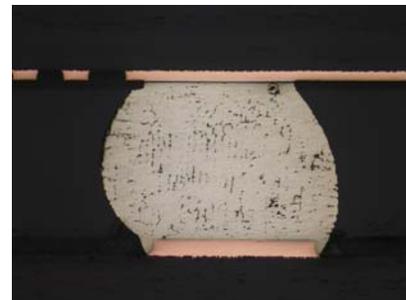
Cross section optical image of the specimen S2 solder joint was shown in Figure 4, whose enlarged image of a selected area was observed by SEM and shown in Figure 5. The reaction of the SnPb solder paste with the SAC balls was more homogenous and the ball solidified with a dendrites structure throughout the entire volume. The dendrites as well as the Pb-rich phase are distributed throughout the volume of the ball. No crack was found in the specimen S2 solder joints.

Figure 4. Cross-section SEM image of specimen S2

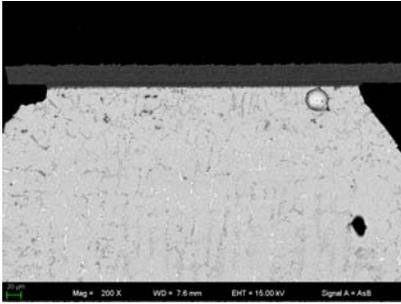
Figure 5. Enlarged image of a selected area of specimen S2 in Figure 4

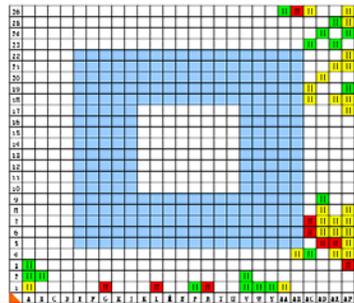
After the reflow and waving soldering process, the specimen S3 solder joints was checked with dye & pry method. It was surprised to find that cracks with various degrees appeared around the BGA chip. The failure mode indicated that the cracks were located between the chip and the ball, as shown in Figure 6. Figure 7 showed an SEM image depicting the same failure mode.

Crack Area	Crack Mode
Type A: 100%	Type I : Between Chip pad and chip Matrix
Type B: 50%~100%	Type II : Between Chip pad and Ball
Type C: <50%	Type III: Among the Ball
Type D: No crack	Type IV : Between Ball and PCB pad
Type E: No joint	Type V : Between PCB pad and PCB Matrix

Figure 6. The Dye and pry mapping for PBGA component showing the crack location and percent fracture of the mixed solder joint

The waving soldering was optimized to keep the temperature of PBGA solder joints below 175 °C, which was the waving soldering profile W2.

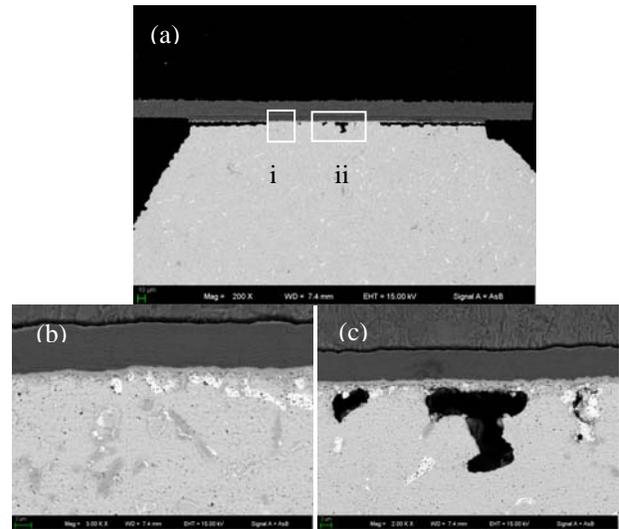
Figure 7. Cross-section SEM image of PBGA component solder joint (a) the entire top area (b) area i (c) area ii

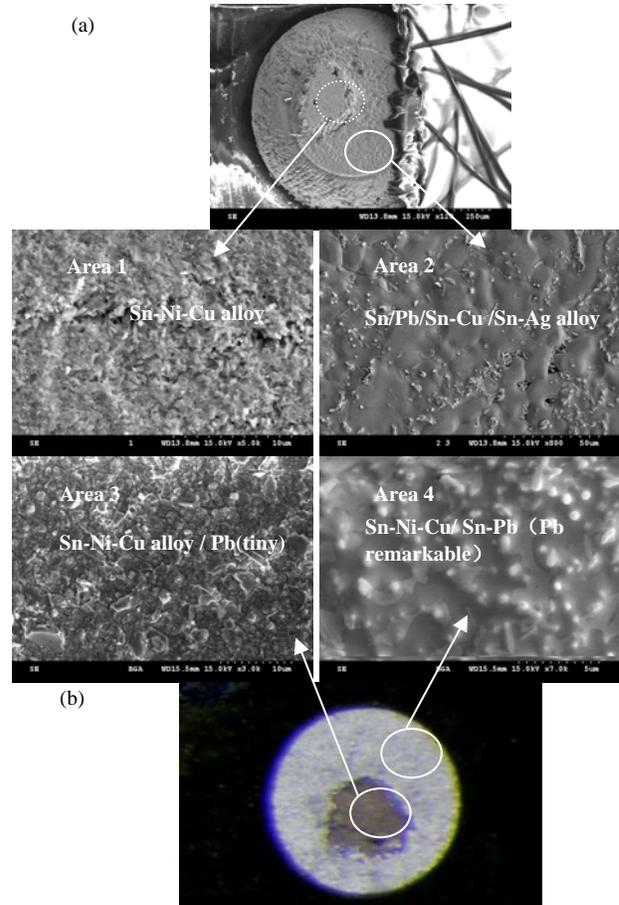
A part-cracked solder joints was mechanically pulled off, whose fracture surfaces were observed and analyzed by SEM and EDS, which were shown in figure 8.

Figure 8. SEM observation of BGA after mechanically pulled off (a) PCB side (b) Chip side

It could be seen that the original cracking surface was very smooth regardless of the PCB side or the device side surface, which morphology indicated that the cracked area of the mixed solder joint should be free solidified without contact each other.

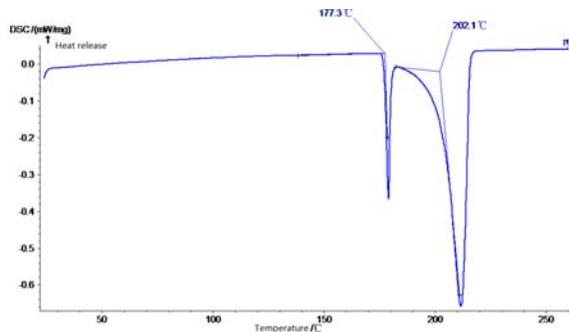
The melting point of the 100% cracked BGA ball in figure 6 was tested by DSC after cleaning and its result was shown in figure 9. It could be seen from the DSC result that the mixed PBGA solder ball began to melt at about 177°C, which was consist with the finding of literature [7-8].

Figure 9. DSC result of entirely cracked BGA solder ball

of PBGA solder joint reached to high temperature (in the experiment test, the peak was 186°C), which exceeded the melting point of mixed solder ball, so the mixed solder ball partially melt and kept at liquid state during the cooling period (from the peak temperature to the solidification above 183°C). Since the PBGA component tried to keep at the sad/positive (+) warpage, the tensile stress was applied on the mixed solder joints around the PBGA component. As a result, a lot of cracks emerged. To avoid such crack, fist the reflow soldering profile should be optimized to keep Pb distributed homogeneously in the entire ball and then control the temperature of solder joints below the melting point of the mixed solder ball in the waving soldering process, as we had done in this research.

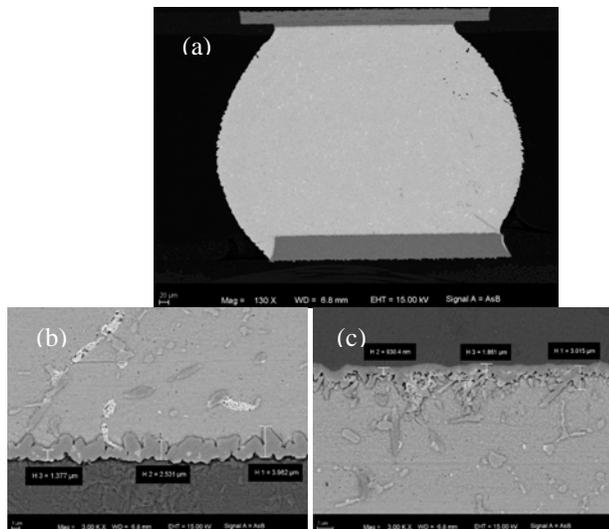
The specimen S4 was processed with the reflow profile R2 and the waving profile number W2 in sequence, as shown in Table 1. No crack was found in the PBGA solder joints and Pb distributed homogeneously in the entire solder ball. Cross section of S4 was observed by SEM, as shown in Figure 10.

Figure 10. Cross-section SEM image of S4 solder joint (a) Entire solder ball (b) PCB Side (c) Chip Side

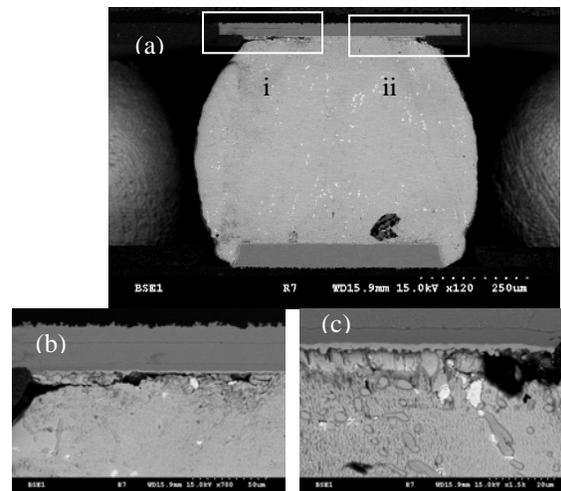
The reliability of PBGA solder joints after optimazaiton was studied with an accelerated thermal cycling(ATC) test in the temperature range of -40°C to 125 °C for 3000 cycles in accordance with IPC 9701A standard. After thermol cycling, the cross section of the solder joints was observed by SEM in Figure 11, which showed the fracture appeared near the pad interface on the component side, though the PBGA solder joints had not completely failed yet.

Figure 11. Cross-section SEM image of PBGA component solder joint (a) Entire solder ball (b) area i (c) area ii
