## **Review of Interconnect Stress Testing Protocols and Their Effectiveness in Screening Microvias**

### **Abstract**

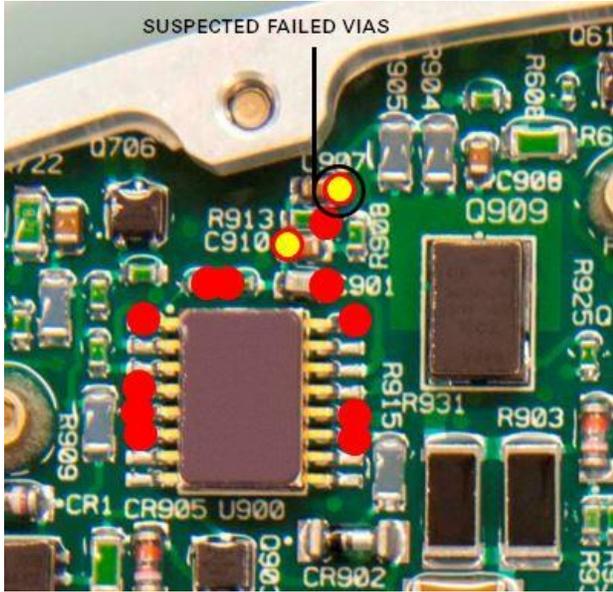
Figure 3 - Top Side of Interest

The resistance in this circuit is only allowed to vary by 10  $\Omega$ , and an absolute resistance greater than 100  $\Omega$  would constitute a failure. An exhaustive troubleshooting procedure was undertaken to determine the root cause of the monitor circuit problem. Setup for the test isolated the trace by removing all parts, leaving only the suspect trace. The removed parts were then inspected and tested with no anomalies noted. Thermal cycling showed that the resistance of this circuit (two microvias and buried trace) spiked randomly up to, but not over, 500  $\Omega$  during the ramping of the temperature during thermal cycling. A bare board was used as a control unit during this thermal cycling. The resistance of the monitor circuit on the control unit changed in a linear and predictable manner consistent with the thermal changes. The conclusion is that there is a disturbance in the trace that could be attributed to a microvia failure and that this disturbance is isolated to one location, preventing full performance of the module. After this bench testing, a destructive physical analysis was conducted. The locations of interest can be seen in Figure 3 and Figure 4.

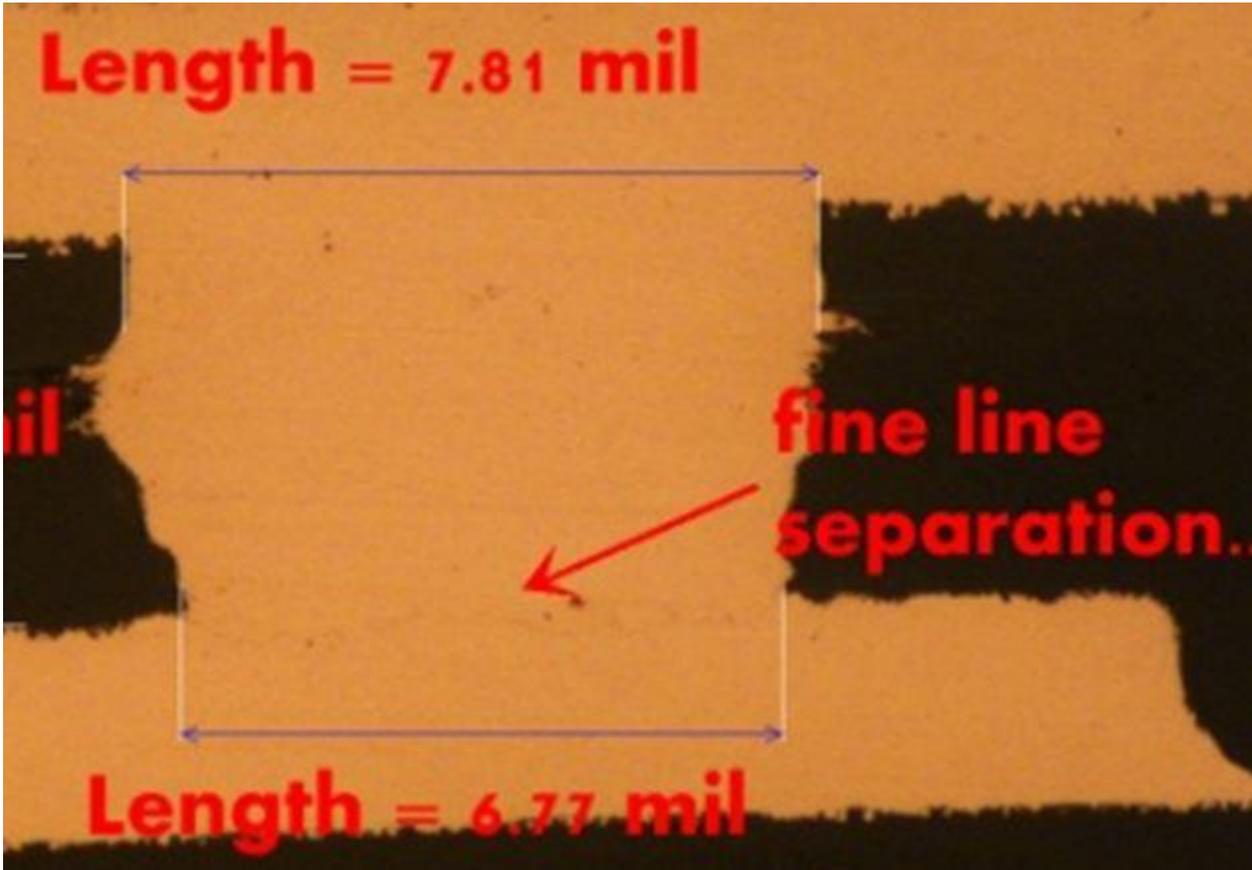
Figure 5 - Via C907 Fine Line Separation 200x

The site was removed and mounted for microsection analysis. Before getting to the first vias of interest, leads on the microcircuit (top side) were used to align the polishing plane. This minimized the need for polishing all the way to the sites of interest. Most sites encountered had good via to target pad connection. Of the 2 suspected failed vias, both had evidence of fine line separation at the via to target pad location. An example can be seen in Figure 5 and Figure 6. At a magnification of 200x, the fine line separation is hardly visible, but at 400x, it is much more pronounced. The single via between the two suspected (then confirmed) vias, also had fine line separation. Of 17 microvia sites examined, 3 would have failed the program's internally developed criteria for target pad integrity, which requires a minimum connection of 140- $\mu\text{m}$ , with no fine line separation.
