Case Study: Metallurgical and Mechanical Analysis of Castellated Via Rigid-Flex Connection (SAND2022-13021 C)

Rebecca Wheeling, Ph.D., John Laing, Shelley Williams
Sandia National Laboratories
NM, USA
rwheeli@sandia.gov

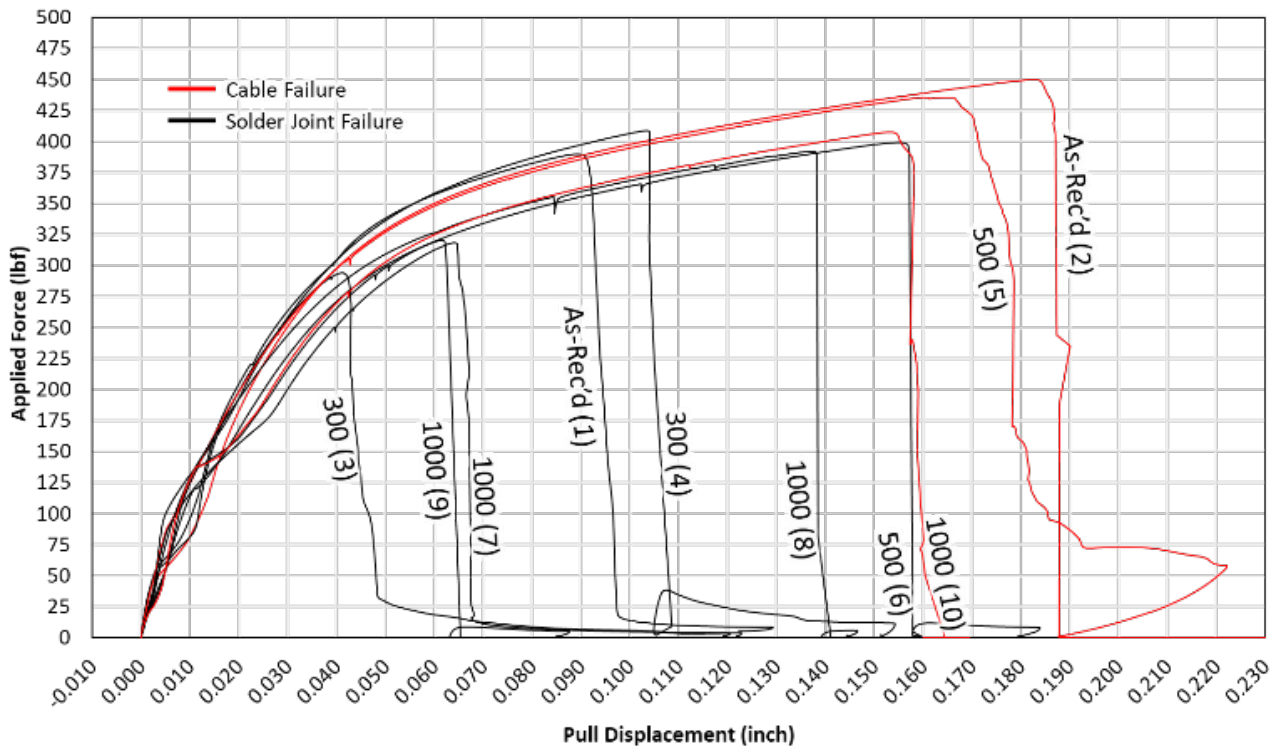
Figure 6. Force vs. displacement plots for all shear tests. Each curve is labeled with its aging condition in number of cycles and its sample ID in parenthesis. Black curves indicate solder joint failures and red curves indicate flex cable failures.

Three out of the top 4 peak load values are due to failures at the flex cable, rather than at the solder joints.

Peak failure loads varied between 294 and 450 lbf with no obvious trend between number of thermal cycles and peak failure load observed. The highest peak loads are exhibited by the units where the cable failed rather than the solder interconnections. The 3 cable failures indicate that the solder joints are not necessarily the limiting factor in mechanical strength. Aging appears to have had little impact on the cable performance either, as these failures included an as-received assembly and an assembly cycled 1000 times.

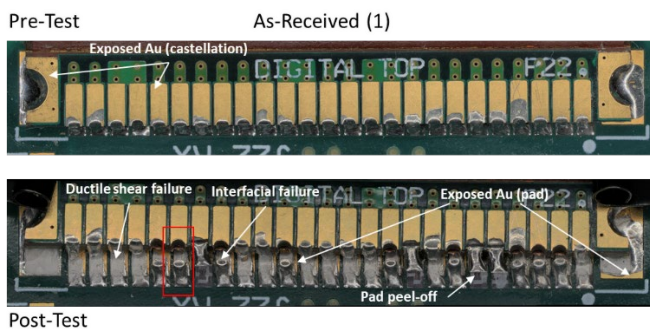
Figure 7. Top views of a flex cable connected to the PCB with castellated via solder joints, before (top) and after (bottom) shear testing. The red box highlights the inset shown in Figure 8. This unit was tested in the as-received condition. Sample ID is shown in parenthesis.

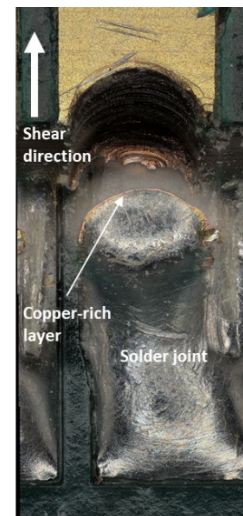
A higher magnification image of a potential interfacial failure highlighted in the red box above is shown in Figure 8. The failure occurs along the castellation-Cu interface. The two options for the exact interface are: 1) along a board-Cu

plating interface; or 2) along a Cu-Cu₆Sn₅ interface. SEM imaging is required for confirmation, however.

Figure 8. Higher magnification optical image of a potential interfacial failure at the castellation-Cu plating interface.

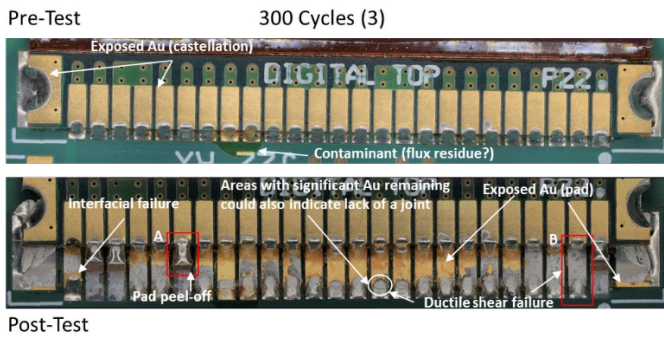
Figure 9. Top views of a flex cable connected to the PCB with castellated via solder joints, before (top) and after (bottom) shear testing. The red box highlights the insets shown in Figure 10. This unit was tested after 300 cycles. Sample ID is shown in parenthesis.

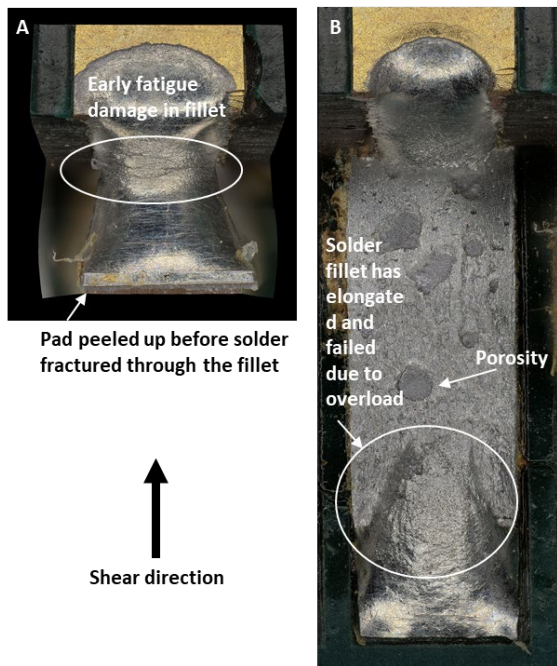
Figure 10. Higher magnification optical images highlighting pad peel-off (A) and ductile shear (B) failure modes.

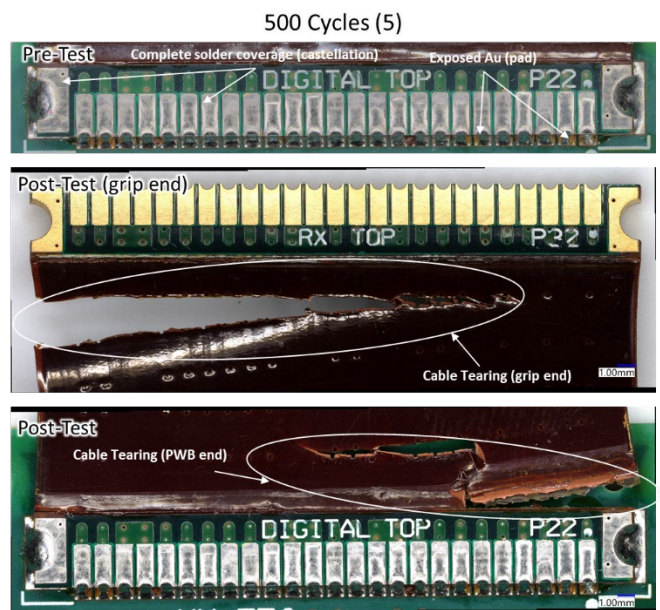
Figure 11. Top views of a flex cable connected to the PCB with castellated via solder joints, before (top) and after (middle, bottom) shear testing. This unit was tested after 500 cycles. Sample ID is shown in parenthesis.

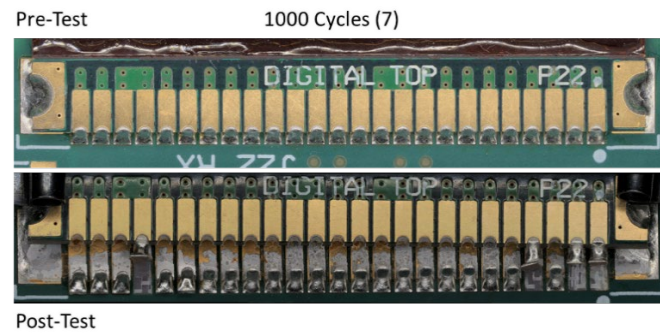
Figure 12. Top views of a flex cable connected to the PCB with castellated via solder joints, before (top) and after (bottom) shear testing. This unit was tested after 1000 cycles. Sample ID is shown in parenthesis.

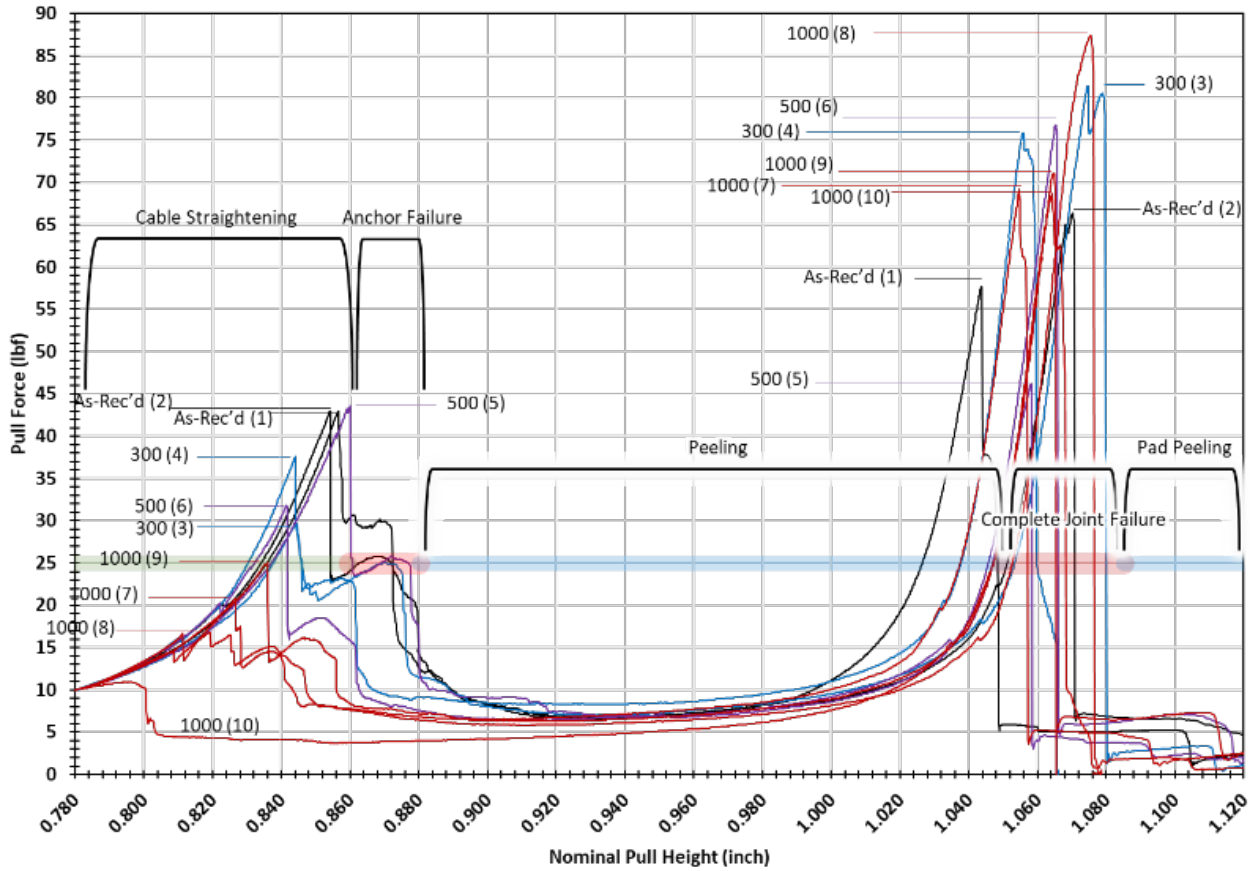
Figure 13. Force vs. displacement plots for all peel tests. Each curve is labeled with its aging condition in number of cycles and its sample ID in parenthesis. Black, blue, purple, and red curves denote as-received, 300 cycle, 500 cycle, and 1000 cycle conditions, respectively. The curves are broken into 5 regions, denoting observed behavior during testing.

The force-displacement curves highlight several distinct loading conditions imposed and associated observations of the flex-cable assembly and solder joints. A bimodal distribution of failures is evident. Two distinct failures were observed in every test: 1) failure of the 2 larger anchor joints; and 2) failure of the remaining 25 castellations between the anchors.

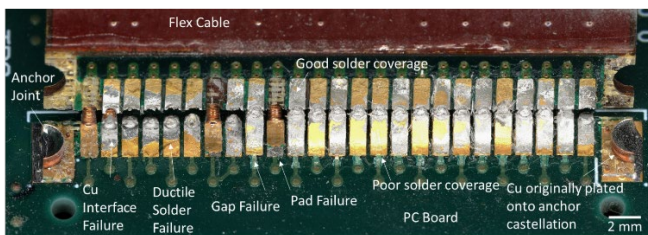
Figure 14 shows an optical image of a cable assembly post-peel test, with various failure modes identified.

Figure 14. Top view of a flex cable connected to the PCB with castellated via solder joints, after peel testing. This unit was tested in the as-received condition.

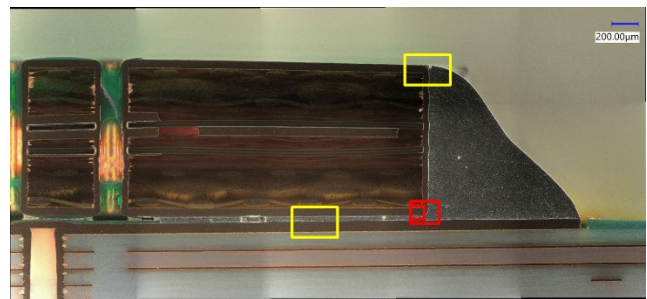
Figure 15 shows the general cross-sections that were cut through the castellation joints and highlights the key areas for potential Au embrittlement (yellow boxes). The red boxes indicate the higher magnification SEM inset images shown in Figure 18.

Figure 15. Optical image showing a low magnification cross-section through a castellated via solder joint. Yellow boxes highlight the high-risk locations for potential Au embrittlement. The red boxes highlight the locations where EDS maps were acquired, in Figure 16

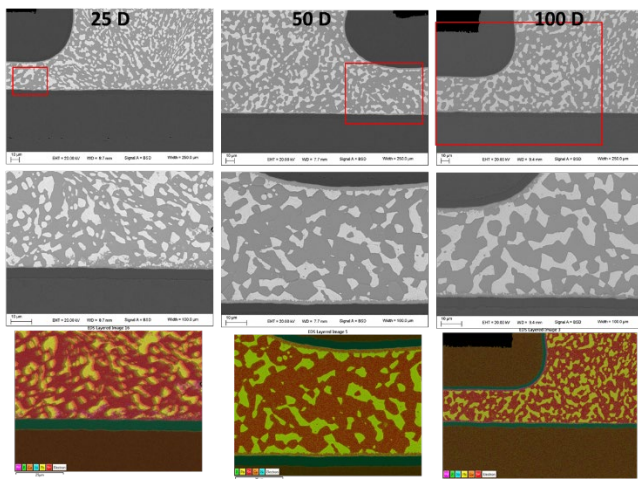
Figure 16. Higher magnification SEM images of the red insets from Figure 15. The columns represent a given aging condition: 25, 50, and 100 days (left, middle, and right, respectively). The middle row shows a higher magnification image highlighted by the red inset box. The bottom row shows corresponding EDS maps. All three samples were aged at the more extreme 100C.

The joint microstructure appears to be relatively stable with increasing time at 100C. The 70C results are not shown here because the 100C condition is expected induce more significant microstructural change, if any. While coarsening of the bulk solder microstructure (Fig. 16) is evident, the interfaces appear to remain stable over time, both the Cu-SnPd intermetallic and the SnPd intermetallic-solder. No voiding is observed, so the concern for microstructural instability over time is relatively low.

Au signals were absent within the bulk solder and along the interfaces where solder was present. No signs of Au intermetallic formation or Au embrittlement along the interfaces was observed, even at the high-risk areas where the solder does not fully wet the pads, leaving elemental Au adjacent to solder. The lack of Au embrittlement can be attributed to the small Au concentration and thickness of the ENIG finish. Further investigation into microstructure continues but is unavailable at the time of publishing this report.

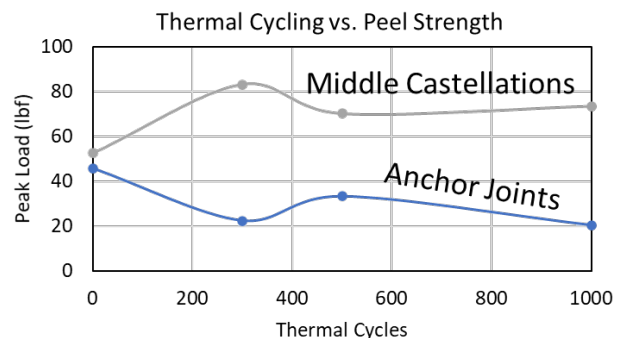
Anchor joints failed at much lower loads, relatively, and should thus be considered the limiting factor for interconnection failure. Figure 17 highlights the average failure loads of the anchor joints compared to the inner castellations as a function of aging condition.

Figure 17. Plot that compares average failure loads of middle castellations (gray) and anchor joints (blue).

The main difference between the side castellations and inner castellations is size and orientation to loading direction; the lower failure loads make sense, as the solder volume shared between these 2 joints is much less than that between the 25 other joints. If the anchor joints are meant to provide the bulk of the mechanical performance for the cable, larger and or more anchor joints may be desirable. The anchor joints do appear to successfully isolate early mechanical failure though, while presumably still permitting the inner joints to provide the electrical connectivity and performance for cable functionality.
