Lessons Learned While Investigating Microvia Reliability Failures.

Tobias Bernhard, Roger Massey, Senguel Karasahin, Frank Brüning
Atotech GmbH, Berlin, Germany

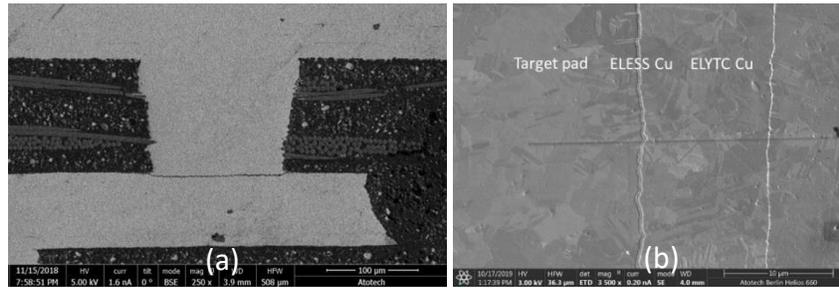
Figure 3. Typical Failure of a BMV at the Target Pad (a) and SEM Showing Target Pad – ELESS Cu – ELYTC Cu Structure. (b)

In terms of failures exhibited by BMVs, the most commonly reported is one referred to as capture, or target pad separation, an example of which can be seen in Figure 3a. For such failures, it is typically found that the failure occurs at the base of the BMV where the plated deposit connects with the previously formed target pad.

From Figure 2 it is clear that this target pad to plated layer interface is a complex structure comprising of the target pad itself, underlying an electroless Copper (ELESS Cu) or other metallization layer, which is then covered with an electrolytic plated Copper (ELYTC Cu) layer, (Figure 3b), as such, it can be appreciated that there are multiple potential locations for failure. (Table 1)

While failure at locations 1 and 5 in Table 1 are possible, they are rarely reported, with the most common failures being attributed to poor “adhesion” of the ELESS and/or ELYTC Cu, or failure within the ELESS Cu itself, although this is rarely so simple to identify.

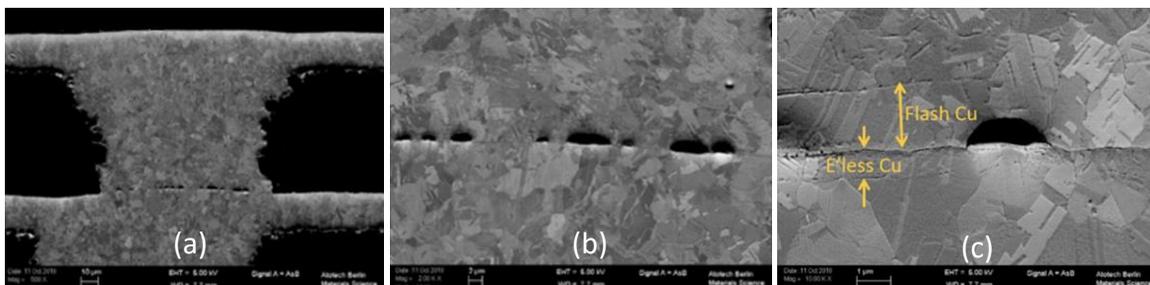
Figure 4. SEM Images of an Electro Polished Sample.

From Figure 4a and 4b it is clear that there is a line of voids at the base of the BMV, what is not known however, is the exact location of those voids, namely do they occur at the target pad – ELESS Cu interface, within the ELESS Cu layer itself, at the ELESS Cu – ELYTC Cu interface, or within the bulk plated Cu? This knowledge is essential in understanding the root cause of the defects, and identifying the process area in need of troubleshooting activities. Following the electro polishing operation, it becomes possible to distinguish the boundaries where the target pad, ELESS and ELYTC Cu layers occur. In

view of this, in Figure 4c, it is clear that the line of voids occur not at the target pad – ELESS Cu interface as is often assumed, but actually at the ELESS Cu – ELYTC Cu interface.

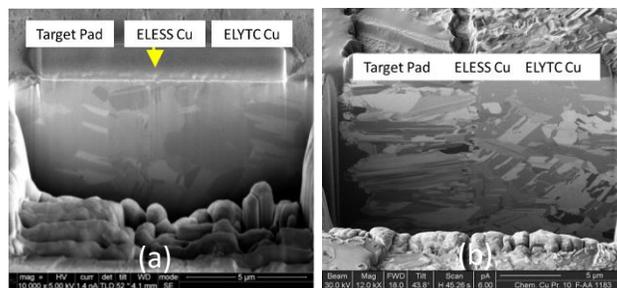
Figure 6. SEM-FIB Showing a Continuous Crystal Structure (a) and Dis Continuous Crystal Structure (b) across the BMV.

One of the first points typically noted during FA of BMVs is the general crystal structure within the plated Copper, and this generally falls into 2 distinct groups. The first showing a single uniform crystal structure where the interface between the target pad and the plated Cu cannot be distinguished (Figure 6a), or a structure where there is a break in the crystal continuity and one or more clear interfaces can be seen (Figure 6b) While, it could be argued which of the two structures would offer the “best” reliability performance, it is offered that a single crystal pattern would be preferential, as any marked changes in crystal structure would generally enable some form of stress concentration, and could exacerbate failure. It should also be considered, that such changes in structure typically occur around the target pad – ELESS Cu – ELYTC Cu interfaces, and as this is commonly the point of BMV failure, it would be sensible to propose that a continuous metallography would be desirable.

Such structures arise due to the crystallization of plated deposits that occurs following plating. Immediately after deposition the plated layer has no defined crystal structure, but will begin to develop one over a period of time, ideally this recrystallization occurs in a “bottom up” fashion, with each new layer following the crystal orientation of the underlying layer, i.e. the ELESS Cu continues the orientation of the target pad Cu, and then the ELYTC Cu follows the orientation of the ELESS Cu layer. Known as epitaxial growth, this process occurs naturally, although it should be acknowledged that there are influences within the process and the chemical constitution of the plating chemistries which can impact the recrystallization characteristics of plated layers.

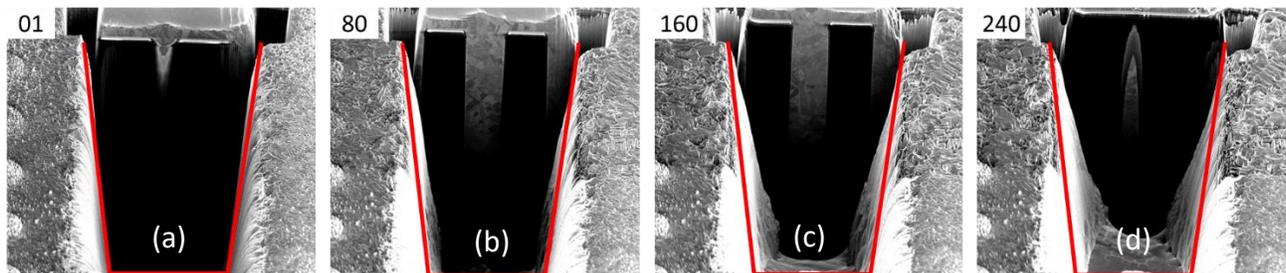
Figure 7. SEM-FIB Images Recorded During an Automatic Milling Operation Showing Redeposition and Buildup of Removed Material.

1. As expected, the Cu filled TSVs become revealed as the cut proceeds through the sample
2. There is build-up of material occurring within the milling box as the operation occurs.
 - a. At 0 automatic slices, there is no material visible in the milling box
 - b. After 80 slices, redeposition can be seen on the side walls of the milling box
 - c. After 160 slices, there is moderate redeposition in the milling box
 - d. After 240 slices, there is significant redeposition in the milling box

It is point 2 that is of most interest as this material build up contains the plated Cu from within the TSV itself. As such, it is a redeposition of the material removed during the cut or milling operation. For the images shown, the redeposition was not considered an issue as it did not impact the investigation being made, as there were no structural defects within the TSV itself, but when such a technique is used to investigate a cracked BMV, there is a serious cause for concern.

The primary requirement during FA is that the techniques used do not influence, or change the sample being inspected, otherwise there is a strong likelihood that the collected data can be misleading. If material redeposits on the sample during a FIB-SEM investigation then this primary requirement is broken, and the conclusions drawn from the analysis must come under question. In the case of a cracked BMV, there is a very high likelihood that the redeposition will occur not only within the milling box but within the crack under investigation, in view of this, the crack may appear to be coated with Cu which can be mis-interpreted as a defined layer or coating.

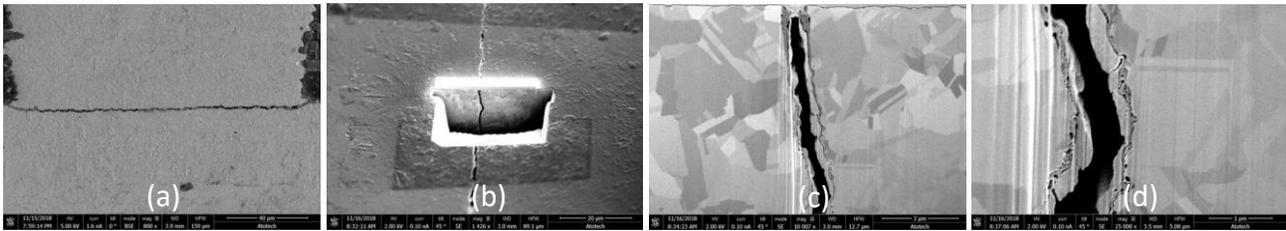
Figure 8. Series of SEM-FIB Images Investigating BMV Failure.

Figure 8 shows a series of SEM-FIB images taken while investigating a failed BMV joint, clearly the point of failure is located at the base of the BMV and it would be reasonable to anticipate that it would be located close to, or cognizant with one of the target pad – ELESS Cu – ELYTC Cu junctions. Through the use of an automated milling procedure, an inspection plane normal to the crack has been created. In Figures 8c and 8d there appears to be a distinct layer of material on either side of the failure crack, and when measured, this is found to be approximately, 1um in thickness, which is comparable to that of the deposited ELESS Cu layer. As such it would be reasonable to conclude that the crack arose due to cohesive failure within the ELESS Cu layer as this can be clearly seen on either side of the crack surface.

In order to support this conclusion it would be beneficial if some additional analysis could be performed in order to locate and confirm the ELESS Cu layer, and typically this would be supplied through Energy-Dispersive X-ray spectroscopy (EDX) targeting elements unique to the ELESS Cu process. In such cases, Palladium or Nickel would be suitable; Pd is commonly used as a catalytic seed layer, so its presence can be used as a reference from which the location of the ELESS Cu layer can be determined, and in the case of Ni, it is often co-deposited with the Cu in order to influence the physical properties of the final ELESS Cu layer, and so, Ni presence can directly indicate the location of the ELESS Cu layer itself. Unfortunately the energy of the incidental electron beam used in SEM-EDX investigations is of a sufficiently high order that the beam penetration can be in excess of 1um in depth, resulting with a high “background” reading. In the case of BMVs, this means that there is a high Cu measurement, and a very low, or no concentration of Pd or Ni detected, thus making ELESS Cu location extremely challenging. When this occurs, without the supporting elemental evidence, the original conclusion would remain, and the failure is attributed to a “brittle” ELESS Cu layer, which would subsequently generate investigations and actions focused around the applicable process.

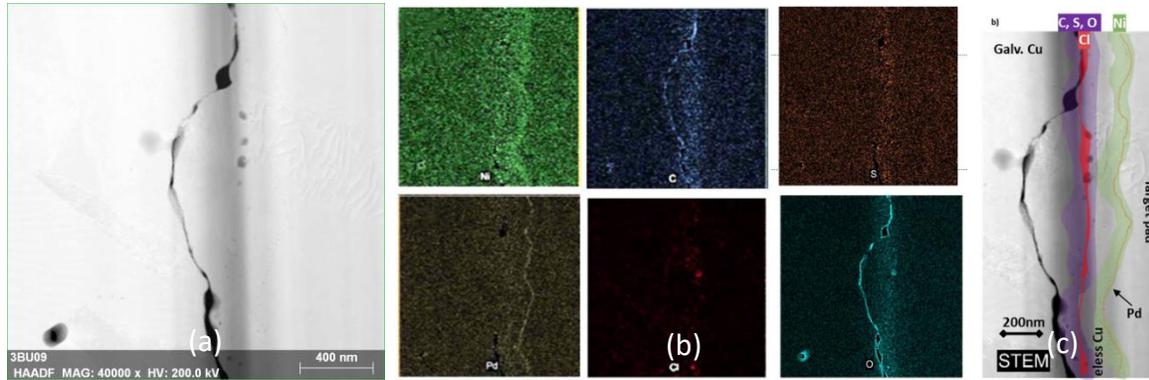
Figure 10. TEM Images of Sample (a) with Elemental Analysis (b) Aiding Layer Location. (c)

Figure 10 shows representative results through TEM investigations, and as can be seen, the primary image in combination with the EDX analysis allows relative locations of the ELESS and ELYTC Cu layers to be determined.

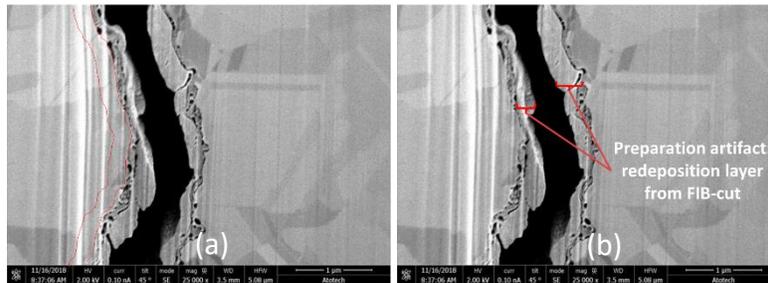
Figure 11. SEM Image with TEM Based Overlay Showing Location of ELESS Cu Layer (a) and Preparation Artifact from FIB Cut. (b)

If we now refer back to the example in Figure 8 where the BMV failure is attributed to cohesive failure within the ELESS Cu layer. Through TEM analysis, we can now determine the location of the ELESS Cu layer itself, which, as shown in figure 11b, is found to be not only wholly intact but located to the left side of the crack, implying that the material found on the inner faces of the fracture surface are in fact redeposited artifacts arising from the FIB cut. In view of this, it can now be concluded that the BMV failure itself could be associated with adhesive failure between the ELESS Cu and ELYTC Cu layers.

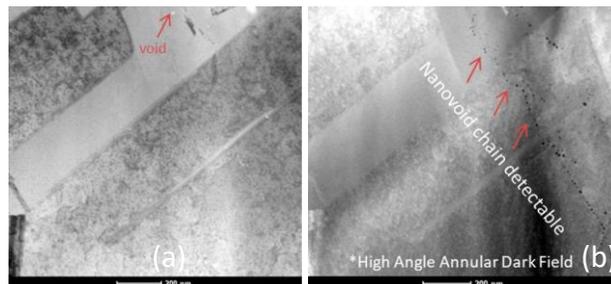
Figure 12. Bright (a) and Dark Field (b) Images of the Same TEM Sample. BF Highlights Crystal Orientation whilst DF Enhances Void Detection.

Similar to most microscopy methods, TEM has a number of applicable inspection techniques, including “Bright” and “Dark Field”, BF and DF respectively. When utilizing BF, the detectors receive a high intensity of directly transmitted electrons, enabling good clarity of crystal orientation, whilst DF has a lower intensity of scattered electrons, making it more suitable for detection of small voids etc within the sample. (Figure 12)
