Double Reflow-Induced Brittle Interfacial Failures in Pb-free Ball Grid Array Solder Joints

Julie Silk¹

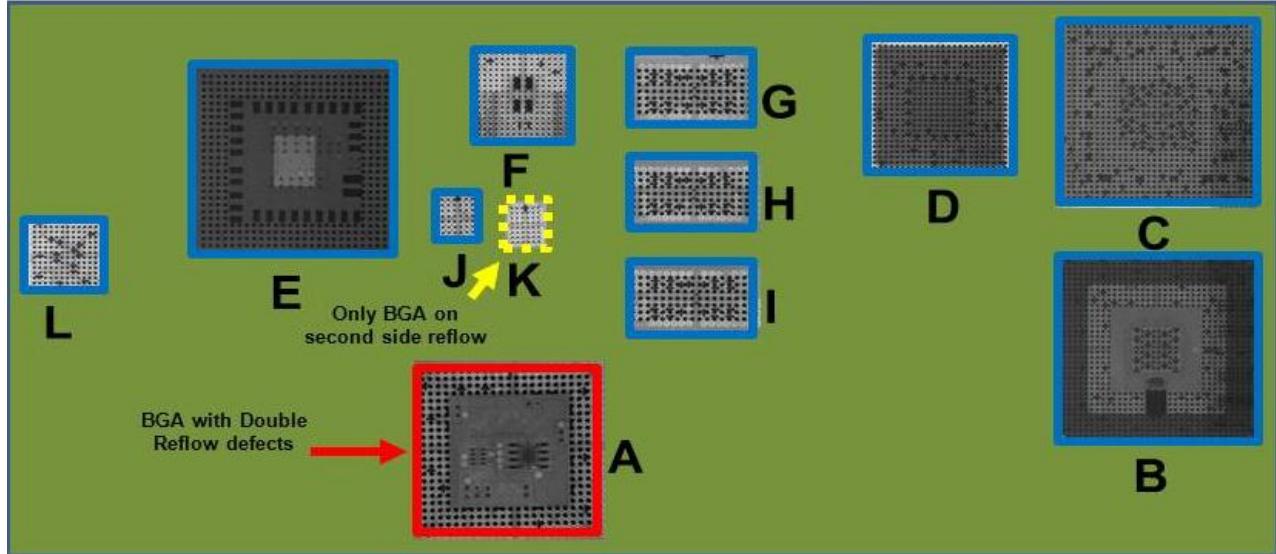
Figure 1: PCBA BGA Component Descriptions, Locations and Reflow Process.

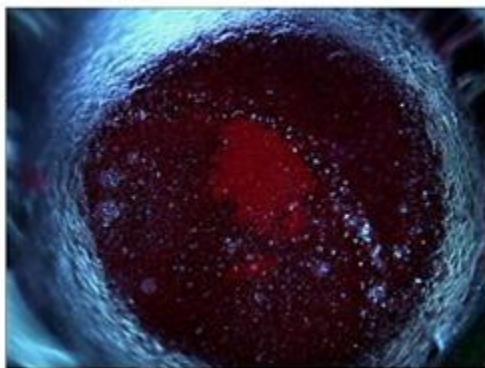
Figure 2: Optical photomacrograph of a failed solder ball surface after dye and pry (DnP) testing. This surface has fractured between the solder ball and BGA package pad (at the component side). The red color on the surface is from the dye intrusion that occurs prior to the mechanical prying.

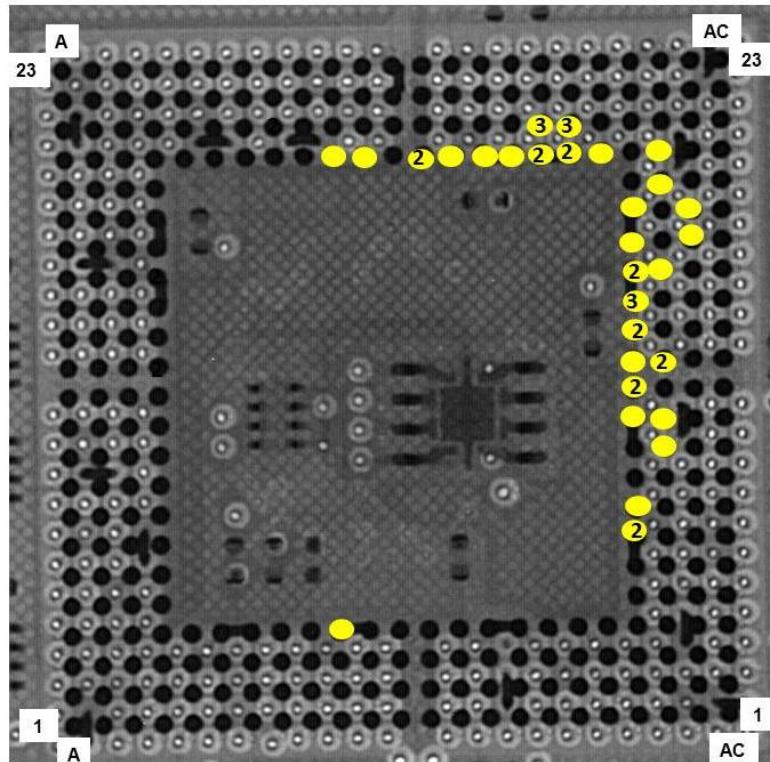
Figure 3: Failure location map from dye and pry test data overlaid on a transmission X-ray image of BGA Component A. This map is a composite of failures for Component A taken from three different PCBAs.

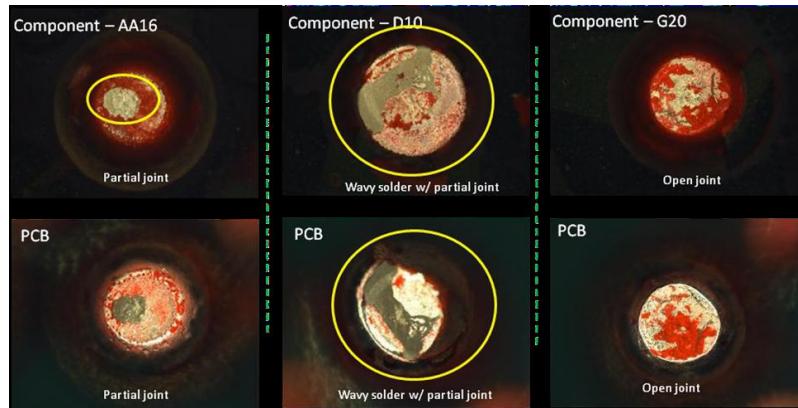
Figure 4: Optical photomacros of various fracture surfaces after DnP testing.

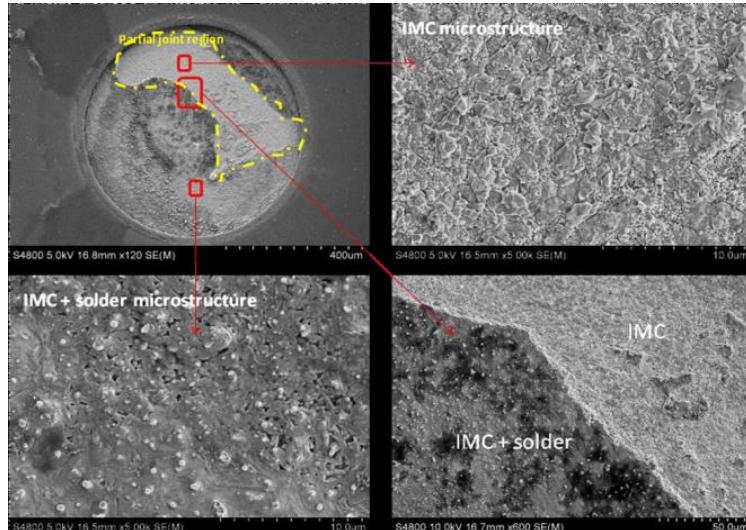
Figure 5: SEM micrographs of various fracture surfaces after DnP testing.

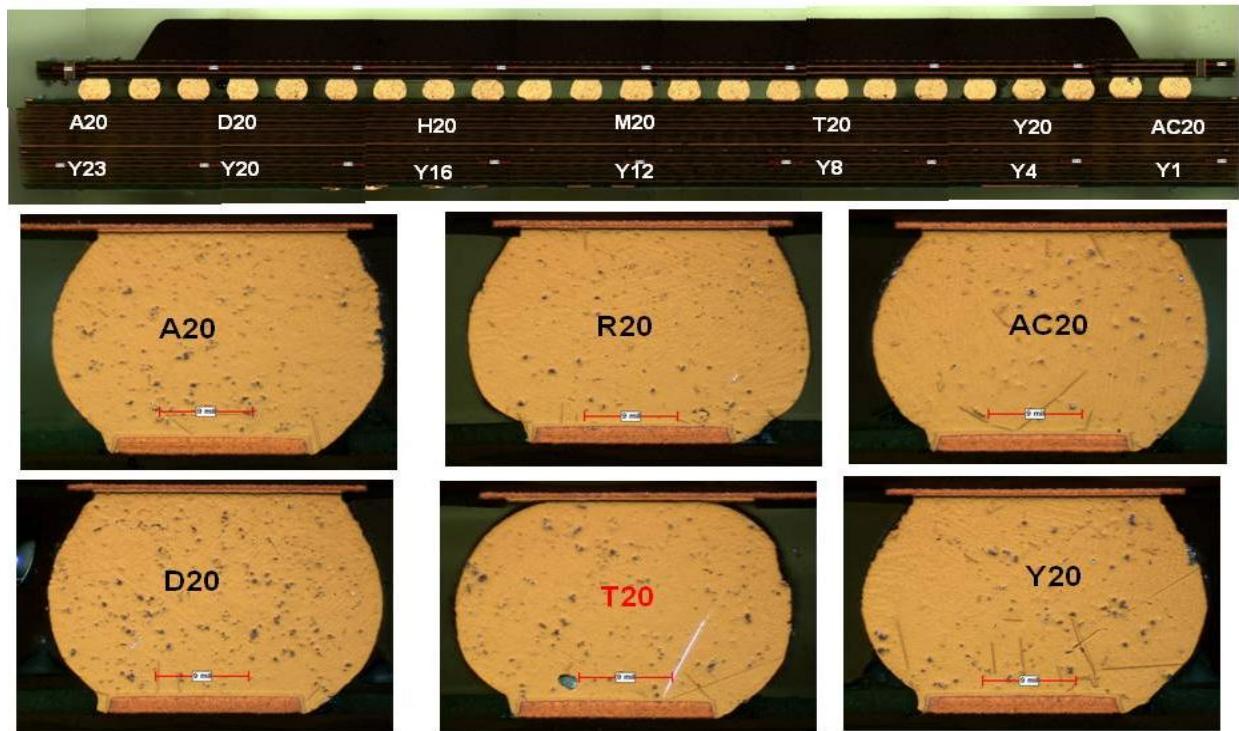
Figure 6: Multiple metallographic cross sections of solder balls in Row 20 of Component A.

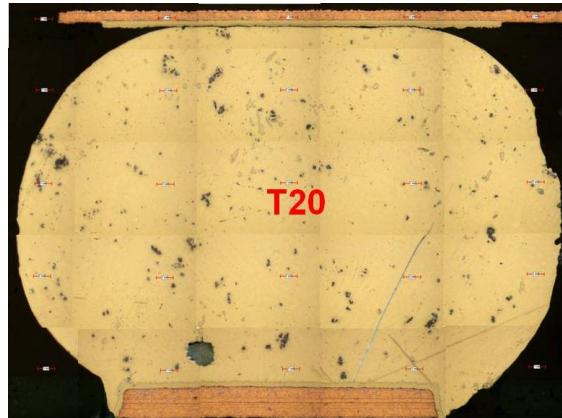
Figure 7: A higher magnification photomicrograph (initial magnification 500X) showing a defect that appears to be de-wetting at package location T20 in Component A. The ball seems to be detached from the package pad.

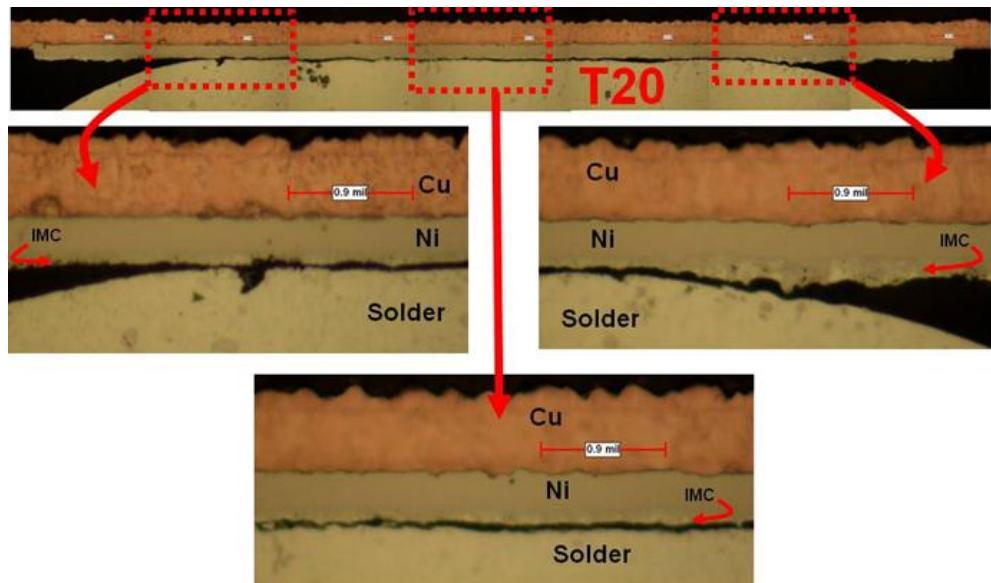
Figure 8: Higher magnification photomicrographs (initial magnification 1000X) adjacent to the T20 BGA pad area showing evidence of a prior successful soldering reaction on the BGA pad with subsequent fracture at the interface between the IMC layer and the bulk solder.

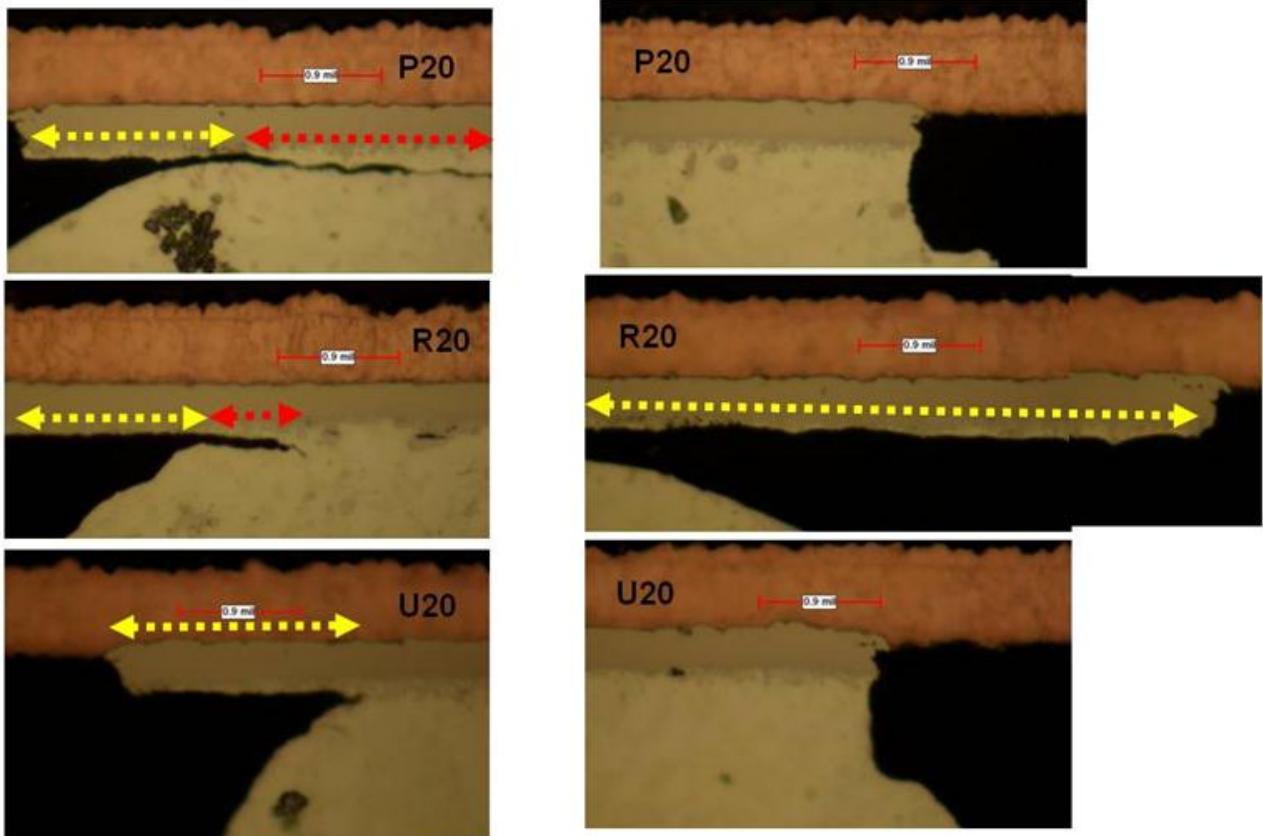
Figure 9 - Magnified cross section, 1000X, of PCBA, Component A, solder balls P-20, R-20, and U-20.

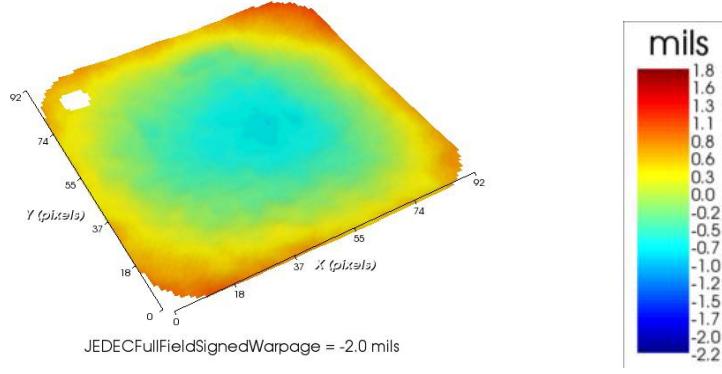
Figure 10: A warpage displacement map across the overmolded area of Component A measured during temperature ramp up at 220°C.

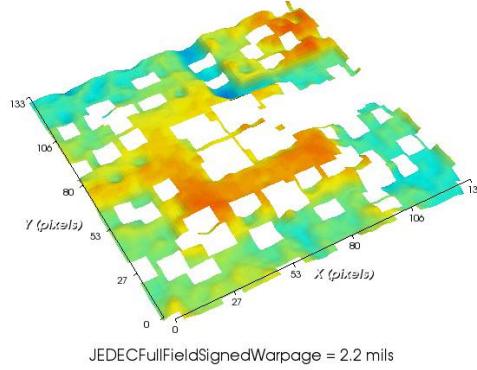
Figure 11: A warpage displacement map for the PCB footprint matching Component A. The measurements were made during temperature ramp up at 220°C.
