Influence of Salt Residues on BGA Head in Pillow (Hip)

J. Servin, C. Gómez,
M. Domínguez, A. Aragón
CONTINENTAL CUAUTLA
Av. Ignacio Allende Lote 20
Parque Industrial Cautla
Cd. Ayala, Morelos 62749, México
E-mail: jose.servin@continental-corporation.com
cynthia.gomez@continental-corporation.com

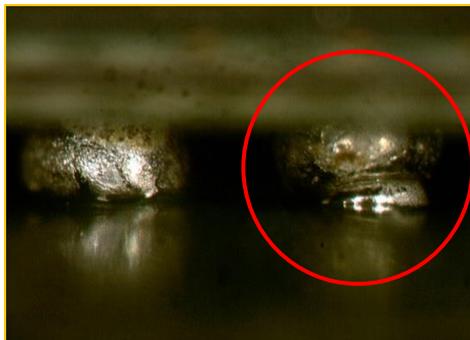
Head in Pillow is a BGA solder joint defect in which the solder paste wets the pad but does not fully wet the ball, see Figure 2. The solder ball physically touches the solder paste deposit but there is not a metallurgical joint. The improper electrical connection situation becomes more severe because many of these type of connections would be electrically intermittent. This is due to a lack of solderability between the ball surface and solder paste alloy due to oxidation, contamination or a mechanisms that prevents the solder alloy to form a joint with the solder balls. One of the main possible causes is excessive oxidation even though the excess oxidation has mainly been attributed to external control problems of solder paste handling or reflow profile.

Figure 2. Head In Pillow Defect in a BGA connection (See the red circle)

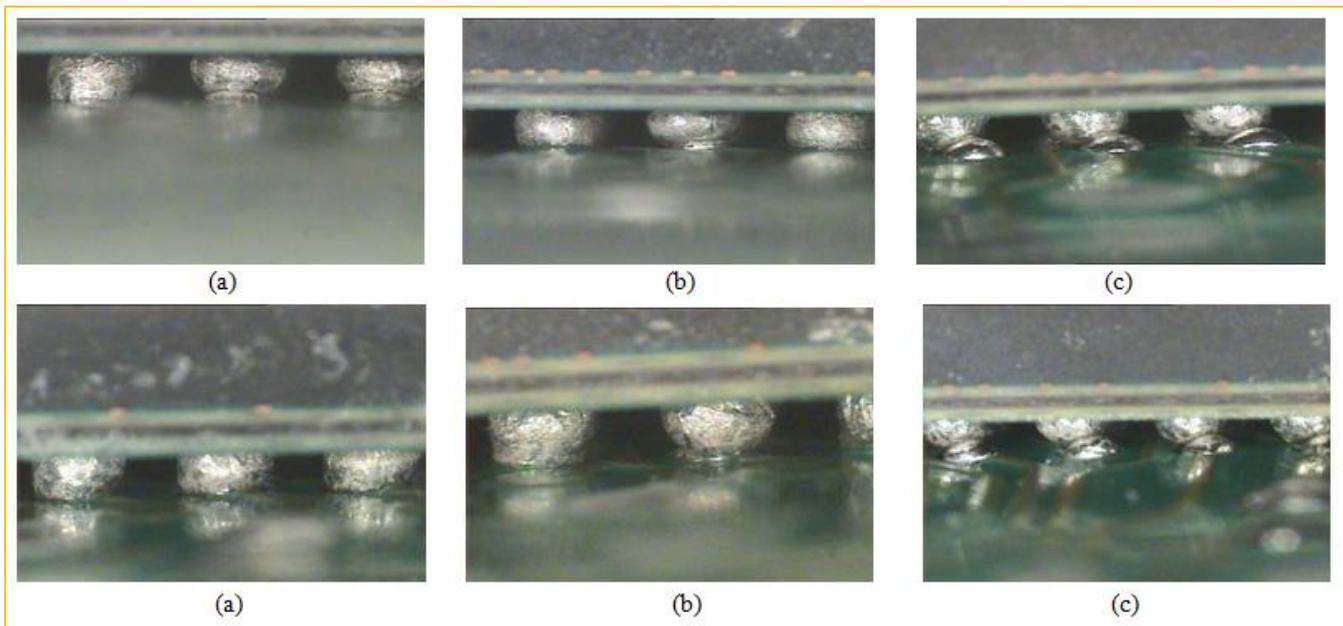
The images in Figure 5 show the HiPs resulted in DOE 1. The images, Figure 5(a), are the test at a time of 4 hours and did not have many defects of HiP. The Figures 5(b) are the components with a steam time of 8 hours, and more defects are seen. Finally, Figure 5(c) are the components at 16 hours of steam. These components got misplaced due to the number of HiPs. According to the results and comparisons, we can consider that the longer the time, the more defects.

Figure 5. DOE 1 Results: (a) Components at 4 hrs of steam, (b) Components at 8 hrs of steam, and (c) Components at 16 hrs of steam, the components are misplaced due to number of HiPs

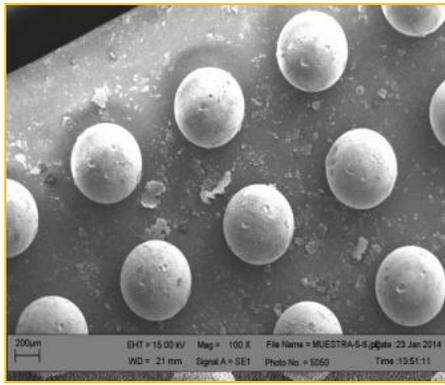
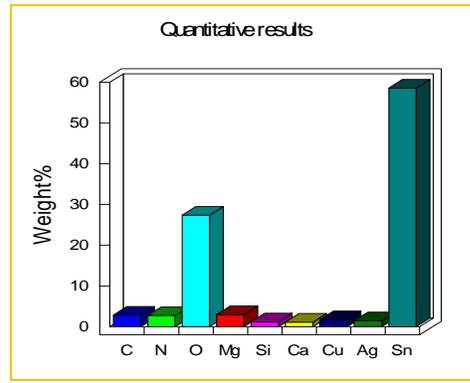
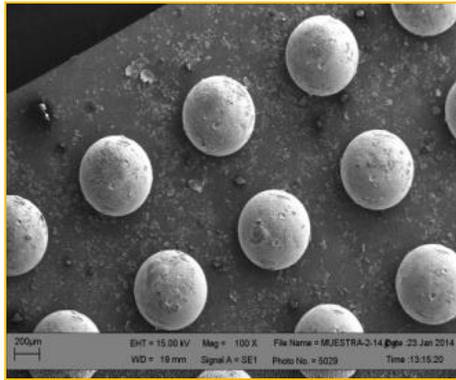
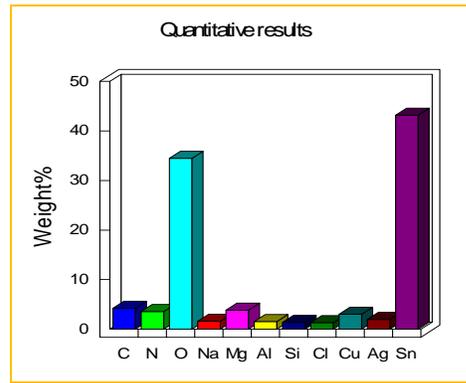
In the analysis of SEM/EDX, components have the presence of several elements on the surface. Figure 6 shows the results for the components at 16 hrs steam. Several elements are found (Mg, Ca, Al) beside Na and Cl. It is interesting to mention the solder balls have specific spots of the elements. Only components with 16 hrs of steam show more uniform distribution of the elements on the surface.

Figure 6. SEM Images of components at 16 hrs of steam, Samples 1 and 2 (A and B), EDX results (a and b)

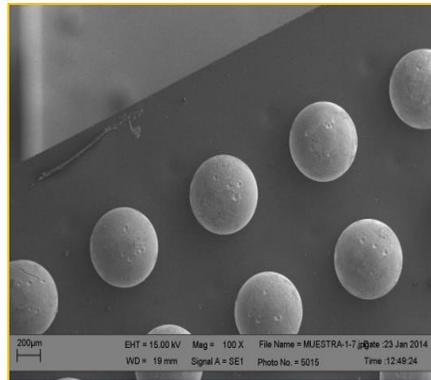
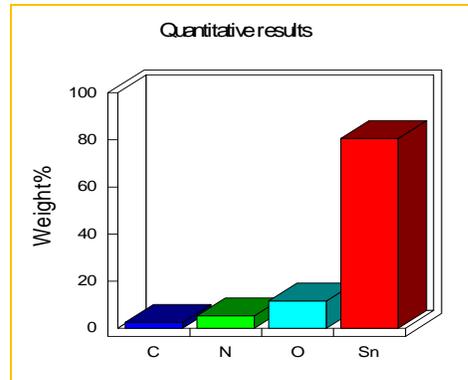
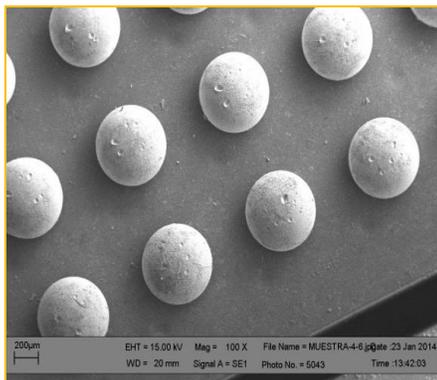
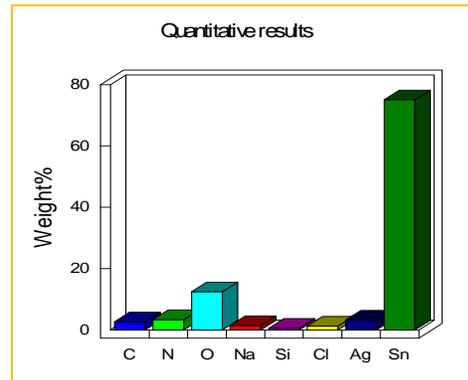
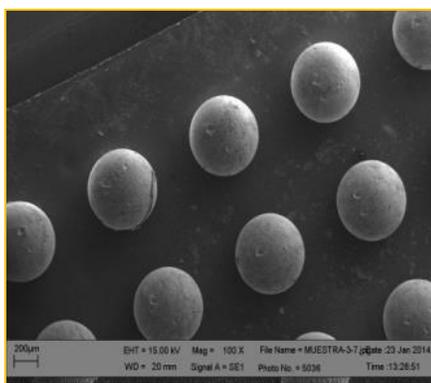
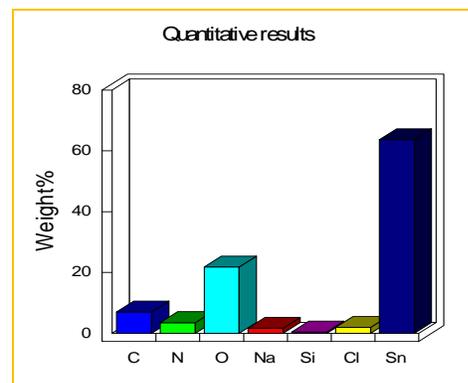
Several components were analyzed before soldering with SEM/EDX. The results are in Figure 10. The BGA images are in “raw” material after steaming. The EDX results are from specific areas where salt was detected and not general analysis. SEM images do not see the presence of NaCl presence until it is too high a value. This means analyzing images is not so reliable as expected to detect Cl presence because the NaCl presence exist but the detection is too low as would expect. However, we can get HiPs with low amount of NaCl under experiment conditions. In case of EDX analysis, Cl presence (in the form of salt) is dispersed and not uniformly distributed over the solder ball surfaces. The analysis had to be done checking specific points where Cl (NaCl) presence is detected. This means NaCl is accumulated in specific spots. In case of components steamed with only DI water, no Cl or Na presence was detected.

Figure 10. DOE 2. SEM Analysis Influence of NaCl in several conditions

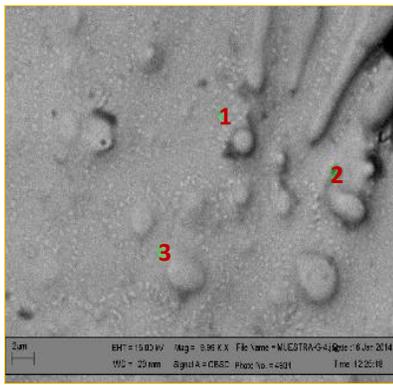
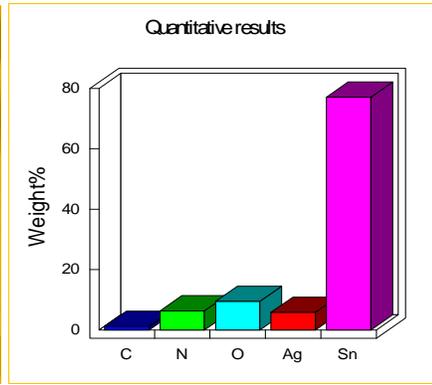
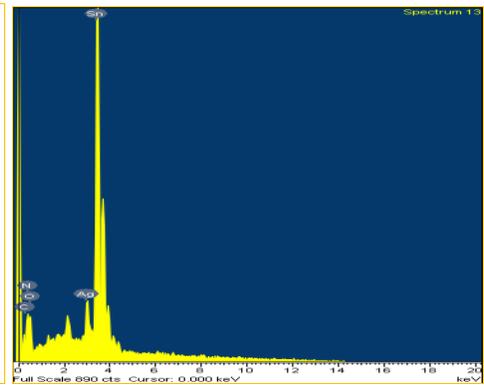
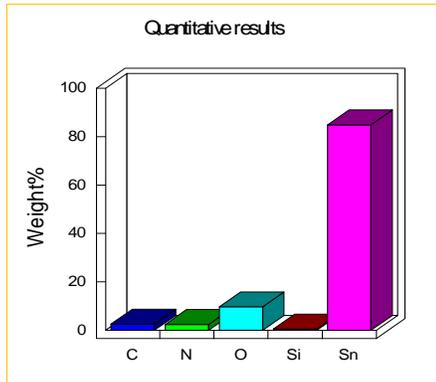
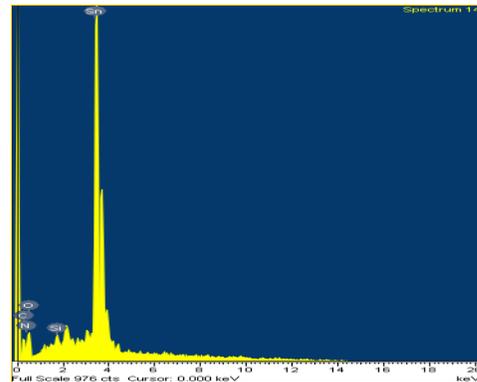
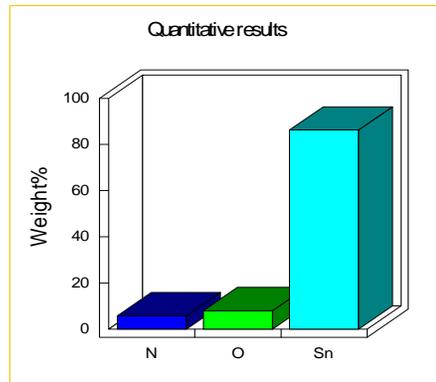
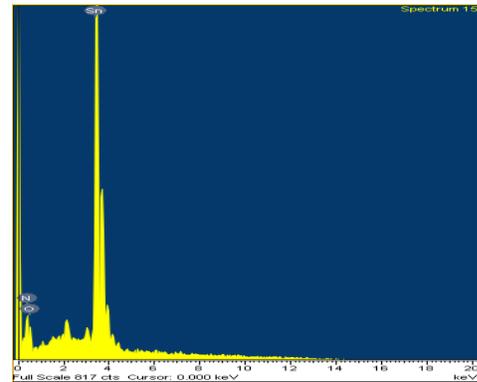
Figure 15. (A) shows three red numbers representing the punctual areas. (1) corresponds to the analyzed point 1, (2) to the analyzed point 2, and (3) to the analyzed point 3. The sample comes from 16 hrs test and DI water

The BGA sample has no NaCl presence. Point 1, 2 and 3, Figure 15, contain only tin, nitrogen and silver. The surface, Figure 16, has similar elements to the analyzed specific points.

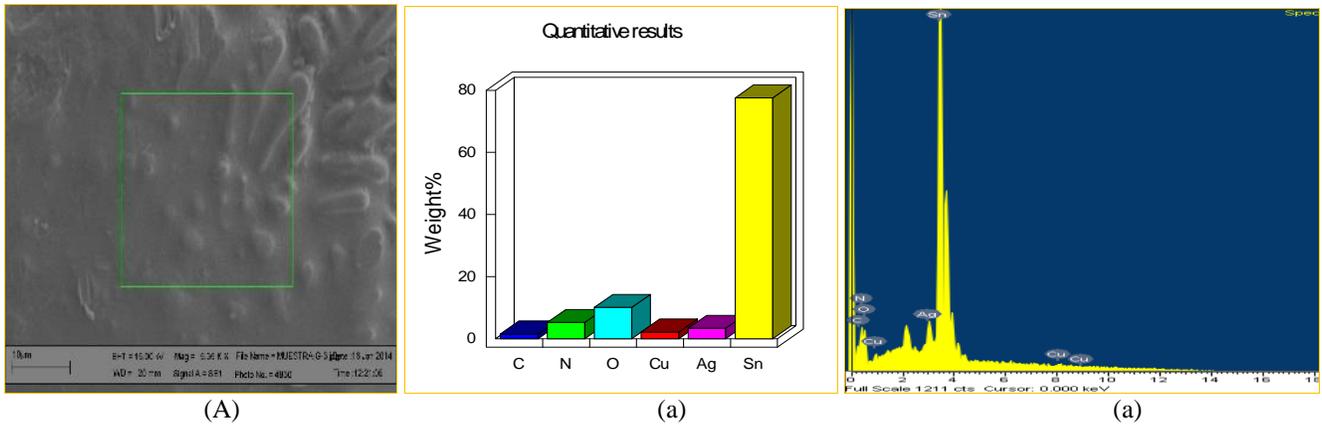
(A) (a) (a)
Figure 16. (A) is a general SEM Analysis. Sample comes from 16 hrs and DI water

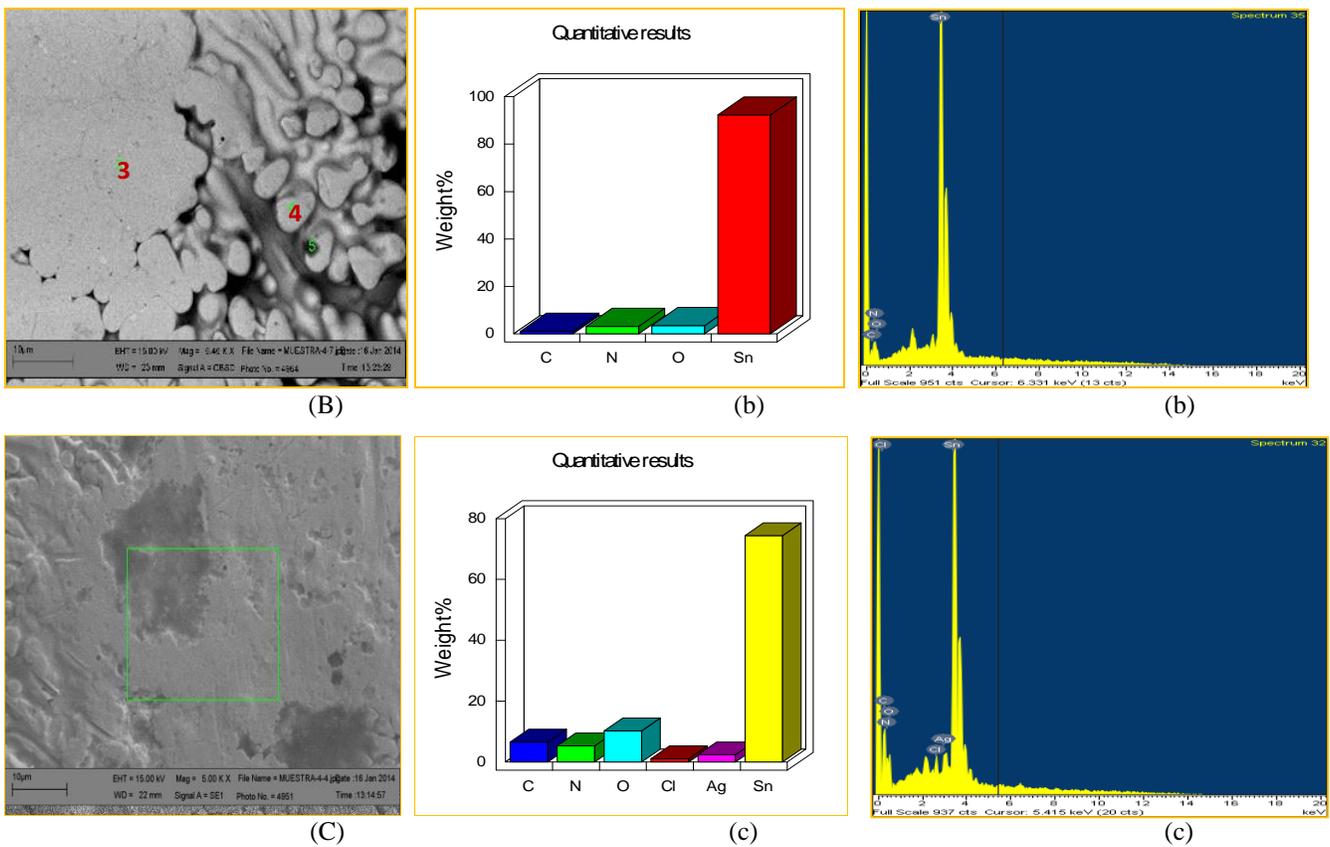
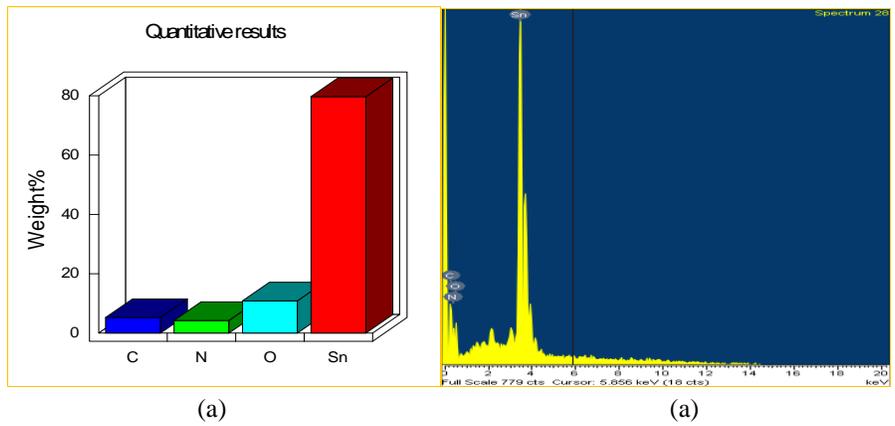
In this case, the results show a small concentration of chloride on the surface of the tin, see Figure 17; however, the presence of these chlorides is not evenly distributed across the surface of the ball but is found at specific points around the same; these points are located randomly.

Figure 17. The Images (B) and (C) are analyses of the sample with deionized water and 0.5% NaCl for 4 hrs

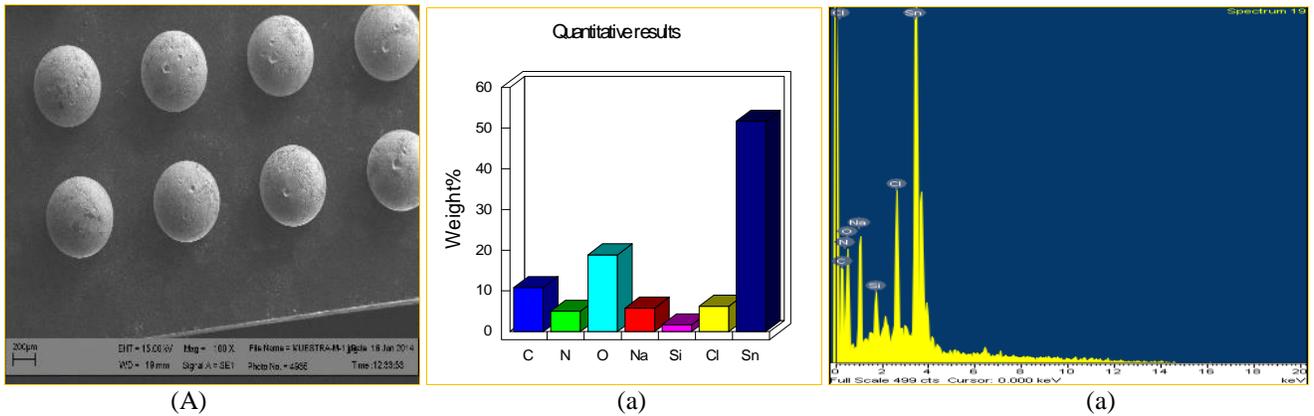
In Figure 18, the sample of analysis comes from deionized water and 1% NaCl at 4 hrs of steam. The samples are more contaminated with NaCl than BGA in Section III.4.2. The results show higher sodium chloride concentrations at specific points around the ball.

Figure 18. (A) Results SEM Analysis (NaCl), Sample deionized water at 4 hrs

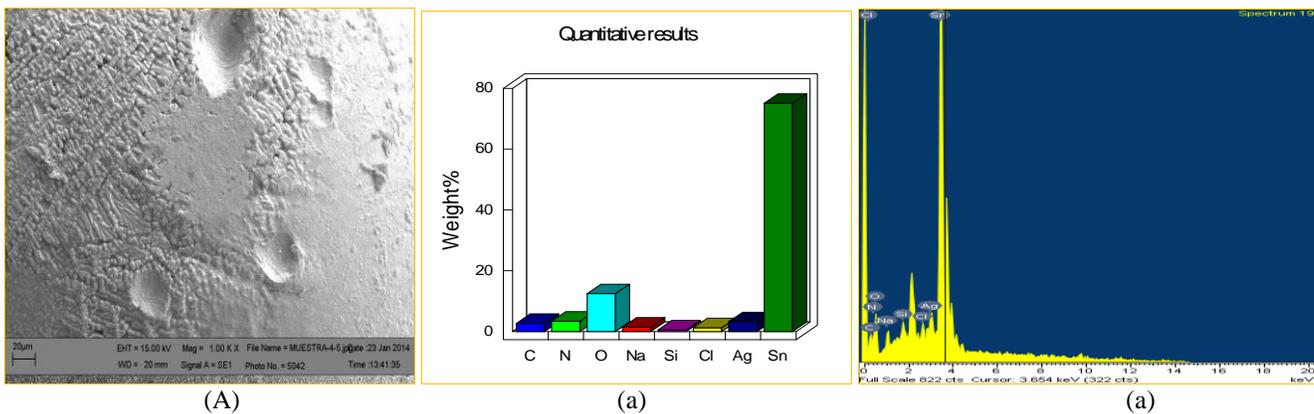
Although the component is exposed to a longer time, see Figure 19, than the component shown in the figure above, the sodium chloride concentrations are not substantially increased but the specific points with sodium chloride increases its presence in number.

Figure 19. (A) Results of test-deionized water at 1% for 16 hrs. The sample presents disperse areas with NaCl

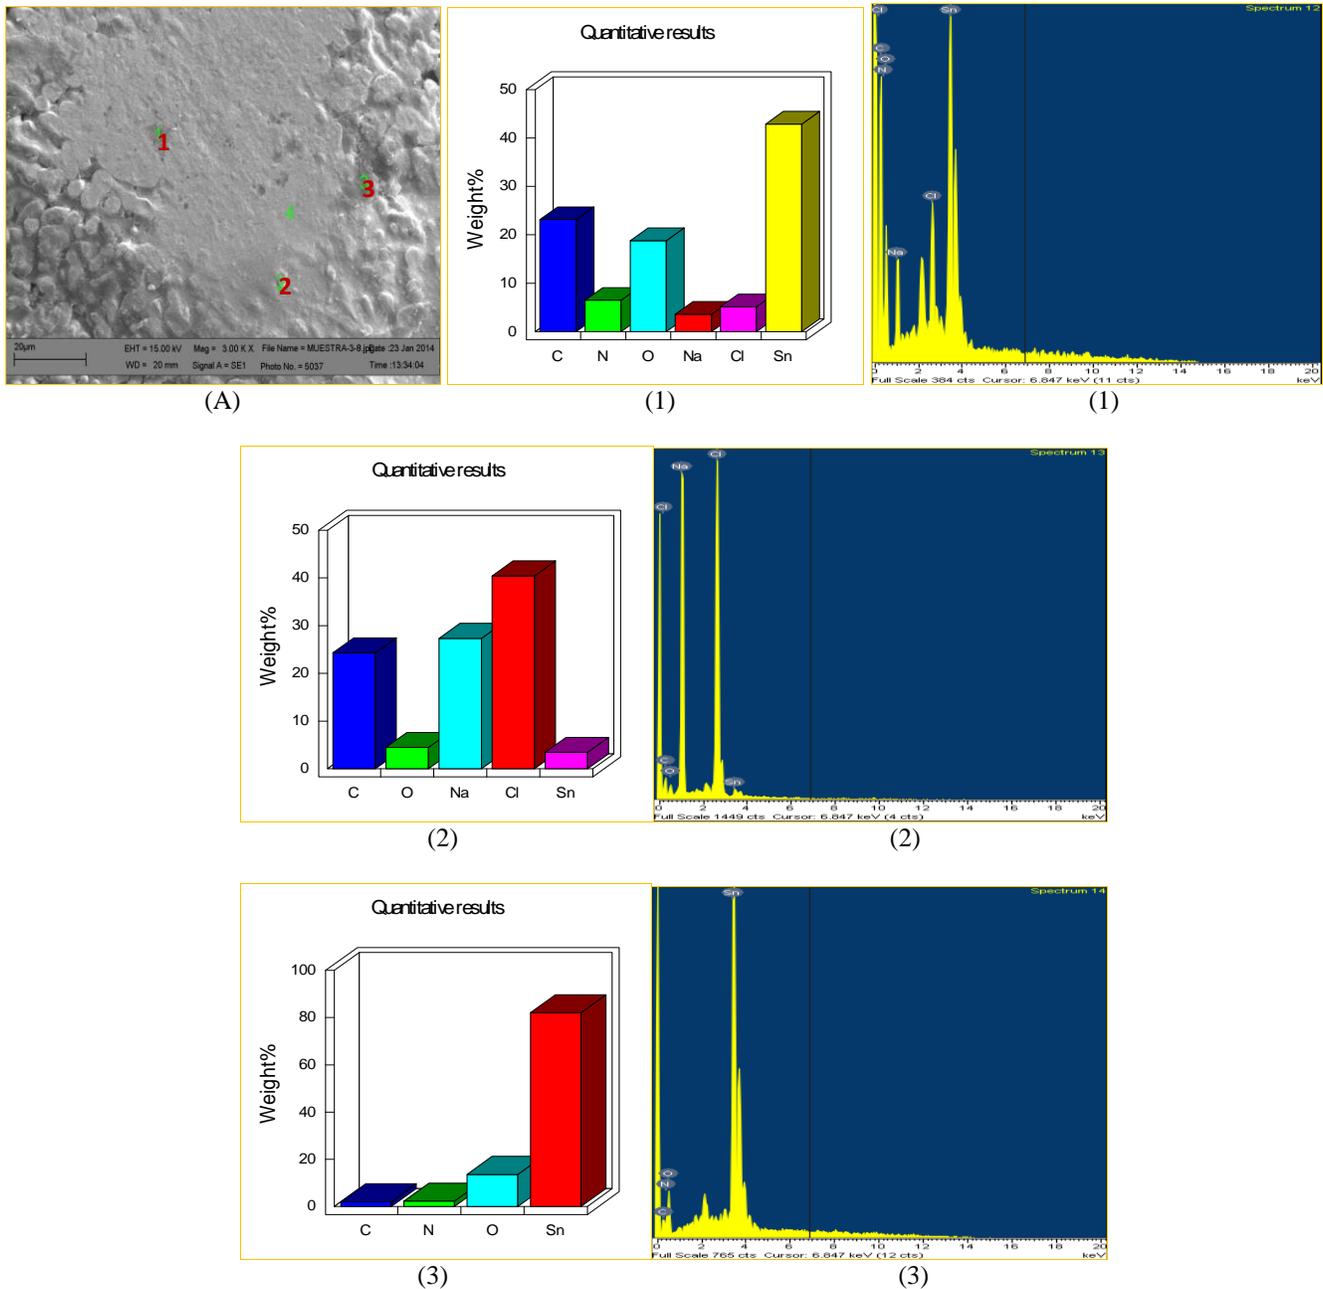
The results, Figure 20, show similar behavior to the previous sample, in which stains on the surface area increase. These areas are those containing a higher concentration of sodium chloride but do not cover the entire area of the ball but certain regions.

Figure 20. (A) Presents analysis showing three analyzed points. The analysis was performed with deionized water at 5% (NaCl) for 16 hrs

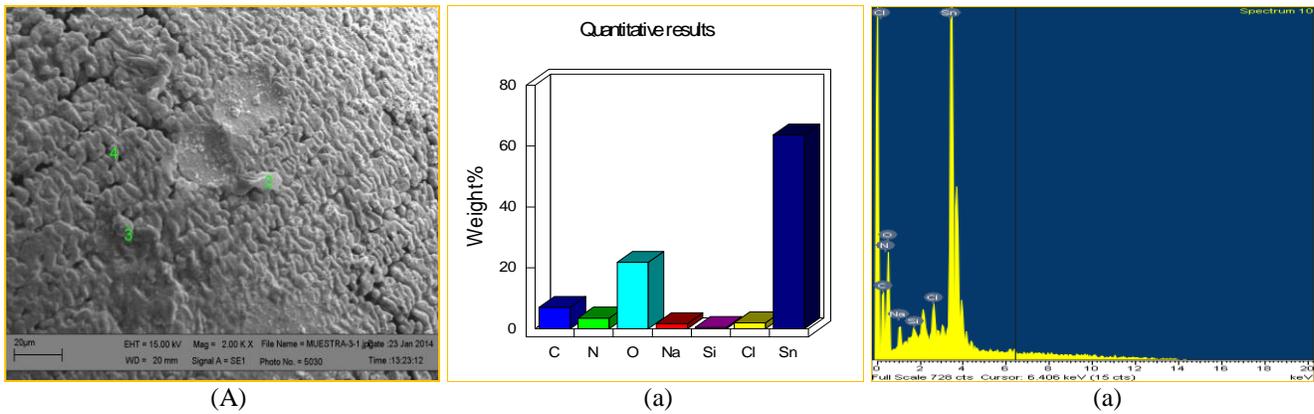
Figure 21. (A) is a general Analysis SEM. The sample was steamed with deionized water at 5% (NaCl) for 16 hrs

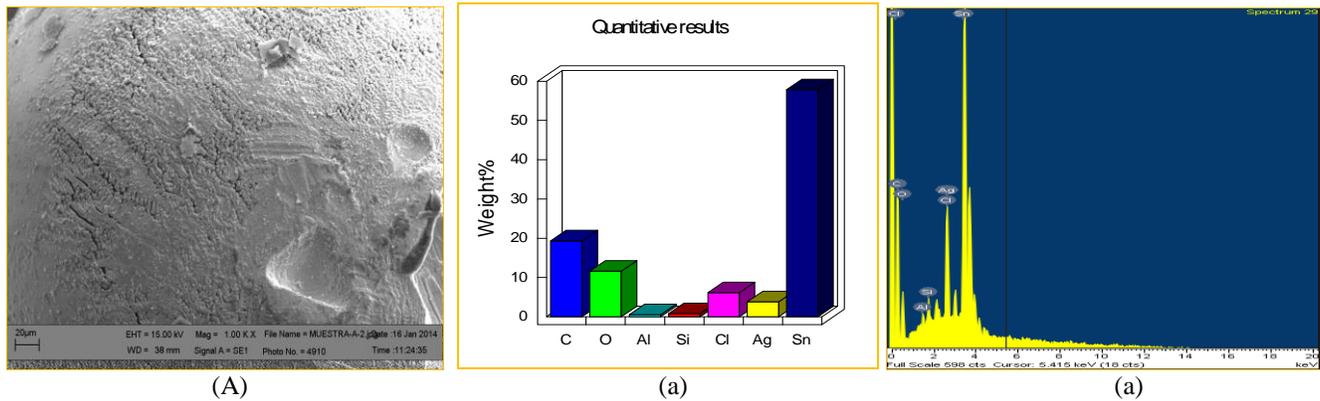
This sample, Figure 22, presents spots in larger surface areas. Additionally the presence of NaCl looks very marked in the component body. This case would be inadmissible in normal production, further the level of defects created with this NaCl concentration is very high.

Figure 22. (A) is a general analysis with SEM. Test in tap water at 10% (NaCl) for 4 hrs. The sample presents Cl and a high percentage of Oxygen

The analysis of this sample presents a large concentration on the surface of the ball in several chemical elements not only NaCl. See Figure 22 (A). These elements are Aluminum and Magnesium which also decrease the solderability of the balls.

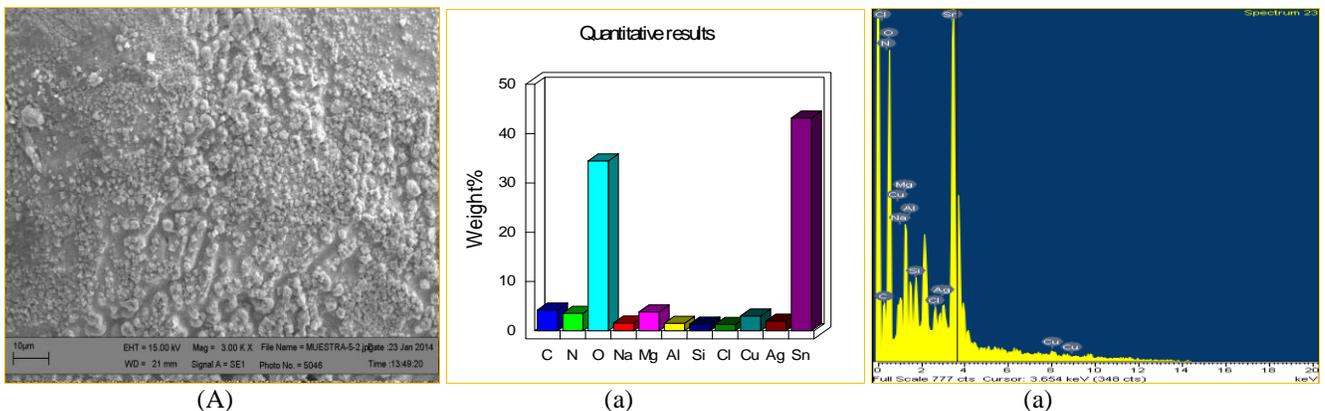
Figure 23. (A) Sample in tap water at 10% for 16 hrs. Aluminum and Magnesium are present elements, which can affect the solderability

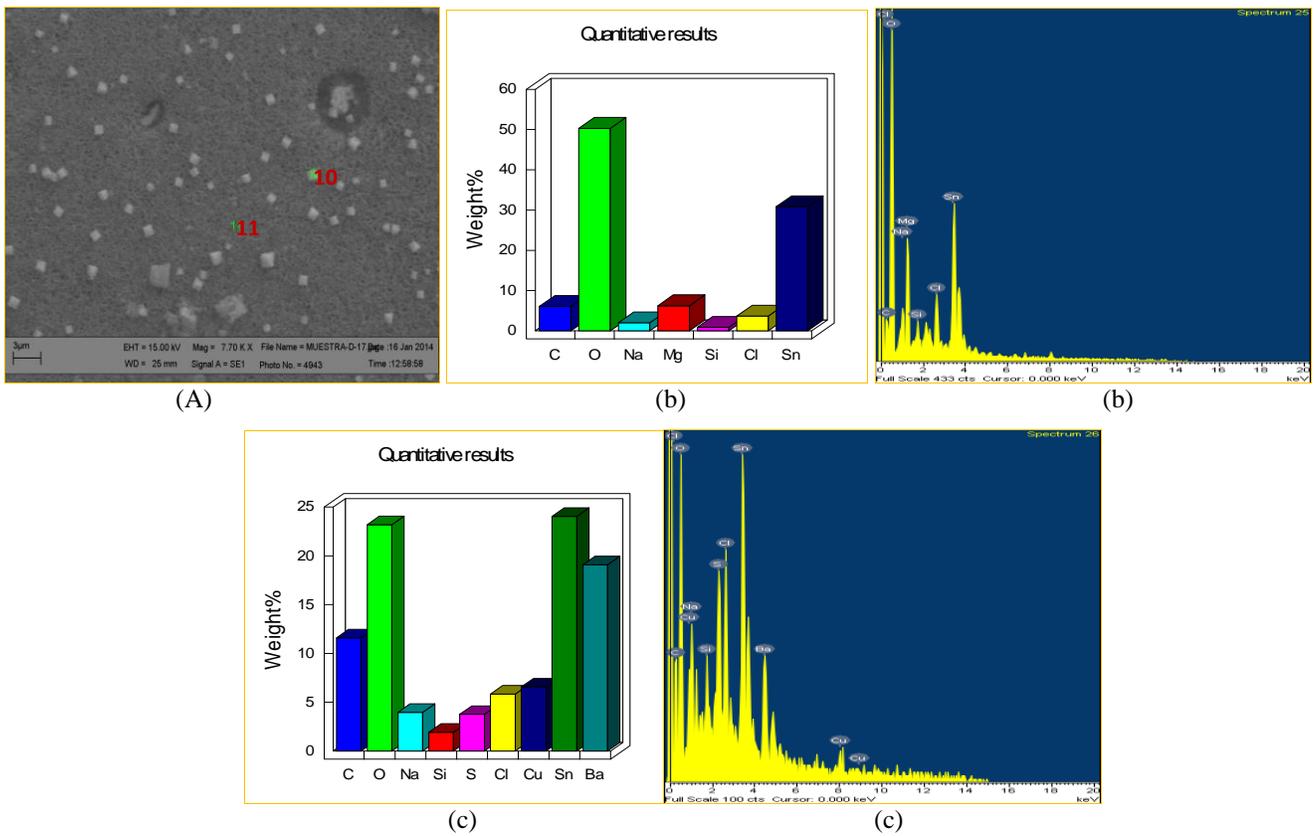
The SEM analysis shows contamination of NaCl in the BGA body in this case, see Figure 24. The contamination is in the form of small squares..

Figure 24. (A) General analysis body component (b) corresponds at point 10, and (c) at point 11

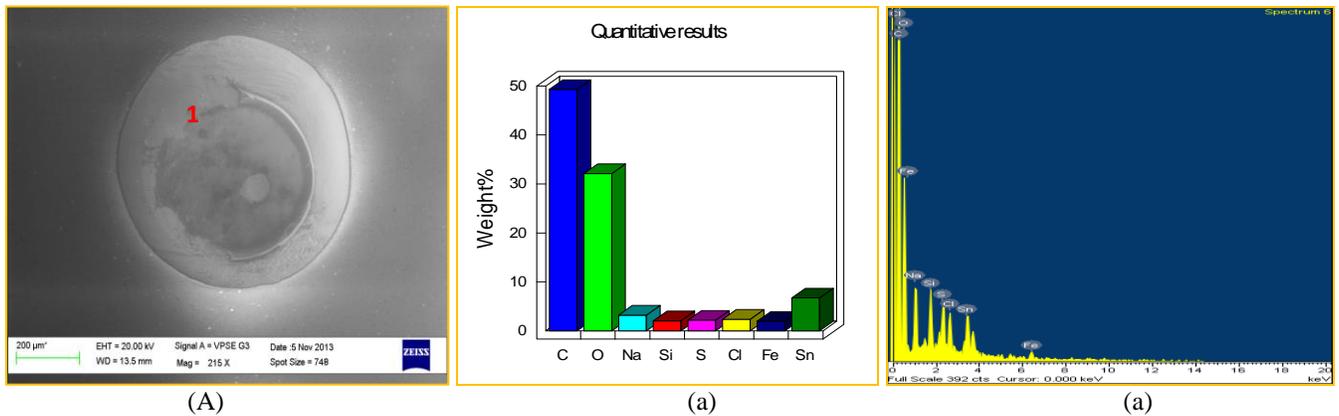
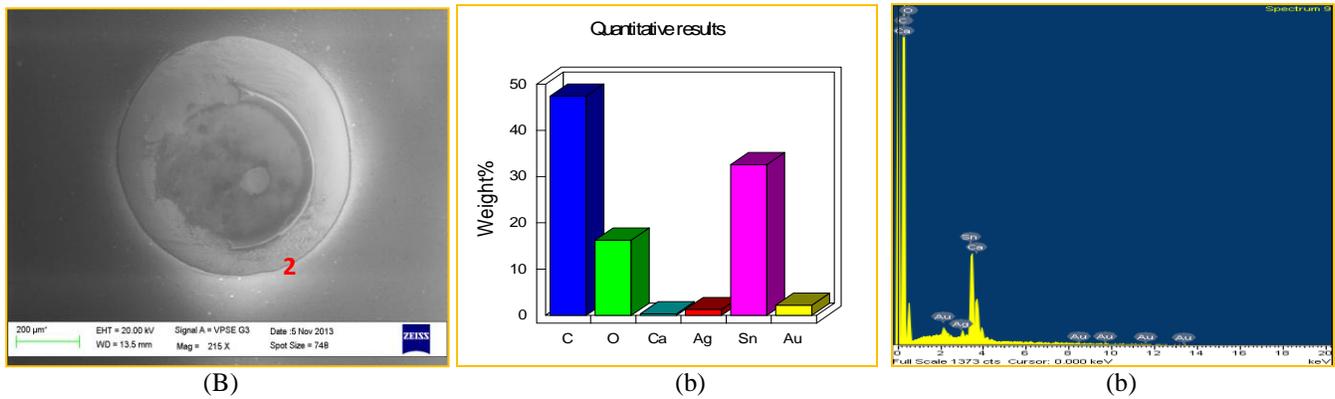
Ball 1: HiP defect

The next analysis points out an actual HiP rejection from production lines. The analysis shows that in some areas Cl concentrations are present and in other areas do not show similar to cases analyzed above. Cl concentrations are found around the component in specific areas. Although the reject would be related to other possible causes, it is interesting to mention the relationship between the experiments and this real case.

Figure 25. (A) The analysis of analyzed point 1 presents Cl; (B) is the analyzed point 2 which does not show Cl in a real HiP

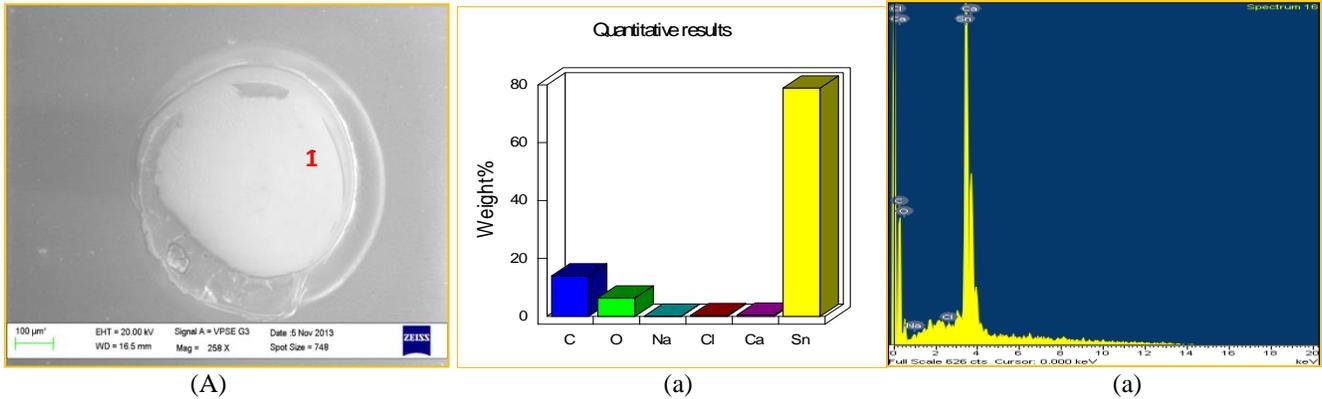
The following images show HiP SEM/EDX Analysis made on the pad. There are only small residues of NaCl left on the surface.

Figure 26. (A) There is NaCl presence on the pad
