PROJECT UPDATE: PROTOCOL DEVELOPMENT FOR TESTING SOLDER RELIABILITY IN COMBINED ENVIRONMENTS

ABSTRACT

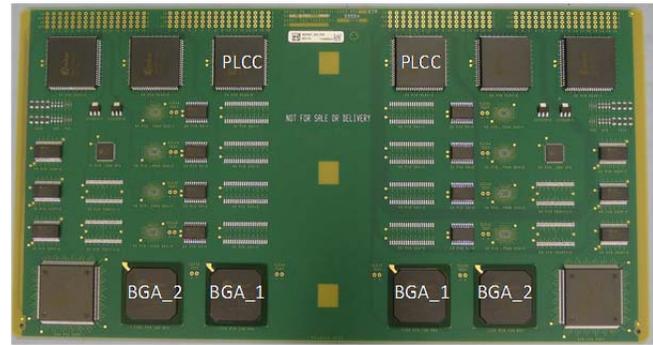
The first challenge was to produce mechanically uniform material for testing. The test vehicle design provided by Honeywell and has been used extensively in mechanical testing. The units for all of Phase 1 were built together in one group using the three alloys shown in Table 1. at a Curtiss Wright facility.

Figure 1: Test vehicle & tech types

The step stress procedure utilized in Phase 1A incorporates multiple dwells of 100000 cycles at 1G increments until at least the four devices exposed to the highest strain levels have failed. The test is terminated at the end of the step that includes the 4th failure. The four devices are the two PLCC 84 devices and the two BGA 1156 devices closest to the centerline of bending. These devices are coded as tech types PLCC and BGA1 respectively and are labeled in Figure 1.

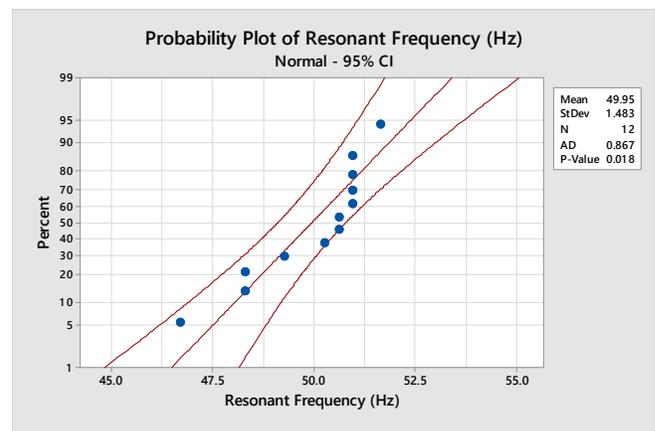
Figure 2: Resonance Frequency - Parametric Analysis

When combined with changes resulting from test temperature this variation can result in unexpectedly high or low strain levels at constant G levels as displayed in Table 3 [1]. The combination of a low RF and a test temperature of 75°C in SN T#-43 resulted in strain levels that deviate from the expected pattern.

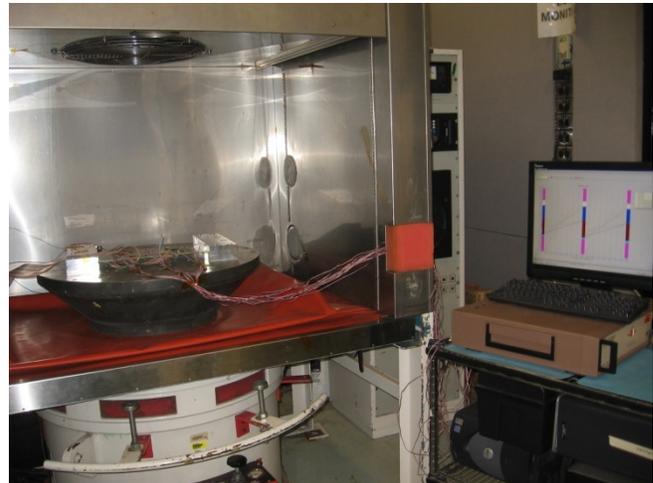
Figure 3: Thermal test chamber & vibration table

All the equipment in utilized for this test program is summarized in Table 4. The Jaguar software system provides control for the electro-dynamic shaker table using feedback from the control accelerometer on the table and collects data from both the table and the (UUT). At 20 second intervals the system records, Time (sec), Frequency (Hz.), Control (g), Response (g), and phase angle. All of the comparative and accumulated measurements are calculated from these channels in post processing.

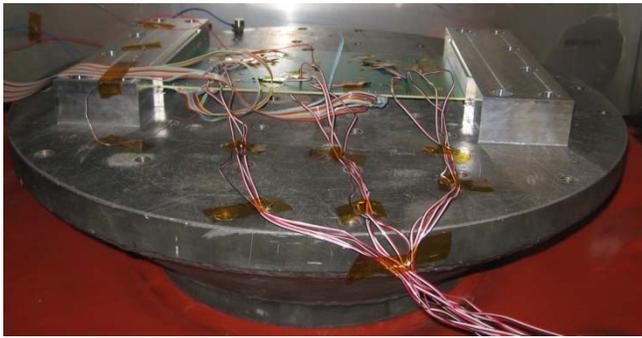
Figure 4: Fully instrumented UUT.

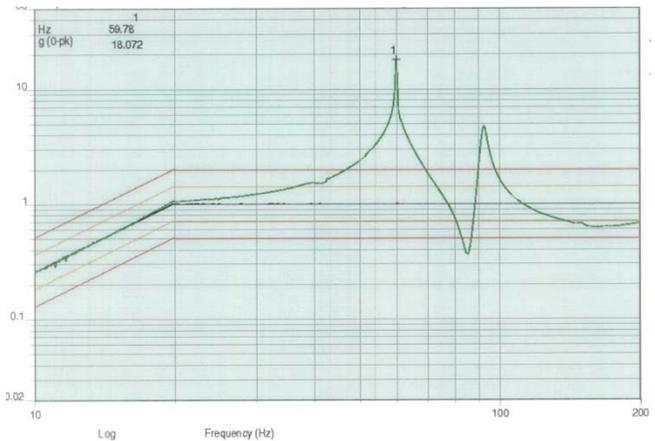
Sine sweep plots highlighting input and response G levels over the range are displayed in Figures 5 & 6. These plots display the variation in shape that can be encountered between temperatures. Compare Figure 5, SN T3-50 at 1G and 125°C to Figure 6: SN T3-51 at 1G and -55°C. The values of RF and response Gpk are different but perhaps not as significant as the differences in shape. The hot sweep exhibits a second resonance peak above 90 Hz. This peak is negligible in the cold sweep. The width of the half power

band at 0.707 of the peak acceleration is also very different, producing different requirements for test control.

Figure 5: T3-50 Sine 1 Gpk 4 Oct/min at 125°C

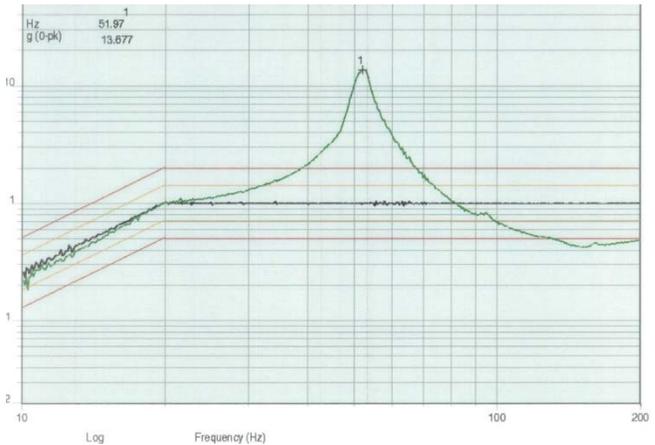
Figure 6: T3-51 Sine 1 Gpk 4 Oct/min at -55°C

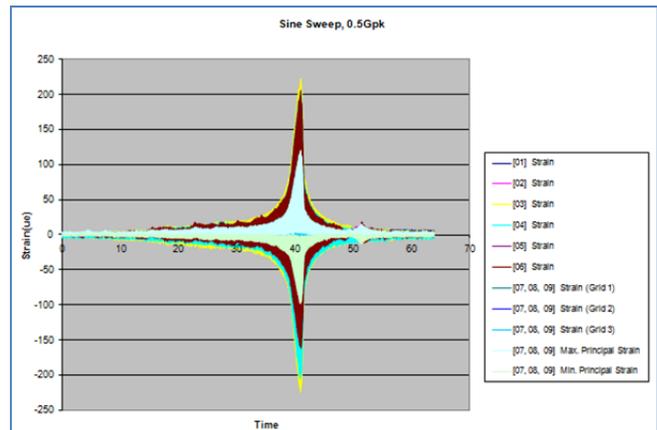
Strain levels recorded from sine sweeps provide a view that are more readily understood by those used to manufacturing strain audits. Figure 8 displays the results from a sine sweep at 0.5Gpk input and 4 Oct/min. The pattern is typical for all of the sweeps recorded in this test phase. Resonance response can easily be 10X the response outside the half power band.

Figure 7: Micro-strain (ue) vs. Time (s)

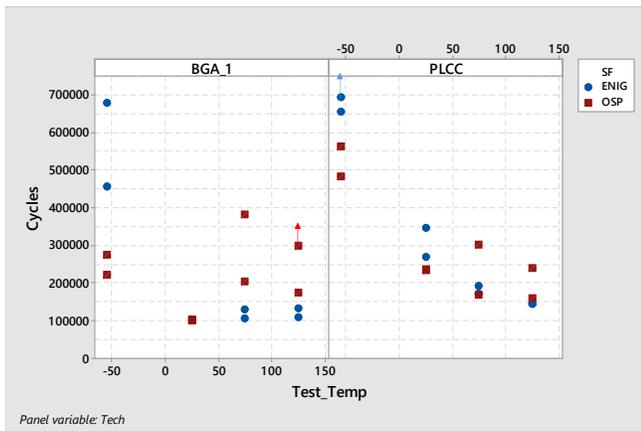
Each assembly has two primary failure locations for both of the technology types BGA1156 and PLCC 84. Phase 1A generated 28 failures and 2 suspensions over the four test temperatures and two surface finish lots. The Cycles to failure data is displayed in Figure 8 with vertical arrows identifying suspended data points.

Inspection of the plotted data in Figure 8 indicates that for BGA devices the shortest life times are not at the highest temperature. This is an artifact of the low RF samples resulting in high strain levels and early failure. In previous work we reported some methods for smoothing the data and incorporating the effect of increasing strain as the step stress testing proceeds. These methods produced more ordered and expected patterns in the data graphs but were not particularly useful in predicting the ratios of cycles to failure at constant strain under isothermal testing. We have discontinued investigation into these techniques as we move into Phase 1B.

Figure 8: Cycles to Failure Vs. Test temperature

The severe impact of test temperature is evident in both Figure 8 and Figure 9 the individual cycles to failure and the main effects plot. It should also be noted that the three highest test temperatures are clearly in the creep zone for SAC305 while the -55C test temperature is more likely to resemble failure by mechanical overstress. This fact is very evident in Figure 9.

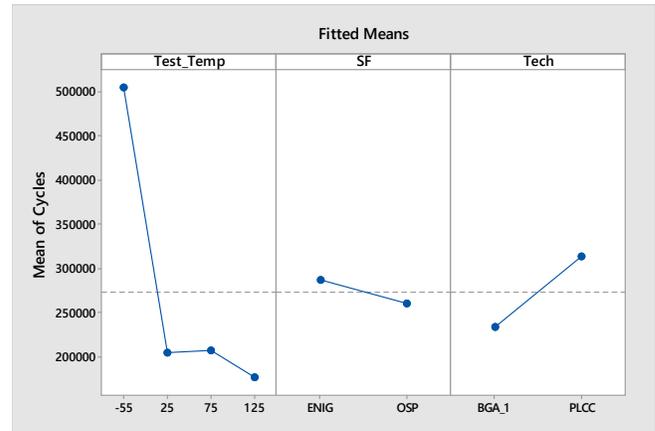
Temperature* Tech Type meet criteria for inclusion at 95% confidence. These results are apparent in the Main Effects plot and Interaction plot which are Figure 9 and Figure 10 respectively. The table of coefficients for this model is provided in Appendix A. Note that Test Temperature is modelled as a category rather than a continuous variable. This is based on differing mechanical regimes. We believe that the 25C and higher temperatures are well within the creep zone but that at -55C mechanical fatigue properties are not related to creep.

Figure 9: Main Effects Plot

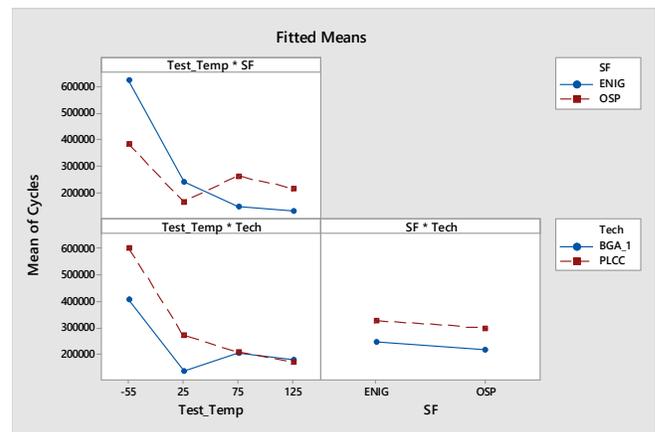
Figure 10: Interaction Plot

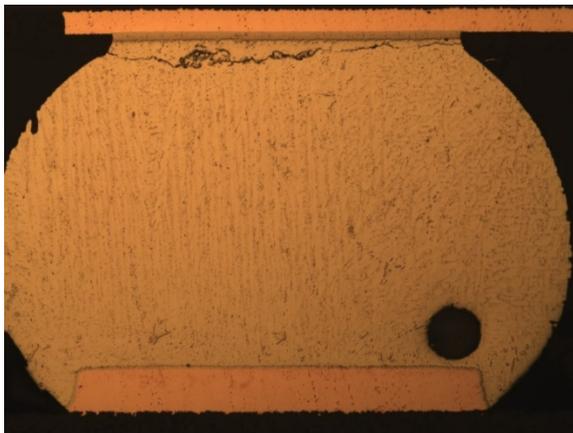
Figure 11: SN31 OSP 125°C 300k cycles

The solder joint in Figure 11 is from the high stress edge of U101 on SN31, an OSP board tested at 125°C and has an original magnification of 200X. The solder joint in Figure 12 is from an equivalent device and position on SN50 an ENIG board tested at 125°C. These devices have been exposed to essentially equal conditions and cycles but outcomes are significantly different.

The OSP device was suspended at 300K cycles without any 300 Ohm events, and only the displayed solder joint

exhibited any damage. The net resistance had increased from 5.7 Ohms to 7.4 Ohms.

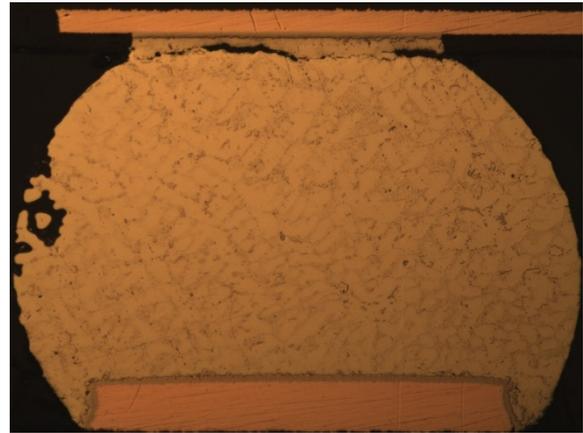
The equivalent ENIG device failed the 300 Ohm criteria at 111K cycles and every sphere on the high stress edge of the component exhibited full width cracks and significant damage by 302K cycles. Since the OSP sample had initiated a crack and resistance was rising we can assume that the difference in performance is in a range near 3 times the cycling life of the ENIG sample at 125°C.

Figure 12: SN50 ENIG 125°C 302K cycles.

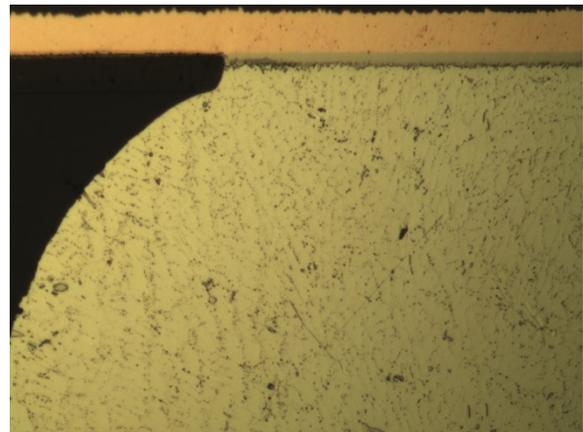
The solder joint displayed in Figure 13 is from the high stress edge of the U1 device on SN32, it failed at 275K cycles and has been subjected to 598K cycles before this cross section was prepared.

Figure 13: SN32 OSP -55C 598K cycles

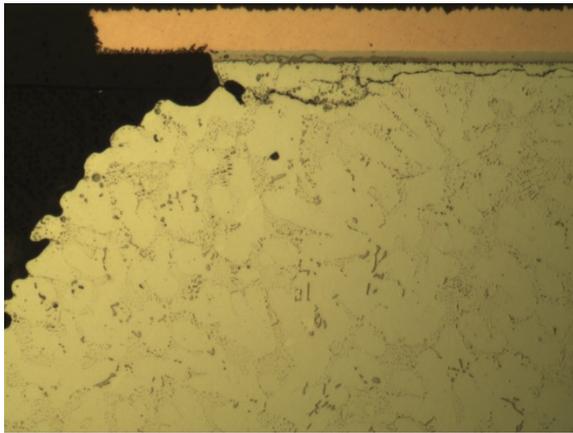
The solder joint displayed in Figure 14 is from the high stress edge of the U1 device on SN51. It failed at 459K cycles and was cross sectioned after being exposed to 696K cycles of step stress testing. At -55C the ENIG assemblies survived on average twice as many cycles as the OSP assemblies.

Figure 14: SN51 ENIG -55C 696K cycles

At resonance frequencies in the 50 Hz. Range 300K cycles requires approximately 1.7 hours of testing, even accounting for chamber ramp time there is no significant thermal aging of the microstructure in the 125°C samples. There are no significant differences between the samples tested at 125°C and -55°C for either of the surface finish lots. There are visible and consistent differences between the OSP and ENIG lots at both -55C and 125C. There are visible differences in the boundary IMC layers, The spheres soldered to OSP have precipitated an additional layer of $(\text{Cu,Ni})_6\text{Sn}_5$ under the primary Ni IMC that exists from the ball attach process at the package assembly house. There are also noticeably more primary Cu_6Sn_5 particles visible in the bulk solder. As would be expected to precipitate from the higher Cu content of the molten solder during reflow. The dendritic structure of the OSP solder balls is considerably finer. βSn . Features are on the order of 7 -7.5 μm in the smallest direction. Several solder spheres attached to the ENIG surface finish exhibit coarser dendrite structures on the order of 15-16 μm in the smallest direction. This coarse structure also has much larger and more irregular inter-dendritic spaces. This coarser structure does not exist in every sphere, but in each cross sectional view there is a significant portion of the spheres that have this characteristic. Spheres with the fine structure can exist adjacent to a fully cracked coarse structure and exhibit very little or no damage.
