Achieving Solder Reliability for LGA Ceramic Image Sensors Through Refinement of SMT Soldering Processes

Lynda Pelley, Teledyne DALSA Inc., Waterloo, ON, Canada
Hugo Gallegos, SMTC Inc., Chihuahua, Mexico

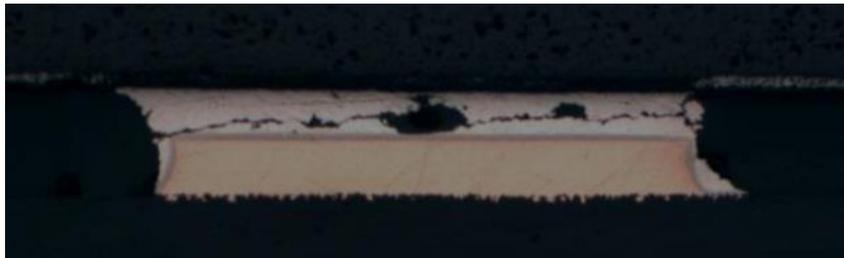
The trend for cross section results was complete cracks in the solder joints nearest to the outer corners (Figure 3) and some partial cracking on the solder joints further in from the edges and corners (Figure 4). The sharp structure within the cracks indicates grain coarsening in the solder joints.

Figure 3 – Complete Crack Example, Outer Corner Locations

Other than the cracking, the cross sections confirmed that the wetting of solder to PCB was excellent and the Inter-Metallic Compound (IMC) was contiguous and normal, with no nickel dissolution.

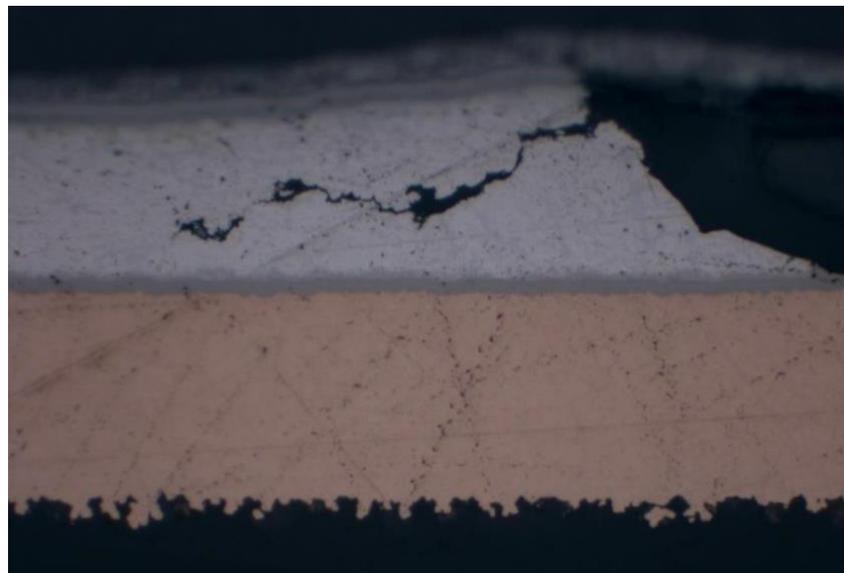
Figure 4 – Partial Crack

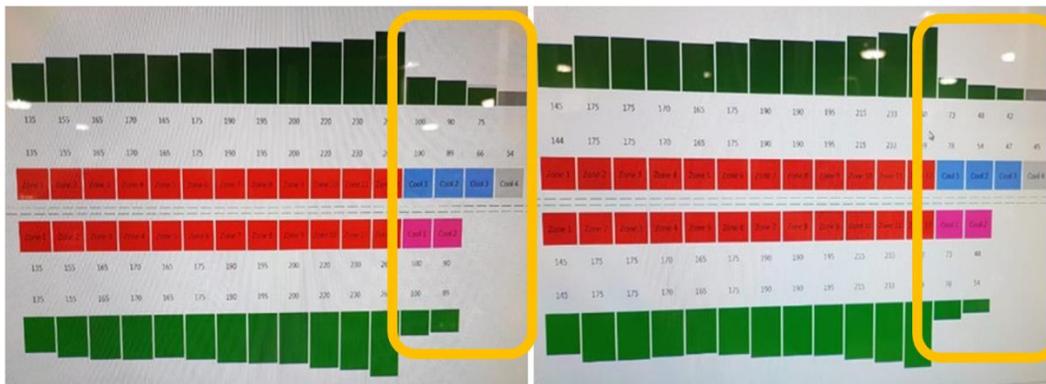
Two cool down slopes were chosen to represent a low and high parameter, Figure 8. To reduce the grain coarsening of the Sn, the cool down must be accelerated, at least during the first cooling zone, to reach approximately 170°C. The process window in this zone goes from -1°C/second through to -4°C/second for cooling. The risk associated with increasing the cool down slope is voids in the solder joints.

Low cool down slope parameter: -1.8°C/second
 High cool down slope parameter: -3.4°C/second

Figure 8 – Oven Cool Down Zones, Left -1.8°C/second, Right -3.4°C/second
