# Approaches to Overcome Nodules and Scratches on Wire Bondable Plating on PCBs

Young K. Song and Vanja Bukva, Teledyne DALSA Inc., Waterloo, ON, Canada  
Ryan Wong, FTG Circuits, Toronto, ON, Canada

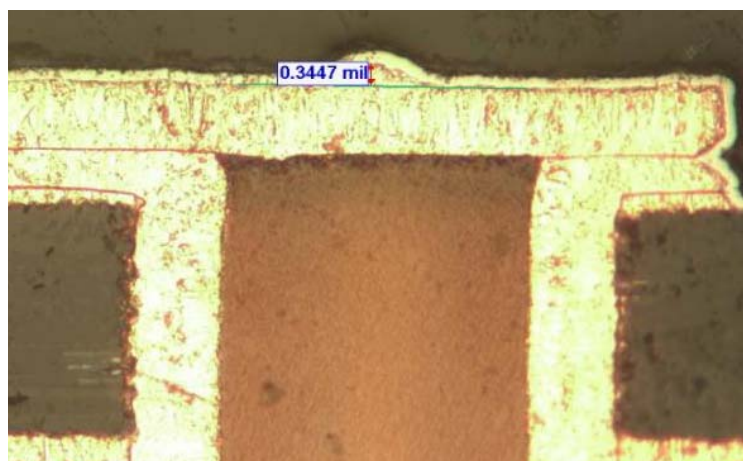
**Figure 3 – Cross-sectioned View of a Nodule as an Example**

Nodules that were observed optically under 40X magnification were cross sectioned in an attempt to determine the process at which the nodule began to form. Given the small size of the nodules and knowing that the nodule starts with an even smaller surface imperfection that grows through electroplating, cross sectioning down to the absolute center of the nodule was difficult to achieve and objective evidence of the nodule's origin could not be found all the time. Figure 3 shows an example of a nodule cross-sectioned. In this case, it seemed to be clear that the nodule was formed prior to the Ni/Pd/Au plating process, and, therefore, nodule formation would have likely happened during electroless or electrolytic copper plating.

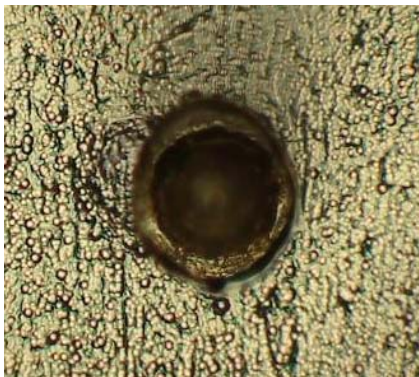
**Figure 16 Wire Bond Made on Nodule**

There was not a way to create nodules artificially, and therefore only PCBs rejected by the manufacturer due to nodules were used. Figure 16 and Figure 17 show examples of wire bonds made on nodules and scratches, respectively. Most nodules were almost completely covered with wire bonds, so that, it was not clear if nodules were under the wire bonds.
