# INNOVATIVE BGA DEFECT DETECTION METHOD FOR TRANSIENT DISCONTINUITY

Steven Perng, Weidong Xie, Tae-Kyu Lee, and Cherif Guirguis  
Cisco Systems, Inc.  
San Jose, CA, USA  
sperng@cisco.com

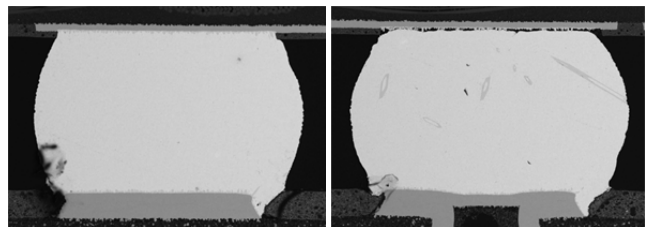
**Figure 1.** Comparison of with (left) and without (right) Solder detachment from the pad on package side

During the process development of a 0.8mm pitch memory device on a 0.147" thickness double sided board with OSP surface finishing, it was found solder detached from the pad on package side, as shown in Figure 1.

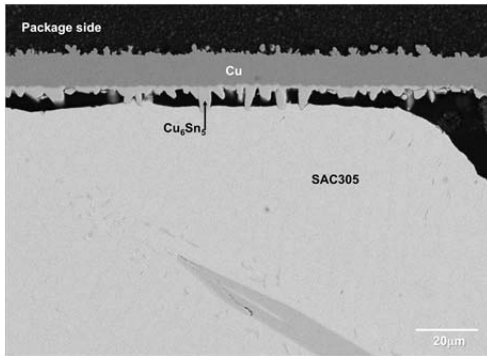
**Figure 2.** SEM image of solder detachment from the top right corner of Figure 1, the image on the right

The detachment can be either a completely detached or partially detached. As the SEM image shown in Figure 2, the Inter-Metallic Compound (IMC) was formed properly on the package side. While on the ball side, the solder forms a smooth contour. Since there is no zigzag counter

fingerprint of the IMC layer on the ball contour, it suggests the detachment was occurred during the liquid phase, either during melting or during solidification.

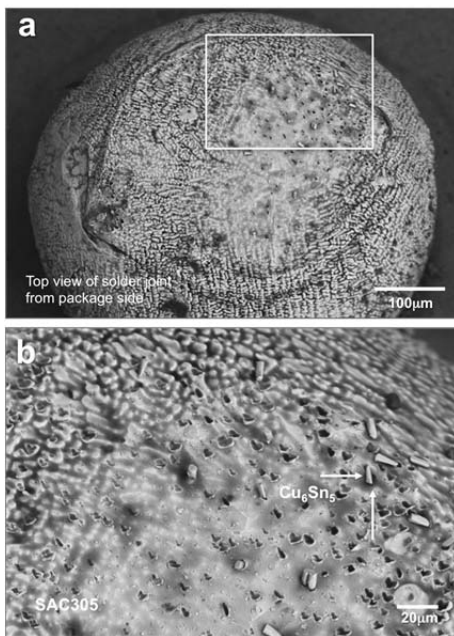
**Figure 3.** SEM images of (a) the top surface of the solder joint and (b) higher magnification on the surface with broken IMC tips

Further analysis on the top surface of separated joints from samples went through second reflow showed numerals pinching marks. Broken IMC tips were observed in some of those marks (Figure 3). These pinching marks suggest the solder joints detached from package side and reconnected in liquid phase.

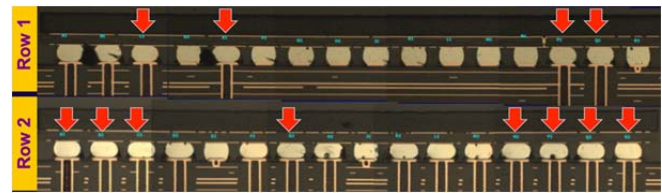
**Figure 4.** Solder detachment only at VIPPO pad design

It was also found the solder detachment occurred on VIPPO pad design only. As shown in Figure 4, the red arrows indicate solder joints with solder detachment. For those solder joints without VIPPO pad design, there was no solder detachment observed on either cross-section or dye-and-pry.

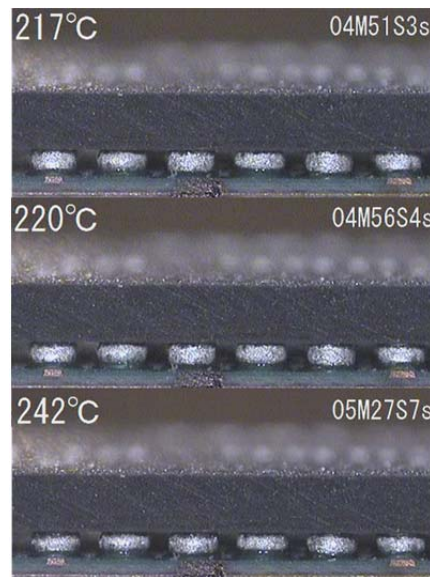
**Figure 6.** Still images from the reflow simulator video

From the recorded video clip, the completion of phase change of solder joint can be observed by a sudden change of surface texture. It is noted that the standoff of solder joints changed significantly before and after phase change. Shown in Figure 6 are some still images taken from the recorded video. The VIPPO joint was marked on the PCB

side with dark marker. It was also observed from the video that the liquidus temperature and timing between VIPPO and non-VIPPO joints were slightly different.

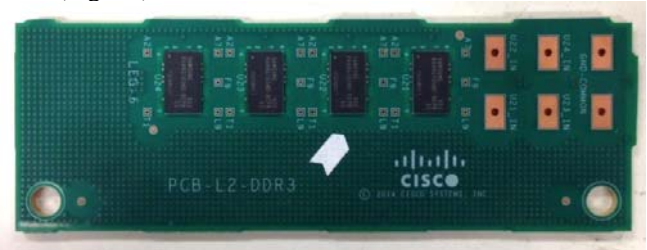
Figure 7. Daisy chain test vehicle

The effectiveness of the method has been verified with a board level daisy chain test vehicle. The test vehicle consists of four 0.8mm pitch Ball Grid Array (BGA) components, which have been assembled onto a 125mil thick 16-layer PCB (Figure ).

It is understood that the thermally induced stress on solder joints are primarily driven by the CTE mismatch, resulted from mixing of PCB pad designs. To ensure the occurrence of solder joint detachment, two test vehicles are designed. One test vehicle has a mixture of Via-In-Pad Plated Over (VIPPO) pads and regular dog bone pads; while the other test vehicle has all VIPPO pads. The all VIPPO design is expected to have no solder joint detachment on package side.

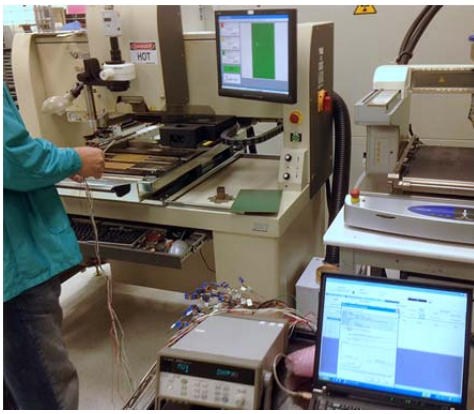
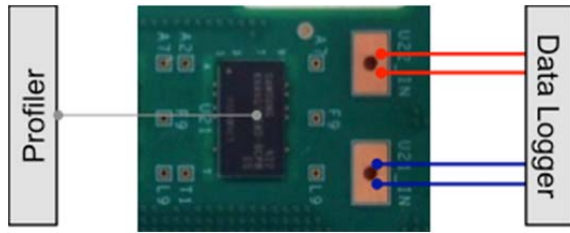
Figure 7. Data logger and profiler setup

Through out the rework process, as shown in Figure 7, a data logger is used to monitor the resistance of the daisy chain of each component. The daisy chain is routed with 4-wire configuration to eliminate the resistance noise induced by wires and connections.

In parallel, a profiler with thermocouples is set up to record the temperatures. It should be noted that the thermocouple was inserted underneath the component, without drilling into the solder joint. It is to minimize the impact due to destructive drilling. Measurement may deviate from true solder joint temperature slightly.

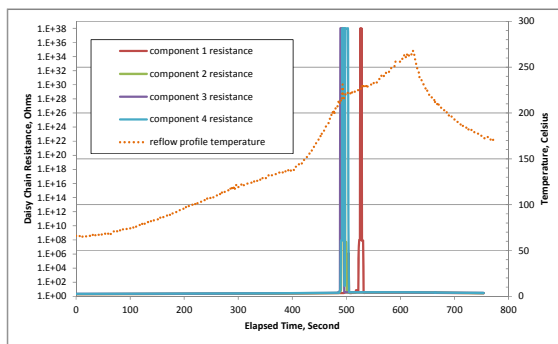
Figure 8. Resistance over time overlaid with reflow profile of the mixed pad design

As shown in Figure 8, the resistance over time of each component is overlaid with the reflow profile, which is temperature over time (with respect to the second vertical axis on the right).

For the mixed pad design, it is clear that all four daisy chains opened, during the solder joints were melting in the ramp-up stage. It should be noted that the vertical axis on the left hand side was capped by the cut off resistance values of the data acquisition system.

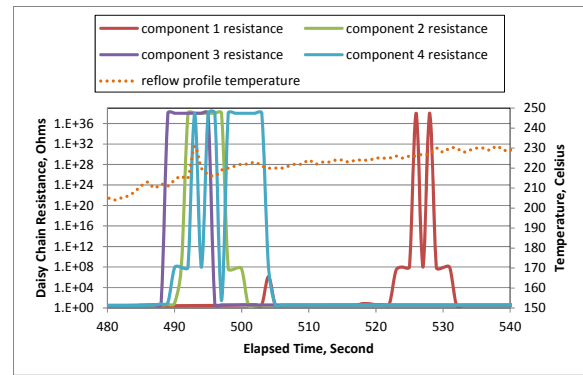
Figure 9. Zoom in view of the daisy chain resistance value, overlaid with reflow profile of the mixed design

The daisy chain of Component 3 opened first at 488 seconds with temperature at 212°C, followed by Component 2 and Component 4 within 2 seconds.

8 seconds later, the daisy chain of Component 3 reconnected at 496 seconds with temperature at 215°C. Similar trend was observed on Component 2 and Component 4.

With unknown reasons, Component 1 opened 34 seconds later than others, at 224°C. And, the daisy chain reconnected 10 seconds later at 230°C.

All four components exhibit discontinuity or solder open during the heating up stage around the melting temperature. And, after 8~10 seconds, the chain reconnected with 3~5°C temperature increasing.

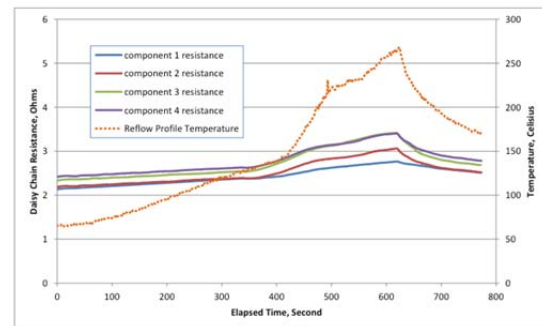
Figure 11. No discontinuity on resistance value for All VIPPO pad design

As opposed to the mixed pad design, the ALL VIPPO pad design kept the continuity thought out the rework cycle, as shown in Figure . No sign of discontinuity is observed. The increasing of resistance from solid phase to liquid phase can be explained well by N.F. Morr <sup>[1]</sup>.

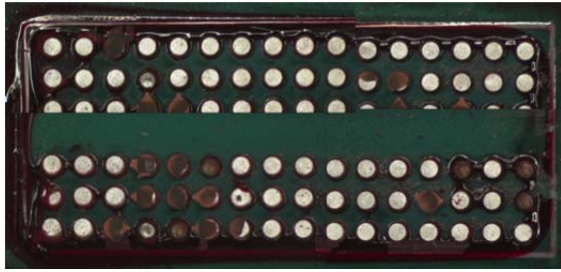
Figure 10. No dye penetration on All VIPPO pad design

For the All VIPPO pad design, as expected, there was no dye penetration observed (Figure 10).

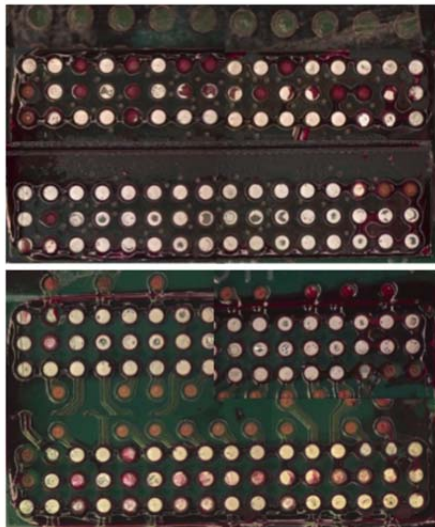
Figure 11. Dye penetration on mixed design, package side (top) and board side (bottom)

As shown in Figure 11, multiple full dye penetrations were observed on the solder joints with mixed pad design, indicating solder joints detachment occurred during reflow.

On the other hand, based on the Resistance-Time chart, the continuity of all four components reconnected few seconds after detachment. However, from the dye-and-pry images, some solder joints still exhibit dye penetration on the break away interface. It suggests, even the continuity been reconnected, the solder joint did not recover entirely. It either formed a partially connected joint or has contact for electric continuity without coalescing into a solder joint.

These solder joints are not reliable. It can be a latent defect. Which means, when under certain mechanical or thermal stress, it may fail in the field.
