Solder Joint Embrittlement Mechanisms, Solutions and Standards

Mike Wolverton

Raytheon

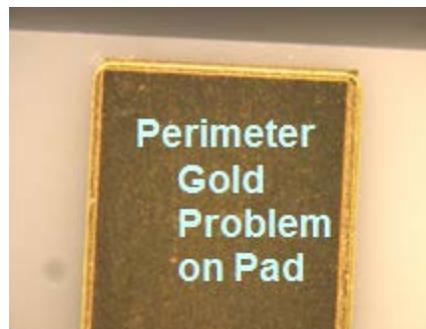
A board pad was examined and found to have a perimeter region, which lacked the plated nickel diffusion boundary layer, as shown in Figure 4. To be clear, the nickel design was meant to cover a thick gold layer completely, and have its own overcoat of thin, solderable gold.

Figure 4. Top View of Circuit Board Pad Shows Nickel Did Not Cover Thick Gold's Perimeter.

The substrate pad design had gold over nickel, but the nickel area did not quite cover all of a layer of gold under the nickel. A perimeter region of thick gold had access into the solder joint.

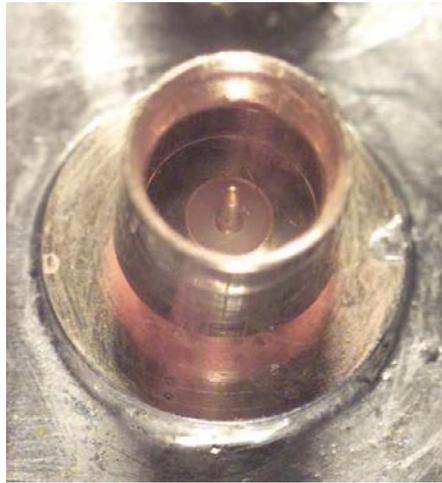
A surface mount soldered connector pin did not always survive mating and demating. The connector is shown in Figure 6 and the pin joint failure is shown in Figure 7.

Figure 6. Surface Mount Connector Center Pin Sometimes Failed Mate/Demate.

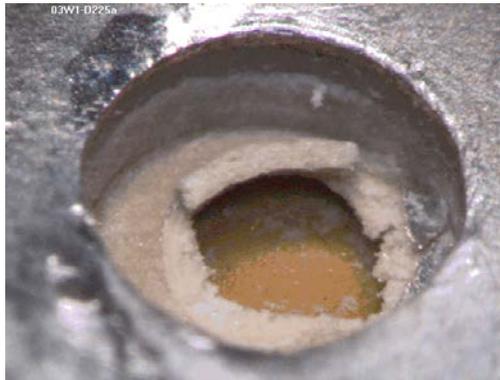
Figure 12. During the Pin Pull Test, the Pin-to-Trace Solder Joint was So Strong that the Trace Pad and the Board Material were Torn Out of the Board.

The excessive gold in the soft solder joint was eliminated by running an experimental design including pre-assembly gold removal steps, per a designed experiment with a validation run.
