TOMBSTONE CAPACITORS REVISITED, NOW DO WE NEED A PSL (PLATING SENSITIVITY LEVEL) SPECIFICATION FOR CHIP COMPONENTS

John Maxwell and Chris England

Johanson Dielectrics, Inc.

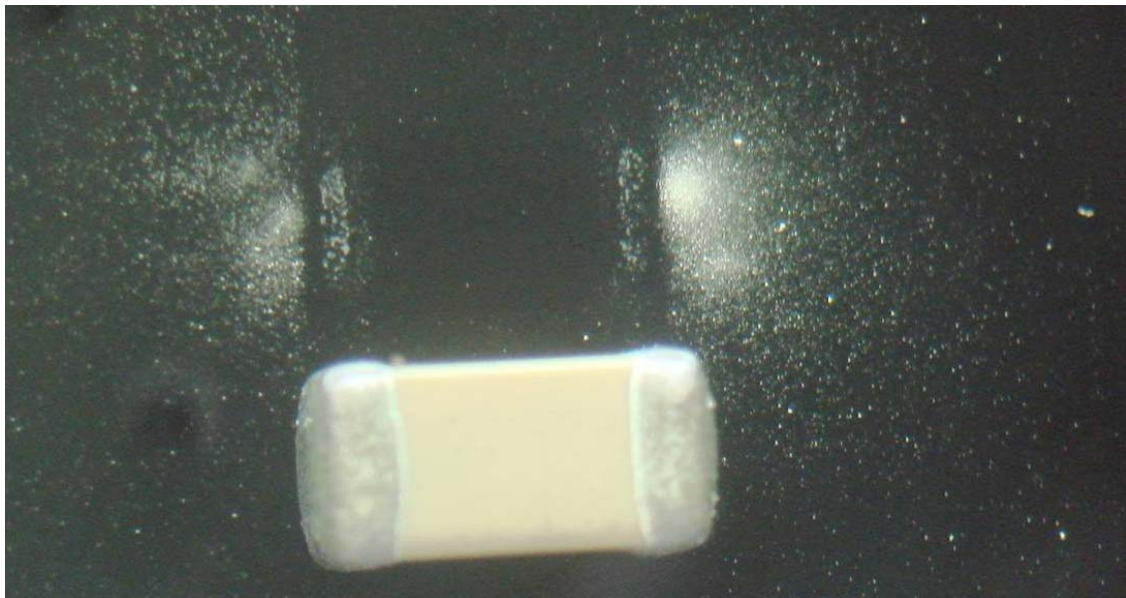
Photo 3. Another Reject from a low cost vendor part showing ejected plating salts and tin particles trapped beneath the chip

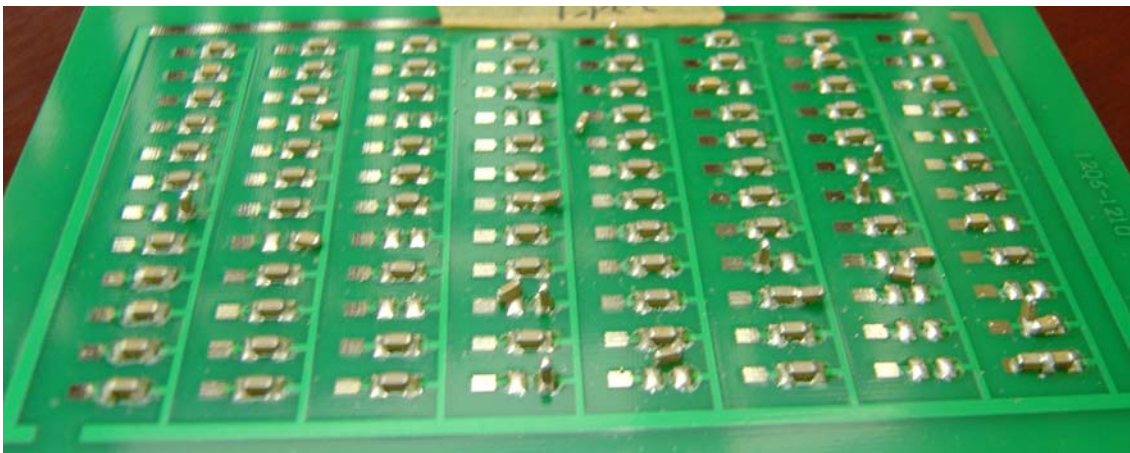
Photo 8. A test board with 96 1206 capacitors with splatter from a low cost Asia vendor

Photo 8 shows a sample board reflow soldered with 96 1206 capacitors from a low cost Asia vendor that exhibited splatter. Out of the 96 pieces, 8 were tombstone defects, 11 jumped off the board and 9 parts flopped around on the board bridging to other parts or hopping off pads.
