## EFFECTIVENESS OF CONFORMAL COATINGS IN PREVENTING RESISTOR SILVER SULFIDE CORROSION

Marie Cole, Jacob Porter, Jason Wertz, Marc Coq  
IBM Corporation  
Poughkeepsie, NY, USA  
colems@us.ibm.com

### ABSTRACT

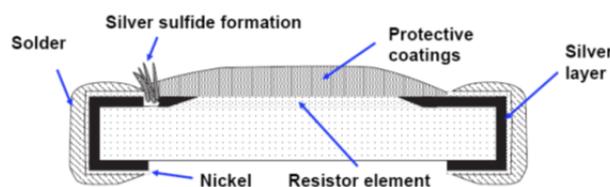
Figure 1. Silver sulfide resistor corrosion schematic [2].

Concerns with airborne sulfur contamination in data centers have been documented for the past several years in regards to the corrosion of both printed circuit boards [1] and resistors [2-4]. The mechanisms for the corrosion failures are significantly different. Printed circuit boards may suffer from creep corrosion of the copper metallization of the soldering pads and vias. Copper sulfide corrosion can form and creep across the board surface, resulting in the electrical shorting of neighboring features. Discrete resistors and resistor networks can be susceptible to silver sulfide corrosion. These thick film resistors typically use silver for the resistor element. If the resistor element is not adequately protected, sulfur can attack and form silver sulfide (Figure 1). The silver sulfide continues to react with the silver resistor element, ultimately depleting the silver to the extent that it becomes electrically open and/or the formation of the corrosion product can crack the resistor package leading to an increased exposure of the underlying silver and thus, resulting in an electrically open circuit.

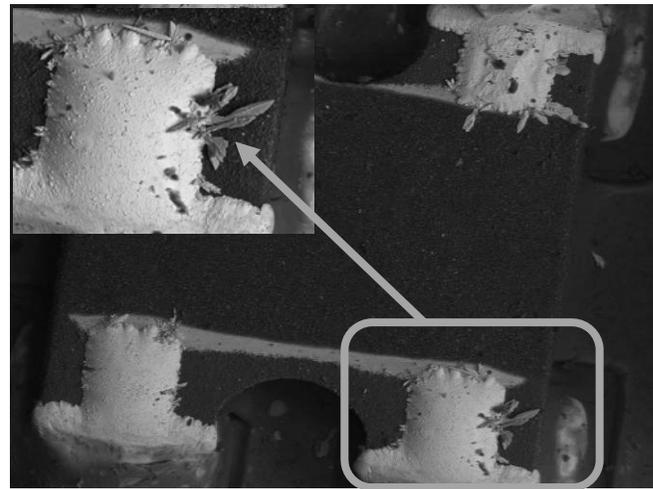
**Figure 3.** Silver sulfide resistor network corrosion at low and high magnification (inset) [2].

Under normal environmental contamination levels, the protective layers are sufficient to provide reliable service of the resistor. In environments high in sulfur-bearing gaseous contamination, the ingress of corrosive gases can corrode the silver terminal metallization. The mechanical stresses arising from the greater volume occupied by the corrosion products can crack the resistor package. The degraded hermeticity of the package increases the rate of ingress of the corrosive gases, hastening the silver corrosion. When all the silver in a local length of the silver termination is converted to silver sulfide, the resistor fails due to the resistor becoming electrically open. The silver sulfide corrosion product is often seen as needles sticking out of the edges of the coating protecting the resistor. Photomicrographs of a cross section view of a corroded discrete resistor and a top view of a corroded resistor network are shown in Figures 2 and 3, respectively.

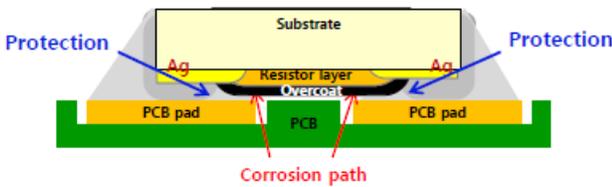
**Figure 4.** Reverse resistor format blocking the sulfur corrosion path [3].

additional plating layer between the overcoat and the final terminal plating and/or improved overcoat application may provide some protection against sulfur ingress and somewhat improve corrosion performance [4]. Another approach [3, 4], called a “reverse resistor,” uses the same basic construction as a standard resistor, but inverts the joining format such that the SMT soldering process blocks the sulfur ingress path to significantly delay silver sulfide corrosion (Figure 4). Here, there are modifications to the thickness of the silver layer and electrode to better facilitate inverted soldering.

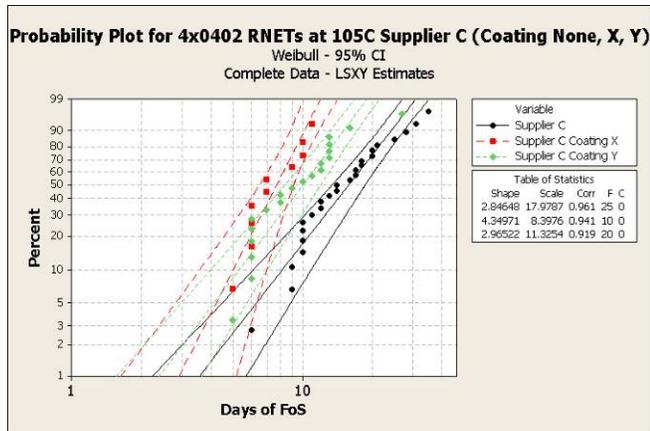
**Figure 5.** FoS time to failure of uncoated resistor networks compared to those with silicone containing coatings [2].

days when coated with epoxy, depending on the supplier of the resistor networks [2]. Results in FoS testing and in actual field applications can vary significantly based on the supplier of the resistor or resistor network. Epoxy coatings can be difficult to integrate into the manufacturing process if they are two-part materials, have limited shelf life and/or must be applied manually. For this reason, it is desirable to evaluate other conformal coating materials that are more manufacturable. Conformal coatings containing silicone having the advantage of easy application and rework, however, are notorious for decreasing the time to failure in a sulfur environment, rather than extending it [8]. The proposed mechanism is that the silicone material absorbs the sulfur and draws it to the silver surface, rather than preventing ingress. An example of the possible negative effect of silicone coatings is shown in Figure 5, where Coatings X and Y were two variations of silicone based coatings.

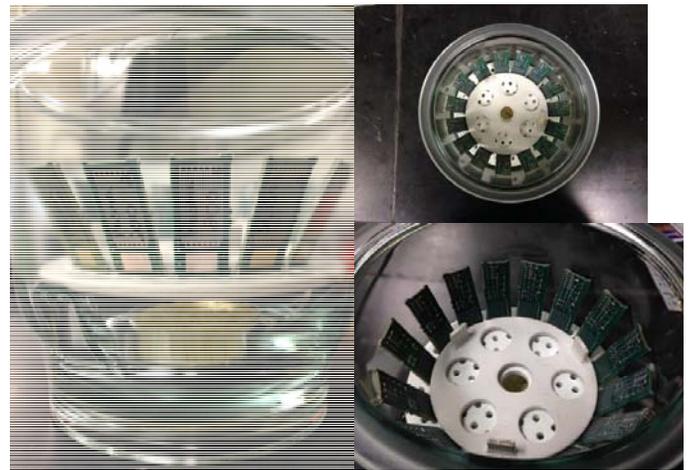
**Figure 6.** Flowers of sulfur desiccator filled with test samples.

It was agreed that the FoS test procedure would be the most logical accelerated test to compare the performance of the coatings. The FoS test used an airtight jar containing 50g of sulfur powder. For consistency with previous testing performed by IBM, 105°C was selected as the testing temperature and 20 days selected as the test duration. A 10% increase in resistance was considered a fail. The test set-up is shown in Figure 6, where the resistor test cards were placed around the desiccator to ensure similar testing conditions for each card.

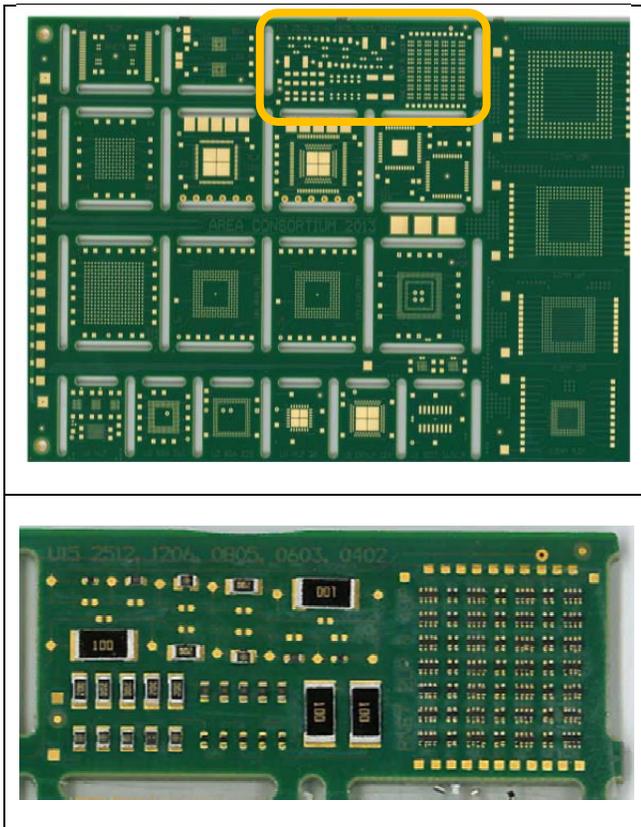
**Figure 7.** Test Board 1203 (Top) and the resistor coupon (Bottom).

The resistor coupon from the Universal AREA Consortium Test Board 2013 was selected for the Printed Circuit Board (PCB) test vehicle for this experiment because of the number and variety of resistor test sites (Table 1 and Figure 7). The coupon included two electrically testable locations per resistor type, along with additional resistors that could be visually inspected for corrosion. The resistors tested were standard thick film format, found to be moderately prone to sulfur induced corrosion in previous experiments.

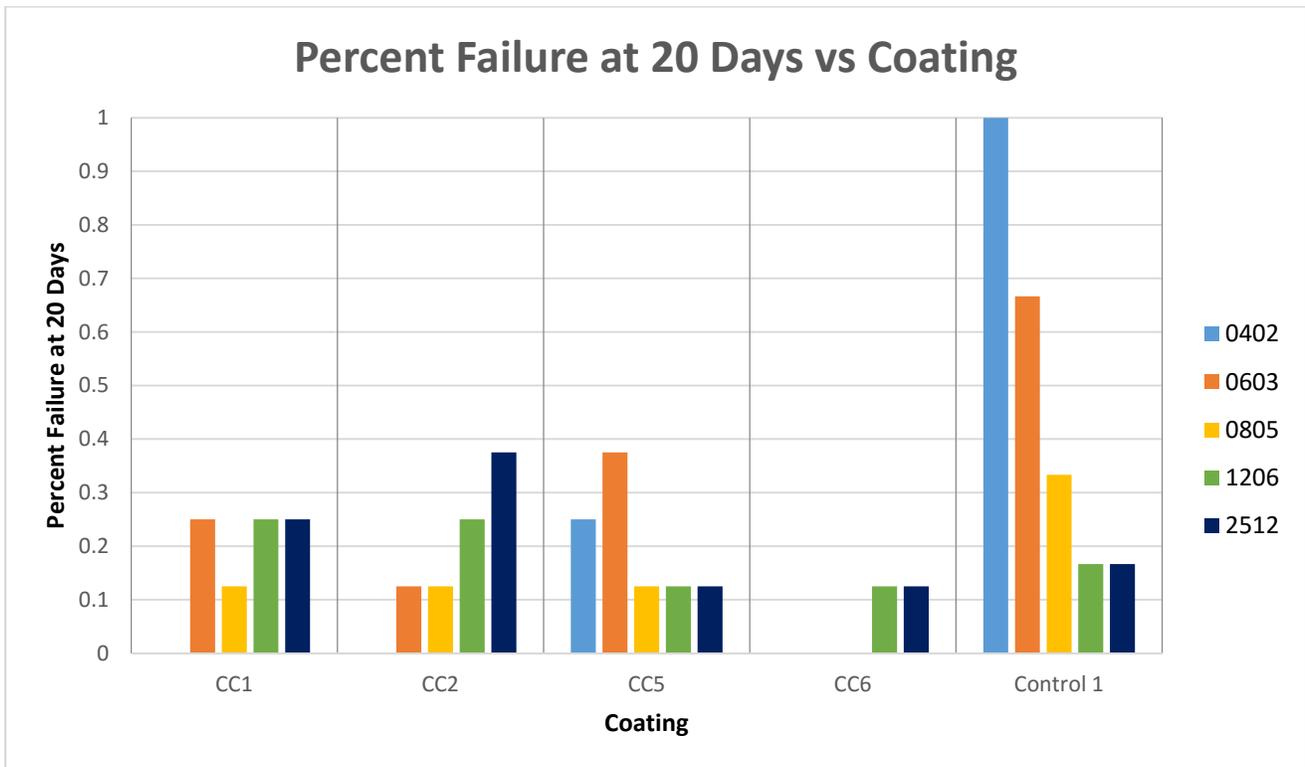
**Figure 8.** Flowers of Sulfur test results at 20 days for Phase 1 conformal coating materials. Note that samples from test cells CC3, CC4 and Control 2 did not fail during the 20 day test.

The results of the 20 days of FoS testing were mixed. The data can be examined for trends, but are not conclusive because the controls did not fail as quickly as expected in many cases. The following trends were observed:

- Uncoated resistors on LF HASL (Control 1) had failures within 20 days, although 100% did not fail in all body sizes
- Uncoated resistors on ENIG (Control 2) did not fail within 20 days
- PU1 coated resistors had similar percentage failure in both thickness cells and typically were equal to or better than uncoated resistors on LF HASL
- A1 coated resistors with cleaning had somewhat worse performance than the PU1 coated resistors
- A1 coated resistors without cleaning had somewhat better performance than the PU1 coated resistors and the A1 coated resistors with cleaning
- PU2 coated resistors in both coating thicknesses did not fail within 20 days

The complete results are shown in Figure 8. Photographs of the coated coupons after 20 days of testing are shown in Figure 9.

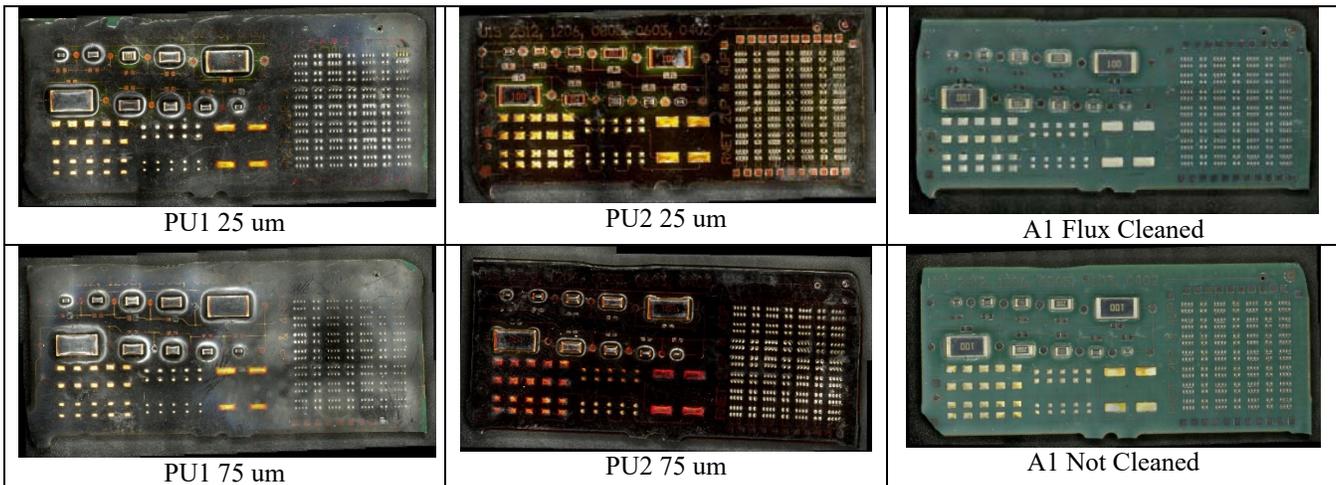
**Figure 9.** Photographs of the coated coupons after 20 days of FoS testing.

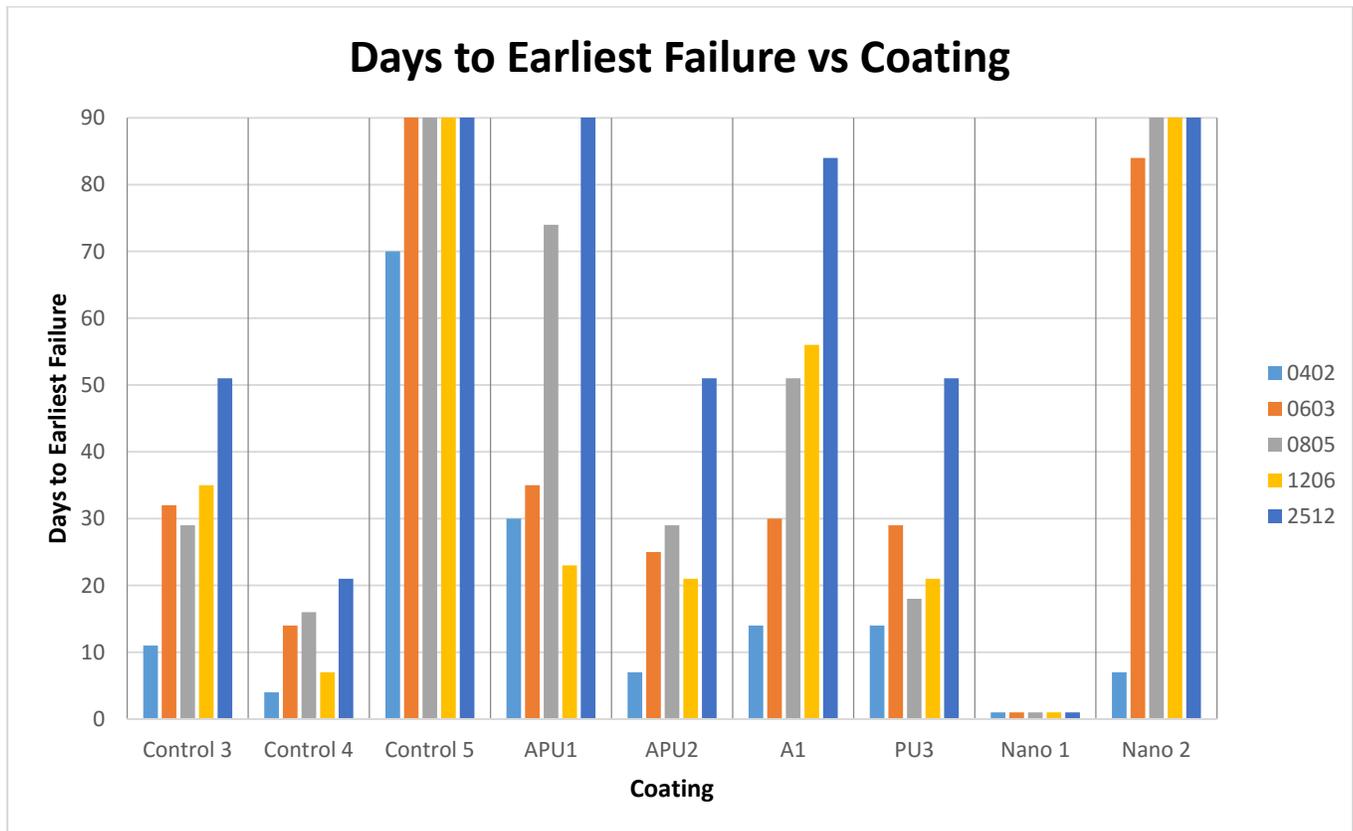
Note that resistors that did not fail are shown as 91 days  
**Figure 10.** Days to earliest failure versus coating.

The results of the 90 day FoS test again were mixed. Figure 10 shows the days to earliest failure and Figure 11 shows the average days to failure.

The controls performed as expected. The silicone-based coating accelerated the first failure and average time to failure across all of the body sizes. The epoxy coating was nearly invincible with one fail occurring at 70 days on an 0402 resistor.

There were some body size trends similar to those observed in previous testing. The 0402 was typically the worst performer. There was a trend of increasing time to failure with increasing body size. This observation was true especially for first failure. There were several cases, however, that did not follow the trend.

The performance of the various coatings being studied was inconsistent. The acrylated polyurethanes provided some improvement, with APU1 outperforming APU2:

- APU1 effective on high risk 0402
- APU1 somewhat better than APU2, especially on average
- APU2 had 0402 early failure

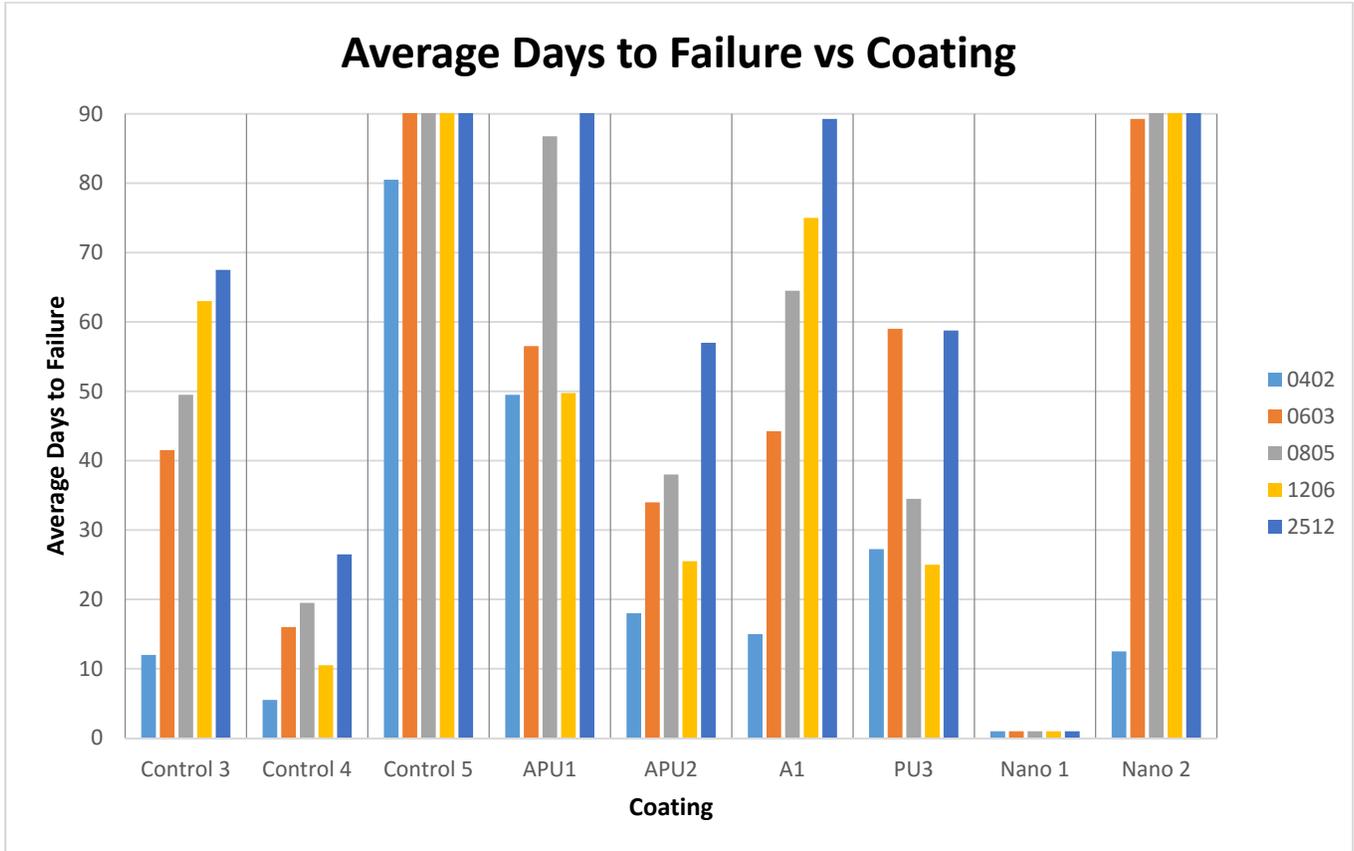
Note that resistors that did not fail are shown as 91 days

**Figure 11.** Average days to failure versus coating.

The two nanocoatings performed quite differently:

- Nano1 resistors failed almost immediately after the start of testing
- Nano2 had an early failure of an 0402 resistor, but otherwise performed well

A1 and PU3 had mixed results:

- Acrylic slightly delayed corrosion vs control, but only for larger body sizes
- Polyurethane provided no significant benefit

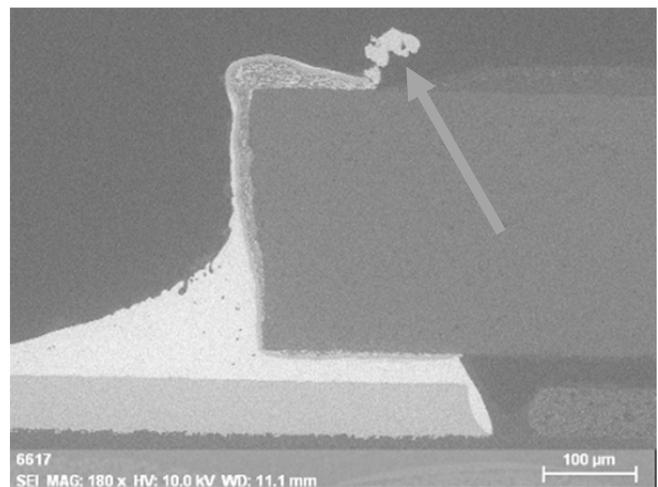
**Figure 12.** 0402 body size resistor with large silver sulfide growth.

A representative 0402 body size resistor cross-section with large silver sulfide growth is shown in Figure 12. A representative 2512 body size resistor cross section with a minor amount of silver sulfide growth is shown in Figure 13.

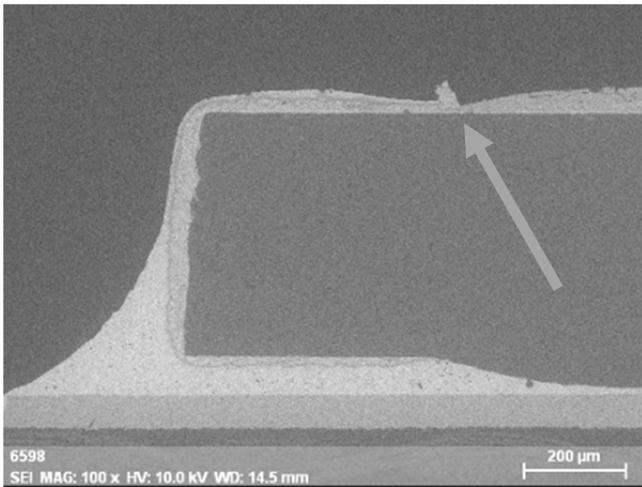
**Figure 13.** 2512 body size resistor with minor amount of silver sulfide growth.

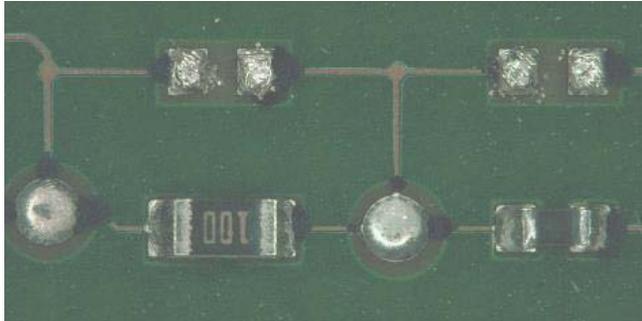
**Figure 14.** Black corrosion observed on cards with Nano1.

The resistors coated with Nano1 that were examined showed very minor amounts of silver sulfide. The electrical failure was determined to be due to an open at the contact pads. Further electrical probing determined that the resistors themselves were still good. Black corrosion product was found on the board with the Nano1 coating (Figure 14) and determined to be copper sulfide (Figure 15). This finding has resulted in the need for further investigation in order to determine the contributors leading to copper creep corrosion for only this coating.

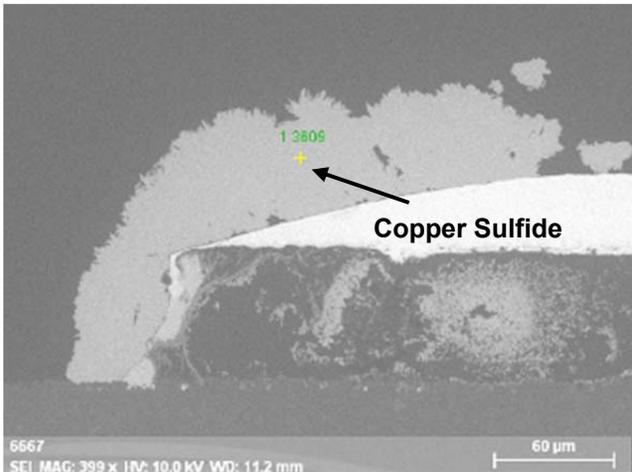
**Figure 15.** Cross section of black corrosion product.
