Failure Mechanisms in Embedded Planar Capacitors during High Temperature Operating Life (HTOL) Testing

Mohammed A. Alam¹, Michael H. Azarian², Michael Osterman and Michael Pecht

Center for Advanced Life Cycle Engineering (CALCE)

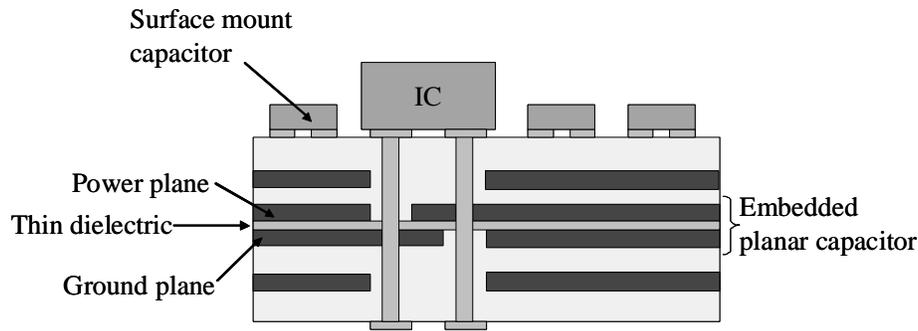
Fig. 1. Embedded planar capacitor

Embedded planar capacitors (Fig. 1) are thin laminates embedded inside a multilayered printed wiring board (PWB) which serve both as a power/ground plane and as a parallel plate capacitor. These laminates extend throughout the PWB, reducing the need for discrete surface mount capacitors adjacent to a switching device (integrated circuit). A reduction in the number of surface mount capacitors [1], leading to miniaturization of the PWB, and improved electrical properties (such as reduced electromagnetic interference and simultaneous switching noise) [2] are the main advantages of using embedded planar capacitors. The reason for a decrease in the number of surface mount capacitors is a low value of parasitic inductance [3] of embedded planar capacitors due to elimination of leads and traces. With a decrease in the number of surface mount capacitors the number of solder joints will decrease, which is expected to increase the reliability of the PWB provided that the reliability of the embedded planar capacitor is comparable to or better than that of the traditional PWB.

The laminate consists of a thin dielectric material sandwiched between copper sheets. The dielectric material is generally a composite of polymer and ceramic. Pure polymers such as epoxy or polyimide are used in some applications but are not preferred due to a low value of the dielectric constant. Pure ceramic such as BaTiO₃ (as used in multilayer ceramic capacitors) is not used since the processing temperature of ceramics is high (~1000°C) as compared to the regular PWB manufacturing processes (~250°C). In order to overcome these difficulties, a composite of polymer and ceramic is used as the dielectric material. This composite combines the low temperature processability of polymers along with the high dielectric constant of ceramics [4]. With an increase in the ceramic loading the dielectric constant of the composite increases and various models have been proposed to model this behavior [5]-[9].

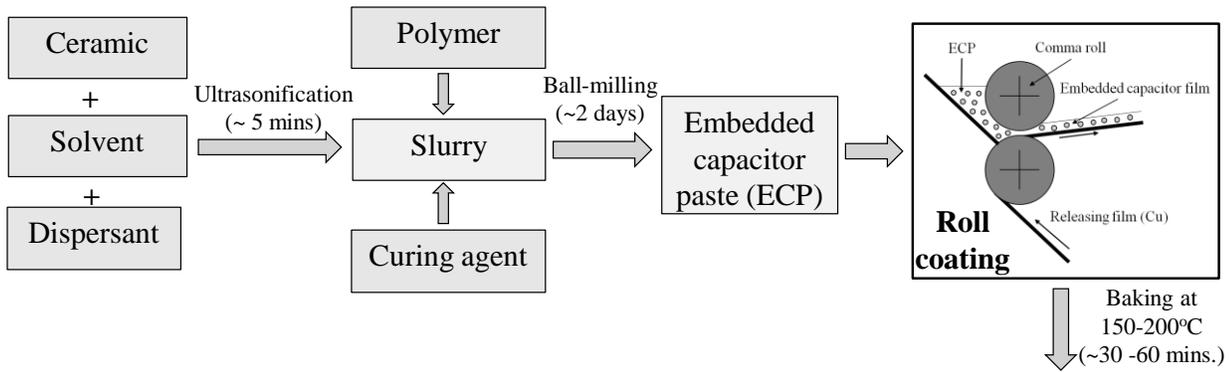
Fig. 2. Manufacturing of embedded capacitors

Since the dielectric constant of BaTiO₃ is size dependent, nanoparticles of BaTiO₃ are used which have a high dielectric constant. In suspension the ceramic nanoparticles are affected by mutual attraction due to van der Waals forces and form agglomerates [17]. One of the challenges in manufacturing these capacitors is to disperse the nanoparticles uniformly in the polymer matrix. Proper dispersion of these nanoparticles in the polymer matrix is essential to prevent any voids or agglomerates in the dielectric. A dispersant in a solvent medium is used that prevents the nanoparticles from agglomerating. [19]. After mixing the various components in the required quantities and following the process steps as shown in Fig. 2, the embedded capacitor paste (ECP) is formed. This ECP is then coated onto a substrate and heated to evaporate the solvent and cure the polymer [20].

The dielectric constant of BaTiO₃ is very high as compared to the dielectric constant of epoxy. When a composite dielectric is made by mixing a material of high dielectric constant (such as BaTiO₃) with a material of low dielectric constant (such as epoxy), the electric field is not uniform throughout the material [21]. The electric field is higher in the material of lower dielectric constant as compared to the material of higher dielectric constant. The electric field can be further disturbed by non-uniform dispersion of ceramic nanoparticles and defects in the dielectric such as voids or agglomeration of ceramic nanoparticles. Defects in the dielectric such as voids have the highest magnitude of electric field.

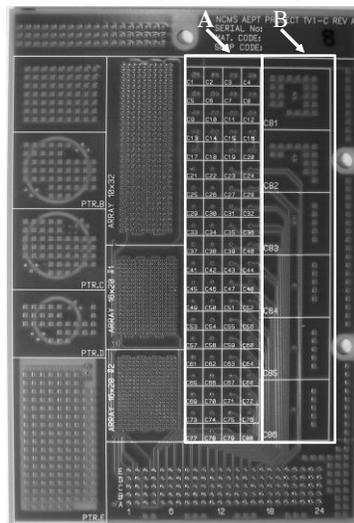
Fig. 3. Test Vehicle

The test vehicle was a 4-layer PWB (shown in Fig. 3) in which layer 1 and 4 were the signal layers, and the planar capacitor laminate formed layer 2 (power plane) and layer 3 (ground plane). The power plane was etched at various locations to form discrete capacitors and the ground plane was common for all capacitors, as shown in Fig. 4. Two types of square capacitors, of area 0.026 in^2 (group A) and 0.19 in^2 (group B), are investigated in this work. There were 80 small capacitors (group A) and 6 large capacitors (group B) in the test vehicle. There were two different test vehicles, one with a laminate of dielectric thickness $8 \mu\text{m}$ and the other with a laminate of dielectric thickness $14 \mu\text{m}$. The dielectric was a composite of BaTiO_3 of mean diameter equal to $0.25 \mu\text{m}$ loaded 45% by volume in bisphenol-epoxy. The dielectric constant and the dissipation factor of this composite was 16 and 0.05 respectively at 1 KHz.

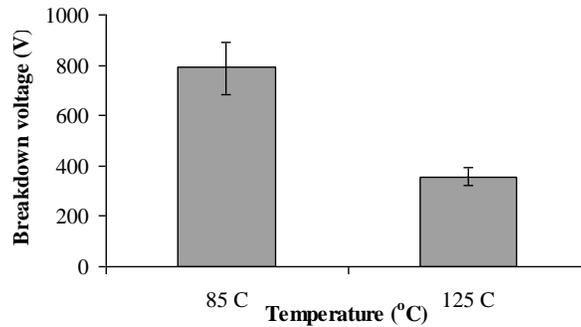
Fig. 5. Breakdown voltage (V_{BD}) of small capacitors (8 μm dielectric thickness)

The temperature at all stress levels was below 130°C which was the maximum operating temperature of the test board. The voltage was selected such that it was significantly lower than the breakdown voltage (dielectric withstanding voltage) of the dielectric at the test temperature. The breakdown voltage (V_{BD}) was measured for 10 small capacitors (8 μ m dielectric thickness) at 85°C and 125°C and is shown in Fig. 5. Breakdown is expected to occur in the polymer matrix due to a large difference in the dielectric constant of epoxy and BaTiO₃, leading to a high electric field in the polymer matrix. It was observed that the value of V_{BD} decreased with an increase in the temperature. The reduction in the V_{BD} with temperature can be explained by an increase in the free volume of the polymer matrix [31]. According to this theory, as the temperature is increased the free volume of the polymer increases which increases the mean free path of the charge carrier. The charge

carriers are accelerated over a larger distance under the same electric field leading to a higher energy and hence the breakdown electric field reduces.

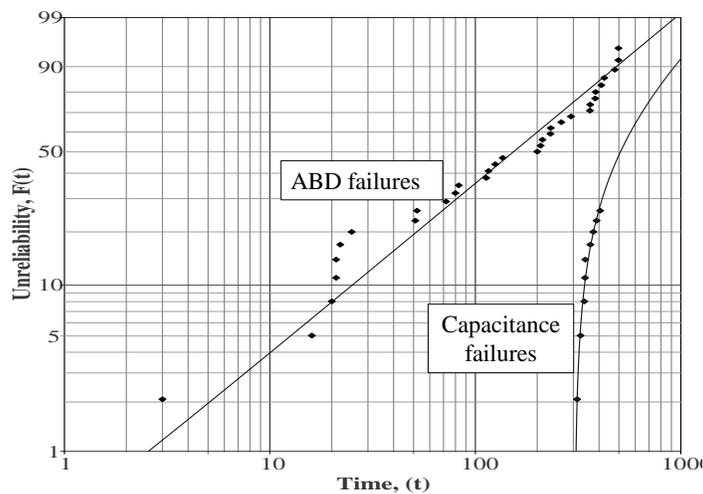
Fig. 6. Unreliability versus time-to-failure for various failure modes

The failure modes observed at all the stress levels were a gradual decrease in capacitance and a sudden decrease in the value of insulation resistance implying avalanche breakdown (ABD). The capacitance was observed to degrade logarithmically and was discussed elsewhere [32]. Only failures as a result of ABD are discussed here since these failures occurred much before the capacitance failures. A plot of unreliability versus time-to-failure of ABD failures and capacitance failures is shown in Fig. 6. This analysis was performed using a Weibull 3 parameter distribution and the parameters of the distribution were found for ABD failures ($\beta=1.0$, $\eta=218$, $\gamma=0.1$) and capacitance failures ($\beta=1.1$, $\eta=287$, $\gamma=305$), where β is the shape parameter, η is the characteristic life, and γ is the location parameter.

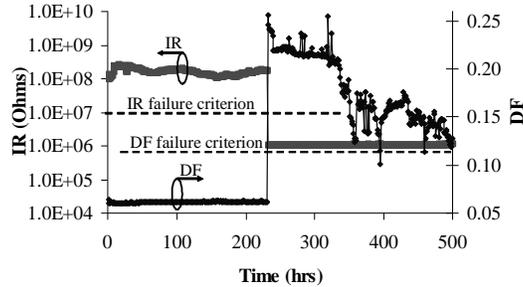
Fig. 7. Failure by both IR and DF failure criterion

At the time of a sudden decrease in the value of insulation resistance (IR) there was a sudden increase in the value of dissipation factor (DF). These observations indicate that the IR failures and DF failures were closely related and were governed by the same failure mechanism, avalanche breakdown. The behavior of IR and DF for one capacitor (small capacitor, tested at 125°C and 285V, with 8 μm dielectric thickness) is shown in Fig. 7. A closer examination of the data revealed that in some cases ABD failures did not result in a sharp increase in the value of DF and the capacitor did not fail according to the DF failure criterion. A representative plot of this behavior is shown in Fig. 8 (small capacitor, tested at 125°C and 285V, with 8 μm dielectric thickness).

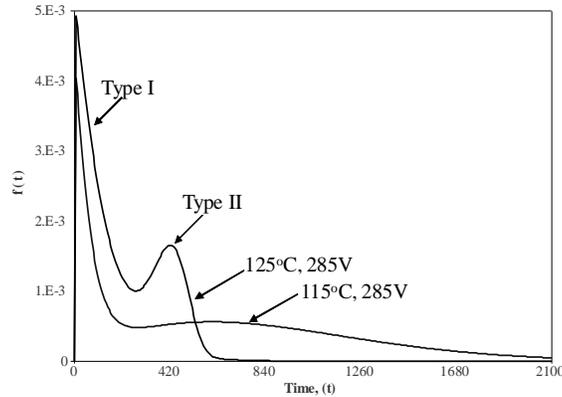
Fig. 9. Effect of temperature - probability distribution function (pdf) plot

It was observed that failures were bimodal (followed two different distributions) so a mixed Weibull distribution with two populations was used. The two distributions as labeled as Type I and Type II in Fig. 9.

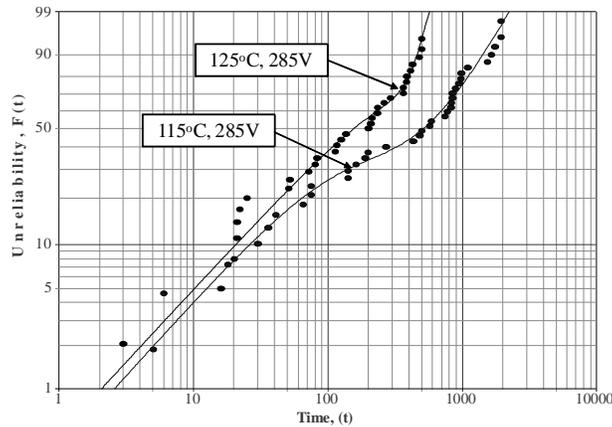
Fig. 10. Effect of temperature - unreliability versus time-to-failure plot

The unreliability versus time-to failure plot at these two stress conditions is shown in Fig. 10. The values of parameters of the distribution, β , η , and P , (the proportion of failures associated with each of the two populations) were calculated and are given in Table 2. It was observed that the value of β for Type I distribution was close to 1 implying that these failures were random in nature. Further it was observed that a decrease in temperature by 10°C , decreased the MTTF for Type I failures (from 130 hrs to 63 hrs). Due to this behavior time-to-failure data of Type I failures are not used to calculate the Prokopowicz constants. The value of β for Type II failures was greater than 1 implying that these failures were actually the result of a wearout degradation mechanism. The value of activation energy (E_a) of the Prokopowicz model was computed for Type II failures and was found to be 0.99 eV.

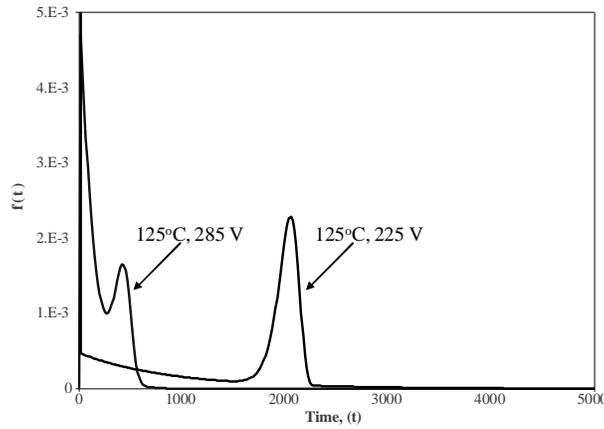
Fig. 11. Effect of voltage - probability distribution function (pdf) plot

To investigate the effect of voltage, the data at 125°C , 285V and 125°C , 225V were compared (for small capacitors with $8\ \mu\text{m}$ dielectric thickness). Statistical analysis was only performed on the time-to-failure data of small capacitors which had a significant sample size. The time-to-failure was observed to follow two different distributions at this new stress level also (125°C , 225V) as shown in Fig. 11.

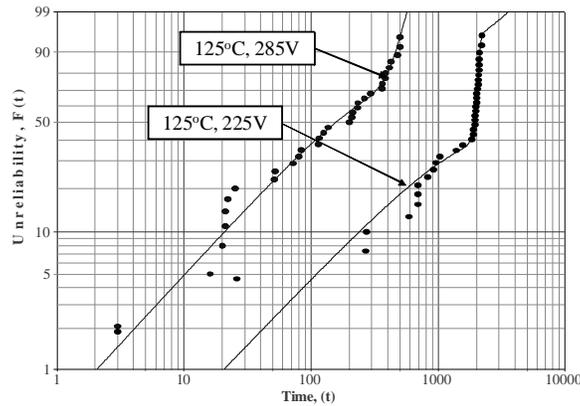
Fig. 12. Effect of voltage - unreliability versus time-to-failure plot

The unreliability versus time-to failure plot at these two stress levels is shown in Fig. 12. The values of parameters of the distribution such as β , η , and P were calculated and are given in Table 3. The value of β for Type I failures was close to 1 implying that these failures were random in nature. The value of the voltage exponent (n) of the Prokopowicz model was computed for Type II failures and was found to be 6.7.

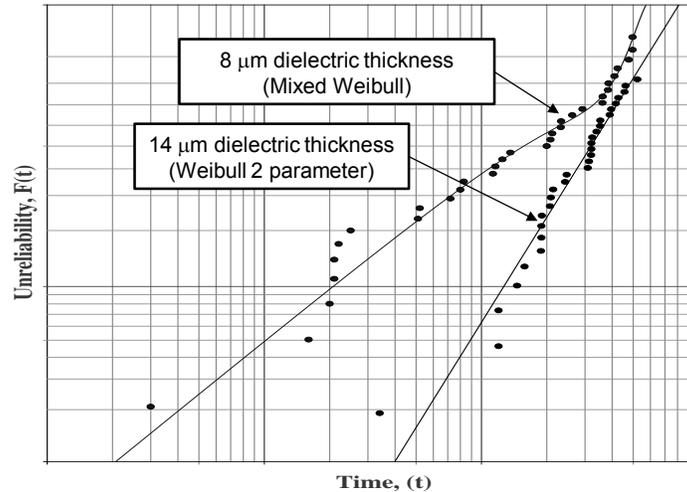
Fig. 13. Effect of dielectric thickness - unreliability versus time-to-failure plot

To investigate the effect of dielectric thickness, the data on embedded capacitors with 8 μm and 14 μm dielectric thickness were compared at 125°C, 285V. Statistical analysis was only performed on the time-to-failure data of small capacitors which had a significant sample size. It was observed that with an increase in the dielectric thickness, type I (random) failures disappeared. The time-to-failure of embedded capacitors with 14 μm dielectric thickness was observed to follow a Weibull 2 parameter distribution. The unreliability versus time-to failure plot for both dielectric thicknesses is shown in Fig. 13. The values of parameters of the distribution were calculated and are given in Table 4.

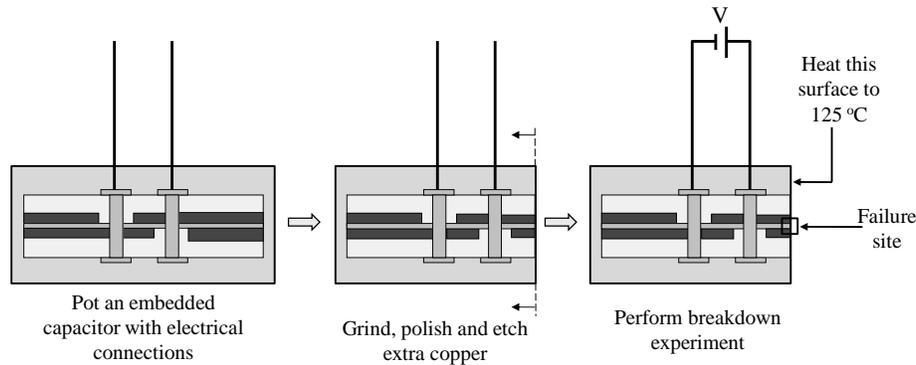
Fig. 14. Sample preparation steps

The procedure involved removing a healthy capacitor from the PWB. Electrical wires were connected to both planes of the capacitor and the capacitor was potted in epoxy. The potted sample was ground from one direction to expose both planes of the capacitor. Finally the sample was polished and etched in FeCl_3 solution to make sure that the spacing between the Cu planes was uniform throughout the surface and also to remove any Cu debris from the dielectric. Defects created during the grinding operation are not desirable. The objective of fine polishing and etching was to eliminate defects created during grinding. The process steps of sample preparation are shown in Fig. 14.

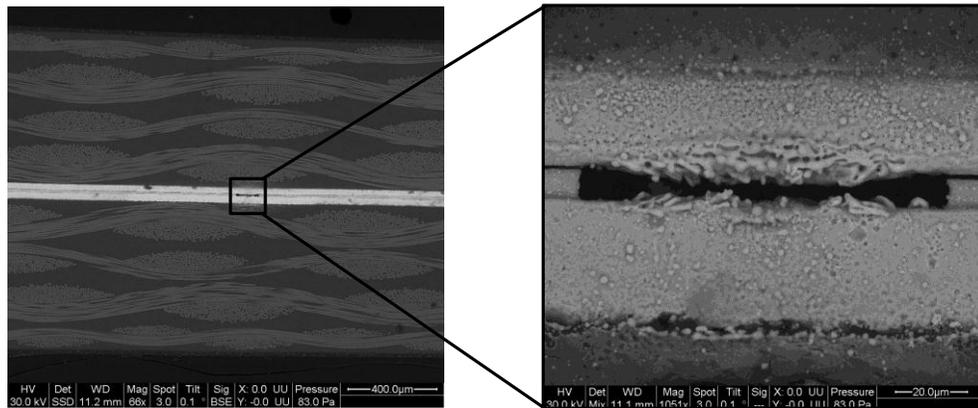
Fig. 15. Site of dielectric breakdown

Once the sample was prepared, this technique was first applied to analyze the failure site of breakdown voltage (dielectric withstanding voltage). The polished surface of the sample was heated to 125°C and the voltage between the capacitor plates was ramped from zero to the point of dielectric breakdown. Since the polished surface of the sample was at the highest temperature (125°C), breakdown took place close to the polished surface. Fig. 15 shows the site of dielectric breakdown that was achieved using the technique described above. Energy dispersive spectroscopy (EDS) showed that the failure site (dark in color) was hollow and the Cu plates melted and moved towards each other. The sequence of events that led to this failure is under investigation

The application of this technique to the breakdown samples demonstrates the potential usefulness of the approach. In the current work failures were created by ramping the voltage from zero until the point of dielectric breakdown. However during HTOL testing failures occur after some time at a constant temperature and voltage. The mechanism of failure in the above two cases appears to be different. In the future, similar samples will be prepared and a constant temperature and voltage (125°C and 285V) will be applied under similar conditions until ABD of the dielectric is observed. These failures will be more representative of failures taking place during the HTOL test. Analysis of the failure site will be useful in understanding the ABD taking place during the HTOL test.

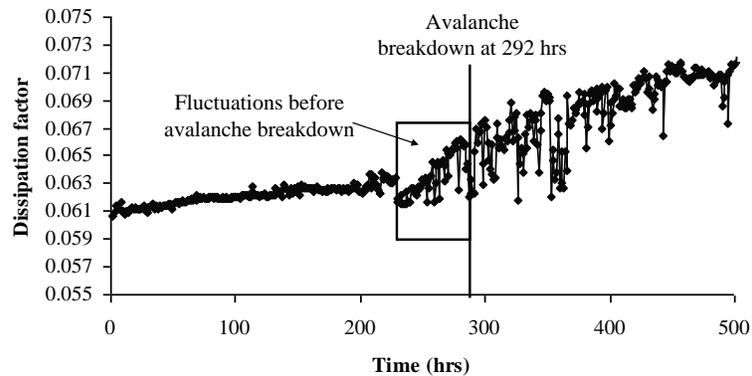
Fig. 16. Fluctuations in dissipation factor before avalanche breakdown

After conducting some preliminary analysis on the dissipation factor data, it was observed that the values of dissipation factor started to fluctuate before ABD failure as shown in Fig. 16. No such fluctuations were observed in the insulation resistance data and this may be because insulation resistance is a DC measurement and dissipation factor is an AC measurement (measured at 100 KHz). Insulation resistance only takes into account the DC leakage current in the dielectric. However dissipation factor takes into account both the DC leakage current and the polarization losses in the dielectric. This might be the reason that dissipation factor is able to show indications of dielectric degradation whereas insulation resistance is not. The fluctuations in the dissipation factor data were not found in all the capacitors and the reason for this is currently under investigation.

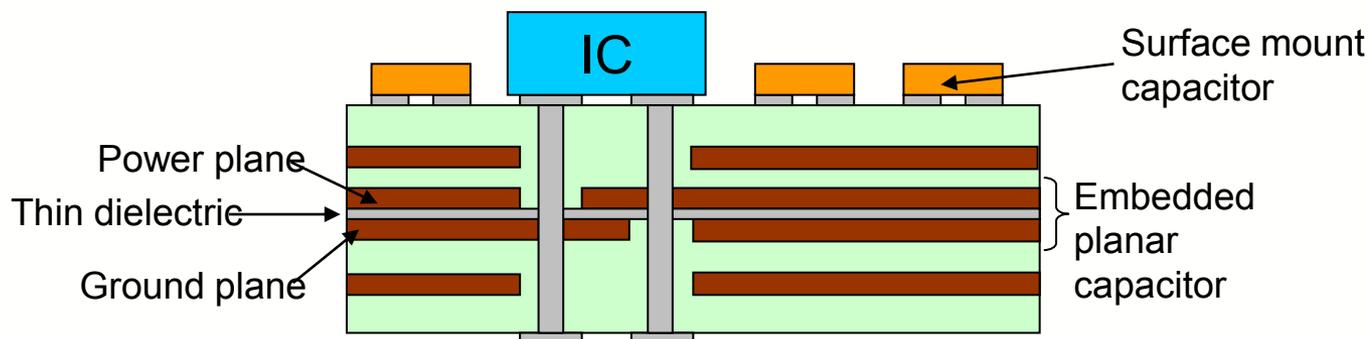
- Thin laminate embedded inside a PWB that functions both as:
 - Power/ground plane
 - Parallel plate capacitor
- Used in decoupling operations and leads to:
 - Reduction in the number of surface mount capacitors^[1]
 - Improved electrical performance^[2](such as reduced EMI)

Embedded planar capacitors can lead to PWB miniaturization

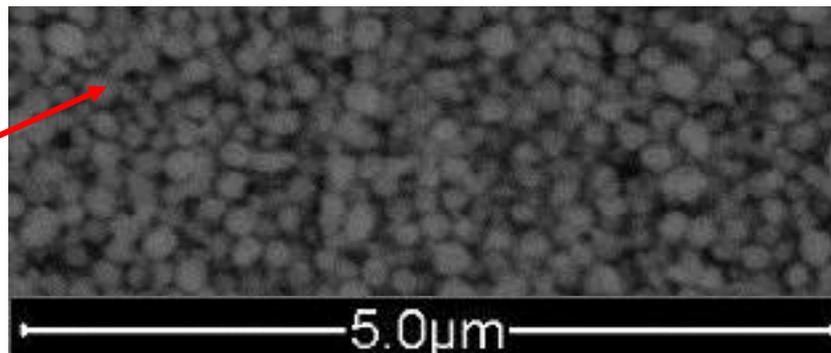
- The material investigated in this work is an epoxy-BaTiO₃ composite.

BaTiO₃ particles
(diameter ~ 0.1 μm)

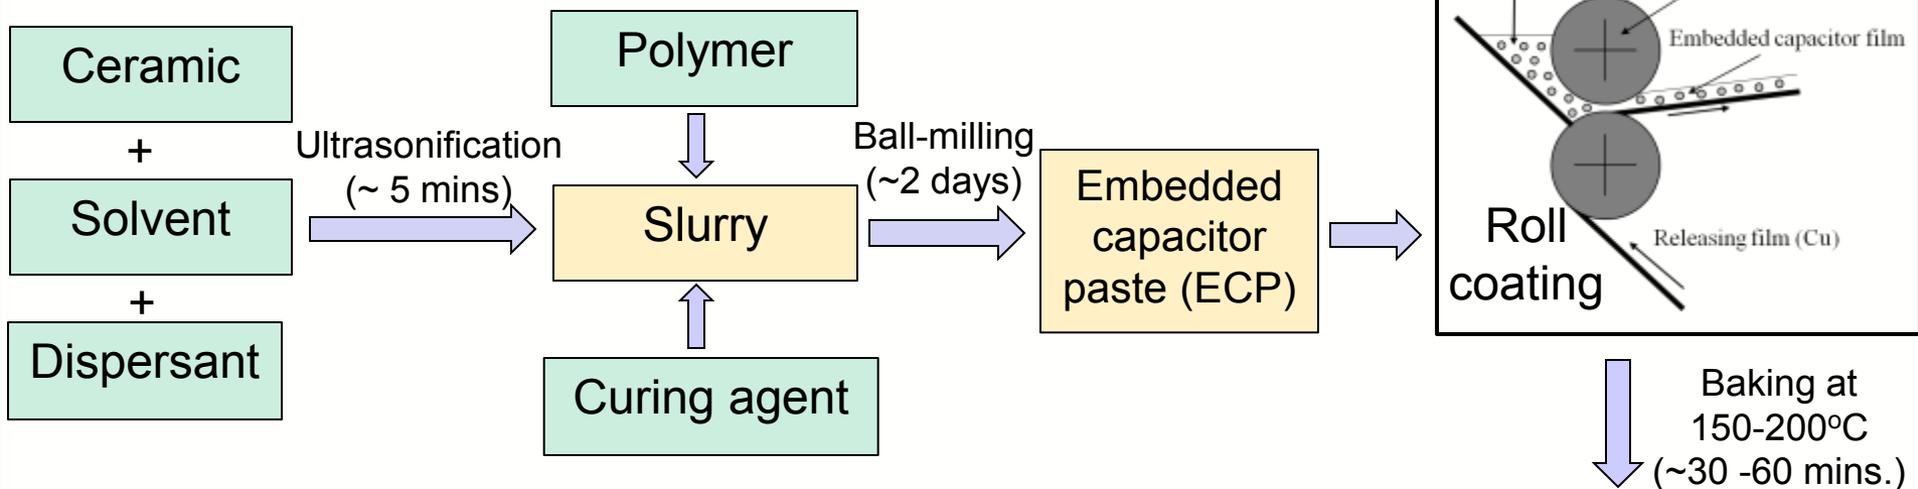
Manufacturing^[1] [2]

- Dispersant: is added to prevent agglomeration of ceramic nanoparticles due to Vander Walls force.
- Ultrasonification and ball milling: are performed to break down agglomerates of ceramic nanoparticles.

Non uniform dispersion of ceramic nanoparticles can lead to defects in the dielectric such as voids, porosity and agglomeration of ceramic particles

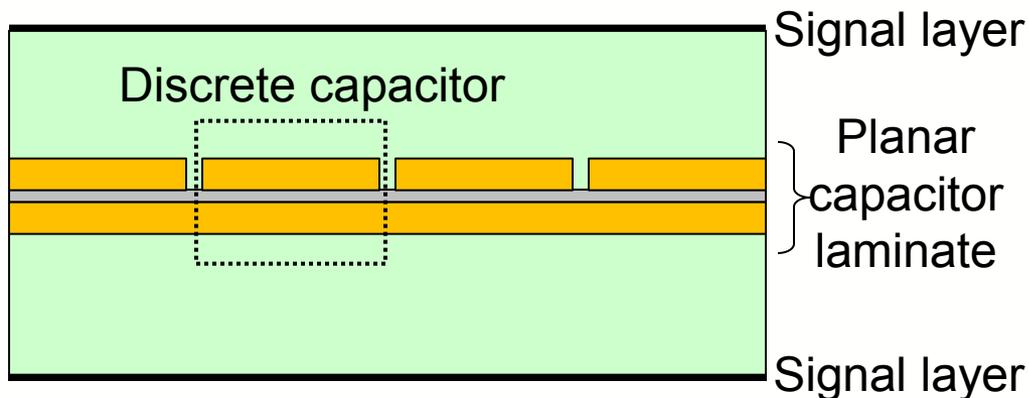
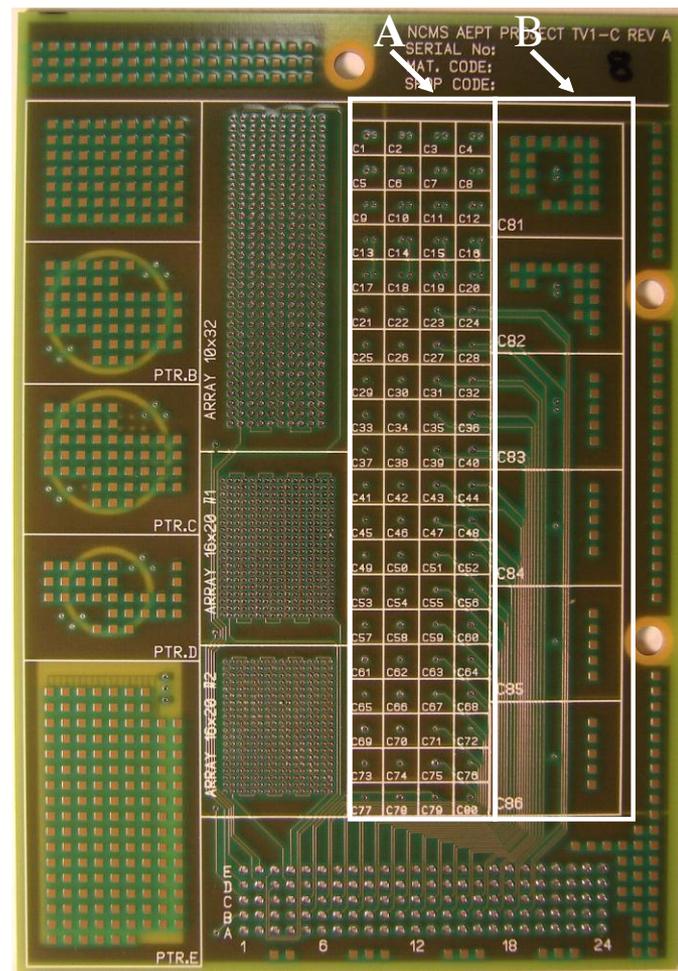
Sectional View of the PWB

- Four layered PWB:

- Two types of PWBs:
 - 8 μm dielectric thickness
 - 14 μm dielectric thickness
- Two types of capacitors :
 - Small (Group A): ≈ 400 pF and 80 capacitors/test vehicle
 - Large (Group B): ≈ 5 nF and 6 capacitors/test vehicle.

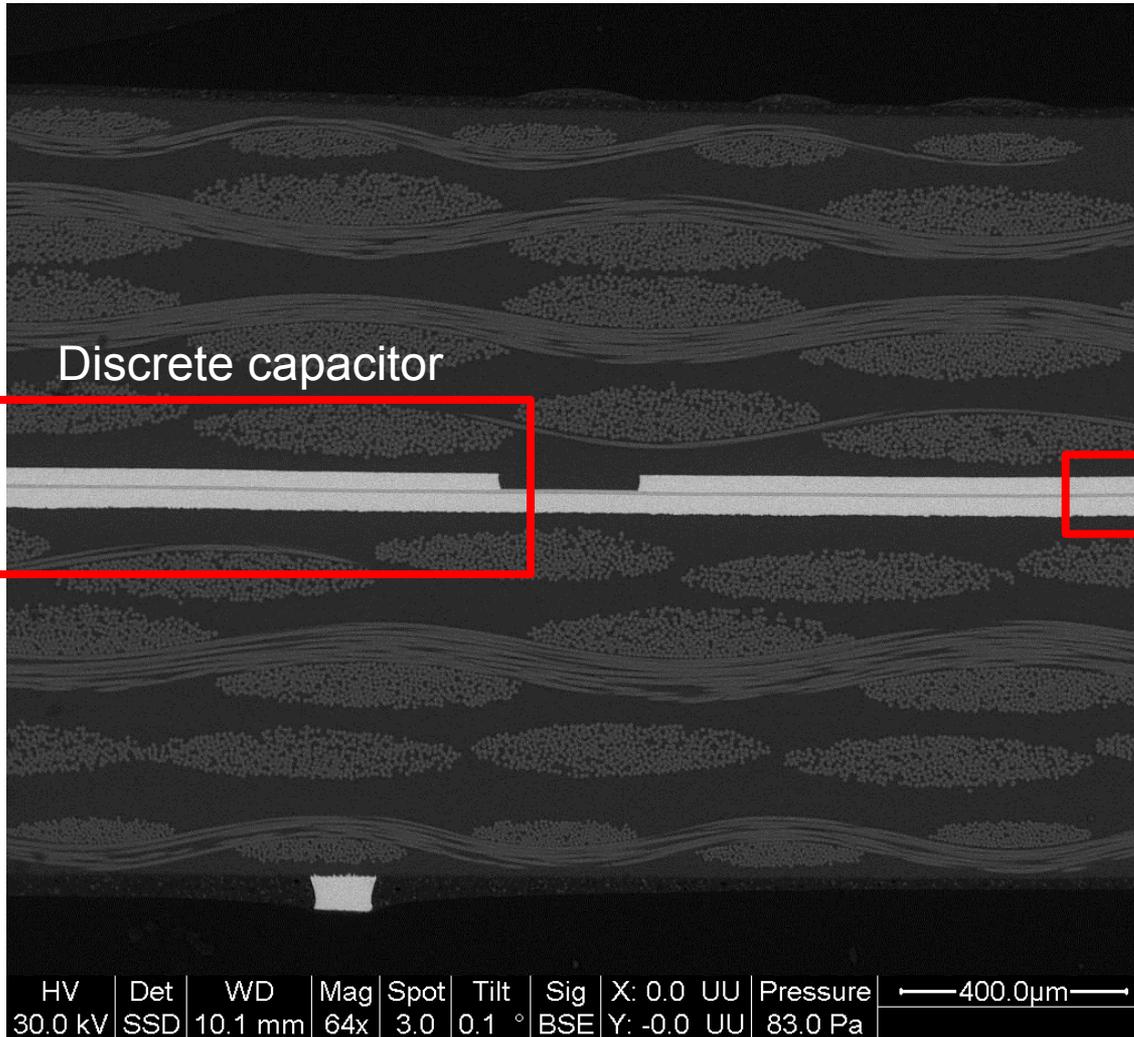
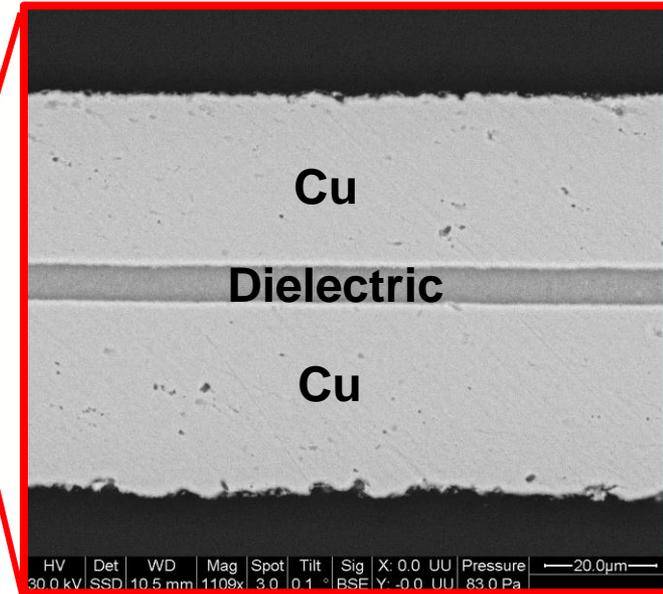
Dielectric was a composite of epoxy and BaTiO₃ (loaded 45% by vol.), whose dielectric constant was 16 at 1 KHz

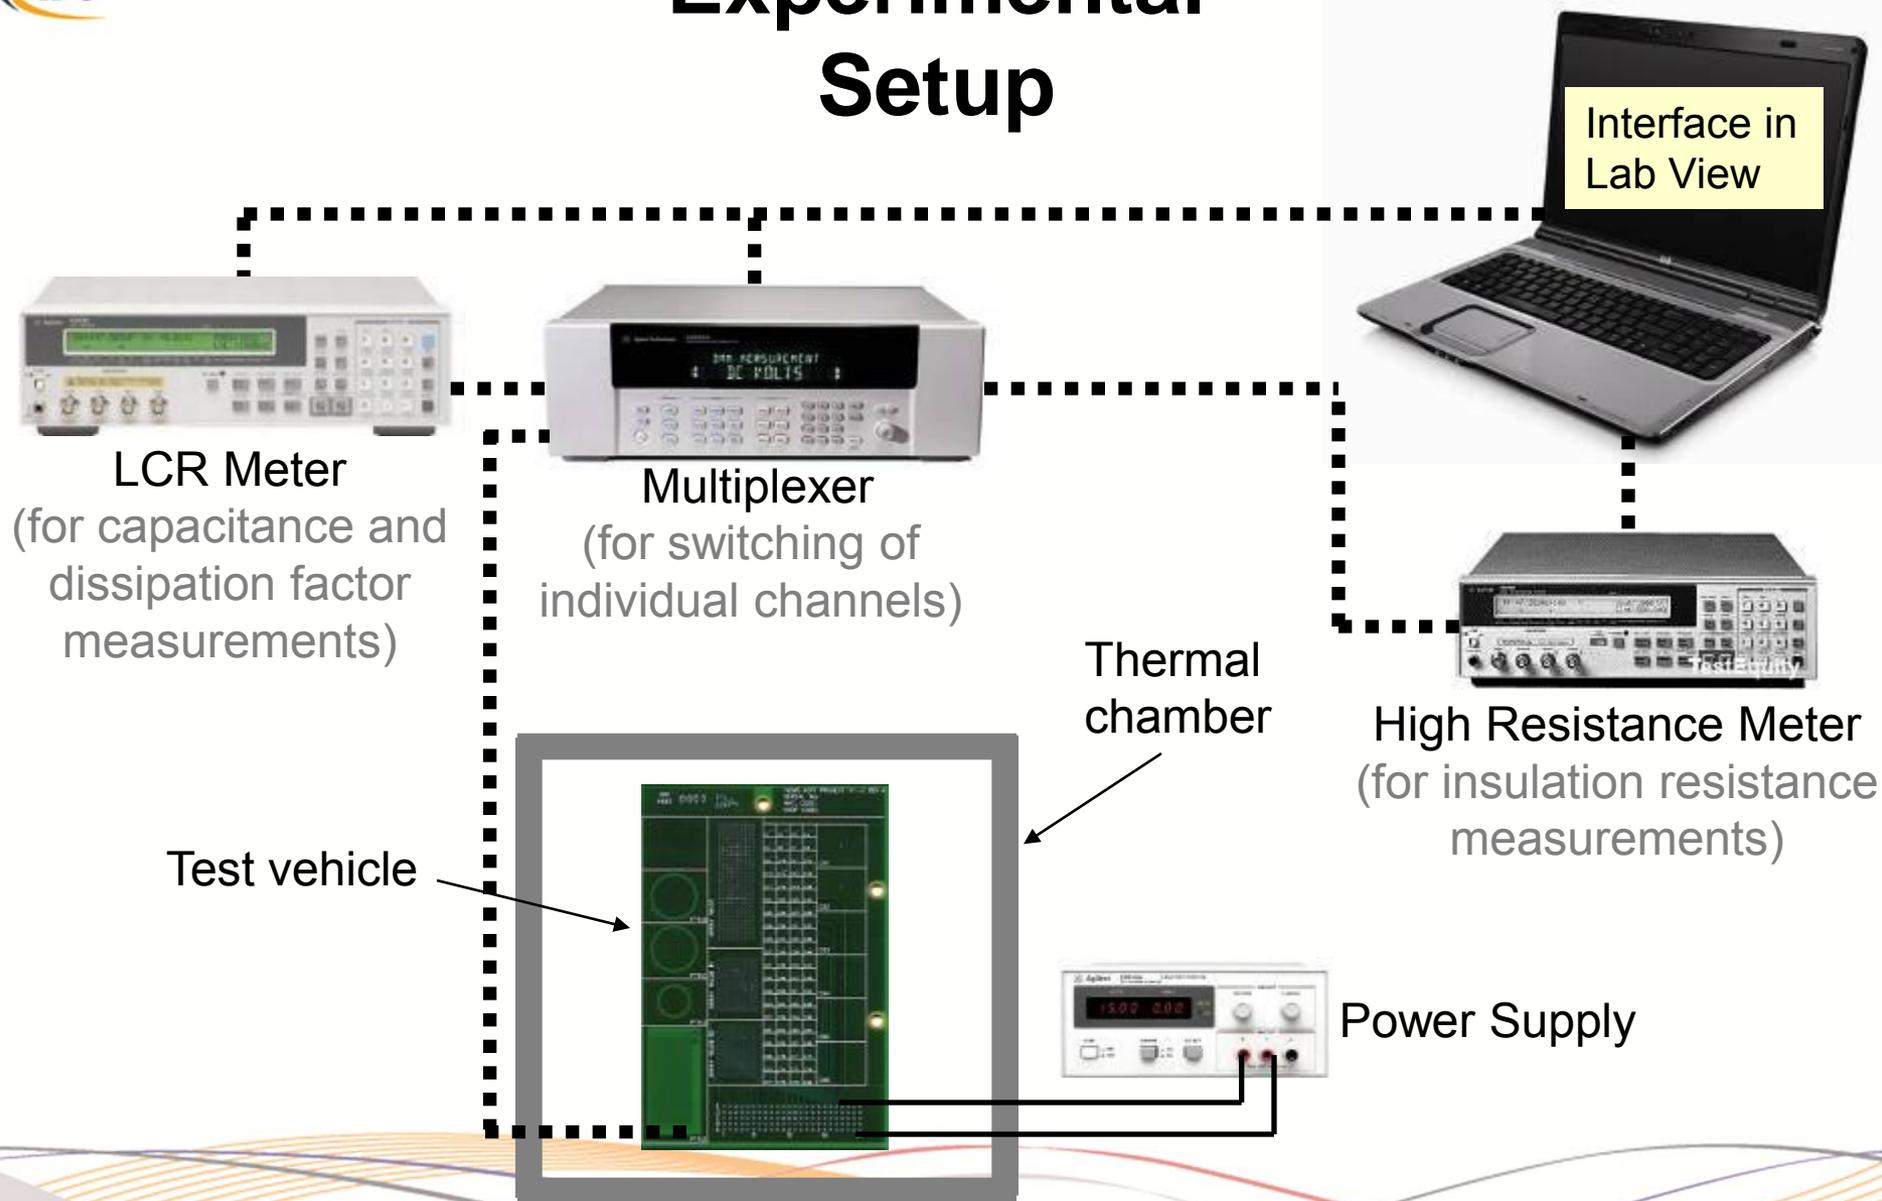
Experimental Setup

- 33 out of 80 small capacitors and 4 out of 6 large capacitors were selected.
- Measured parameters:
The following parameters of each capacitor were measured once every hour:
 - Capacitance (C) at 100 kHz
 - Dissipation factor (DF) at 100 kHz
 - Insulation resistance (IR) at 10 V.
- Failure Criterion:
The failure criteria selected were:
 - 20% decrease in capacitance (C)
 - increase in dissipation factor (DF) by a factor of 2
 - drop in insulation resistance (IR) to 10 M Ω .

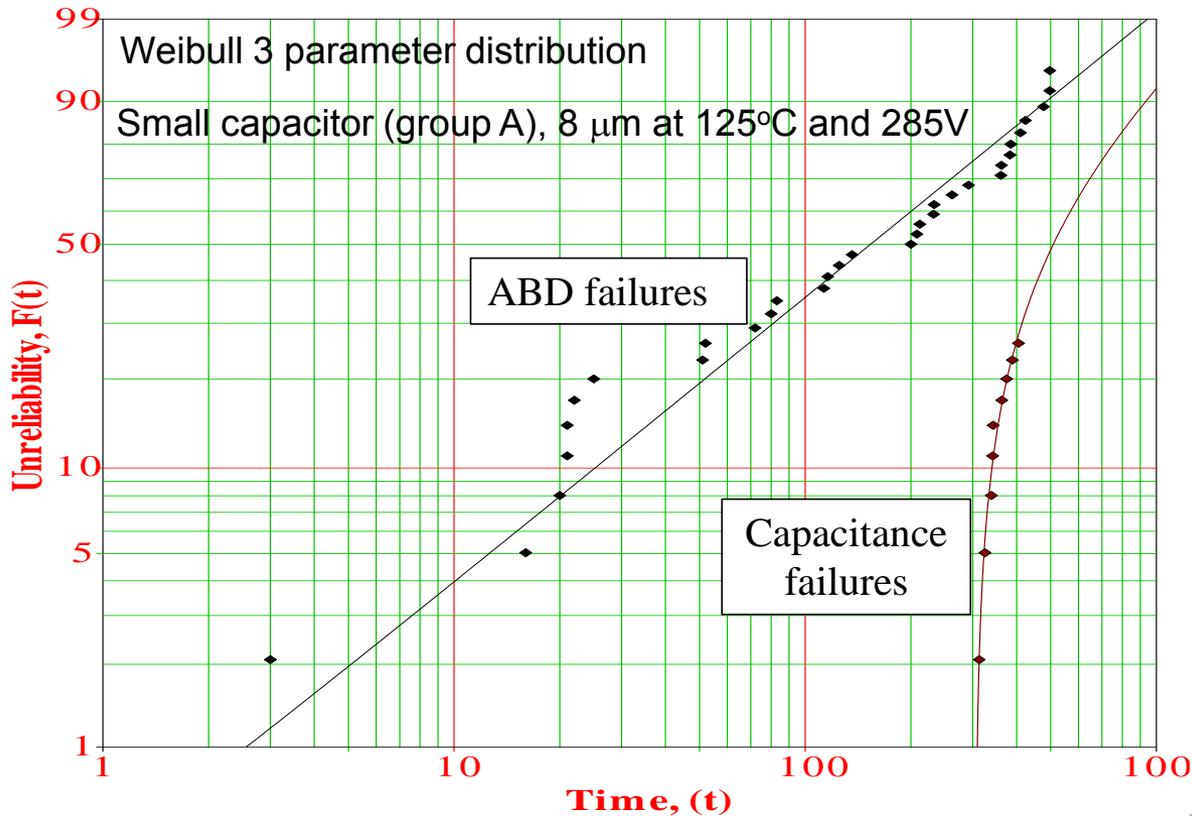
Failure Modes during HTOL Testing

- The failure modes observed were a:
 - Gradual decrease in capacitance
 - Sharp drop in insulation resistance implying ABD

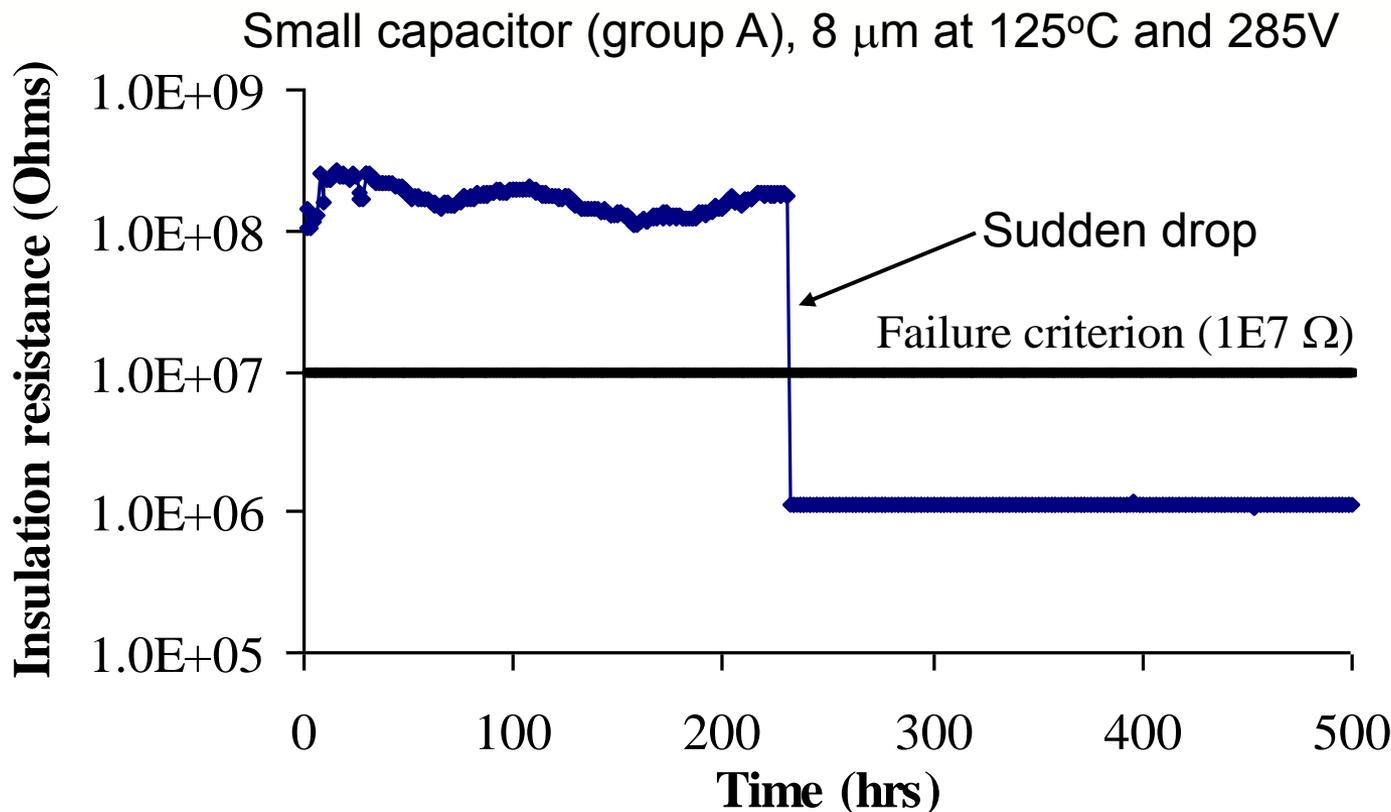
Typical Plot of Insulation Resistance

Since HTOL experiments were conducted under highly accelerated conditions, this failure mode may not take place under normal operating conditions

Failures during HTOL testing took place after the stress was applied for some extent of time, depending on the stress level, which implies that the dielectric degrades with time under these conditions. It is expected that the degradation level in the dielectric increases with time and finally the degradation level reaches a threshold when the capacitor dielectric fails by ABD. The exact nature of this degradation mechanism is not clear. It might be possible that this degradation takes place due to Maxwell's stress in the dielectric [33]. Whatever might be the cause of this degradation, it is clear from Fig. 7 and Fig. 8 that insulation resistance is not able to capture these degradations. The value of insulation resistance was almost constant before a sudden drop at failure.

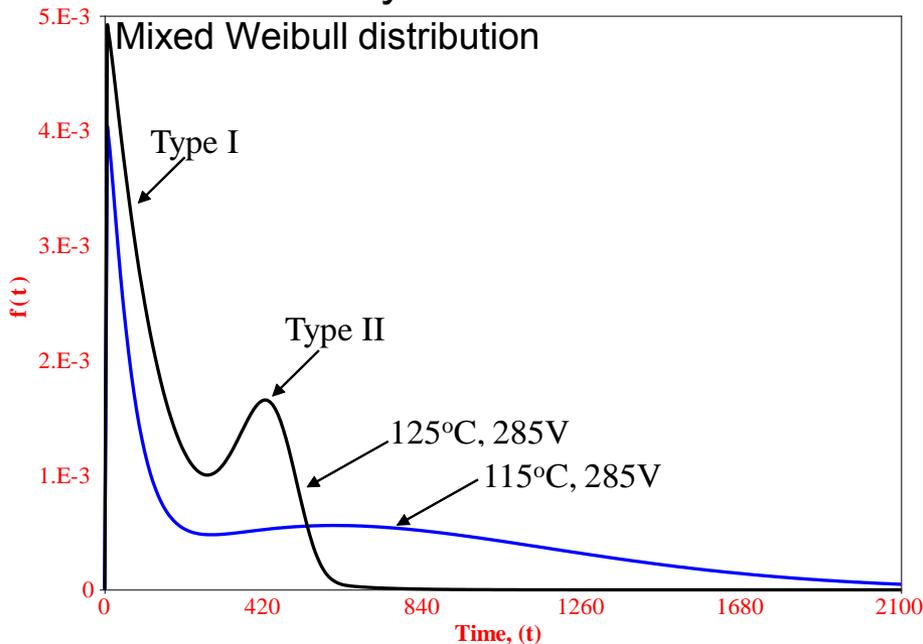
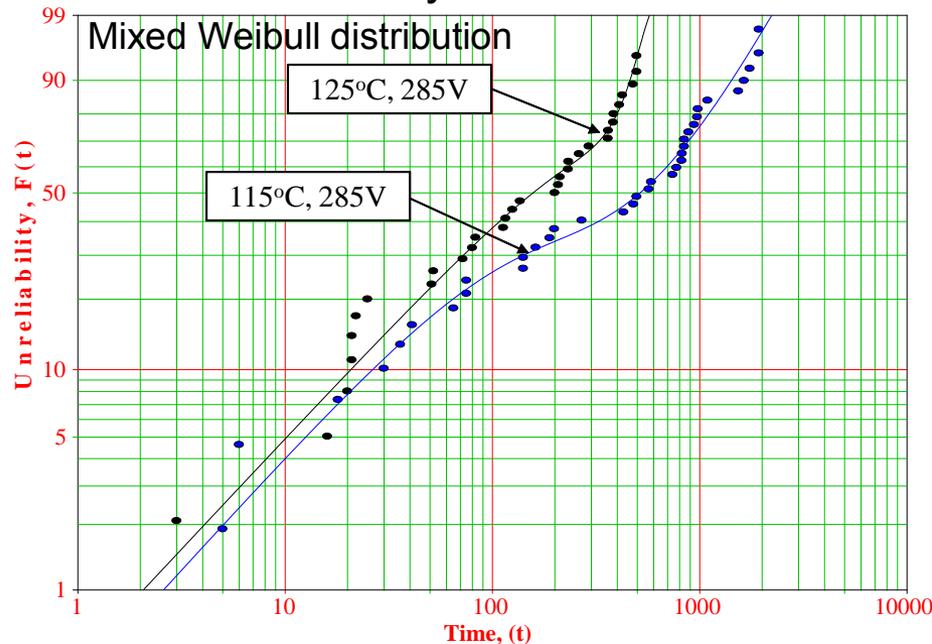
Effect of Temperature (115°C → 125°C)

(285V, Small capacitors, 8 μm dielectric thickness)

Probability distribution function

Unreliability vs. time-to-failure

Aging condition	Test duration (hrs)	Failed	Survived		MTTF (hrs)	β	η	P
125°C and 285V	500	32	1	Type I	130	1.0	130	0.7
				Type II	413	6.0	444	0.3
115°C and 285V	2000	36	0	Type I	63	1.1	65	0.3
				Type II	871	1.8	979	0.7

Type I failures seems to be random in nature since the value of β is close to 1

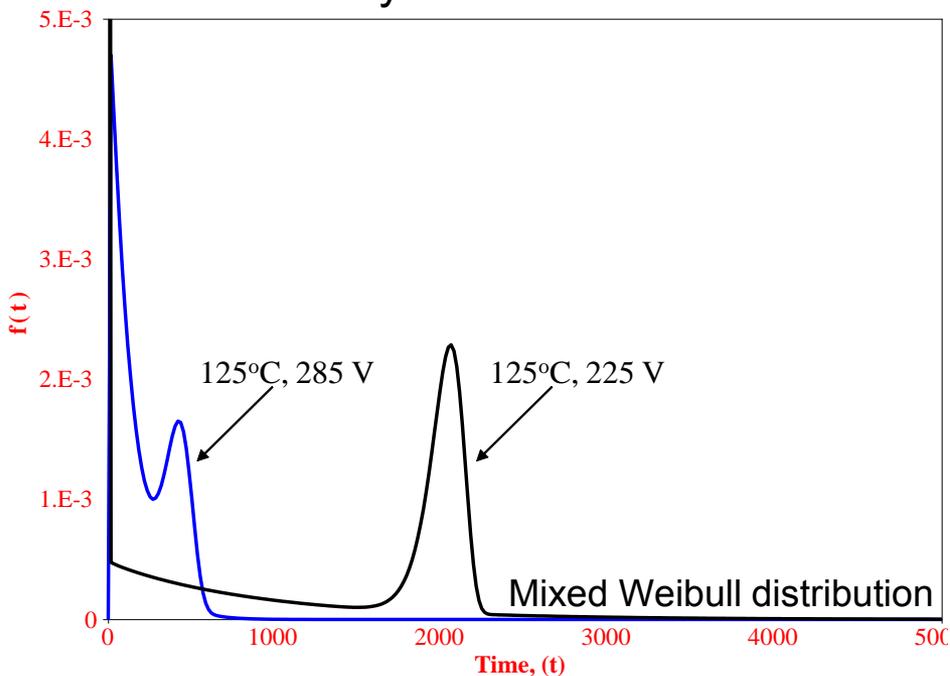
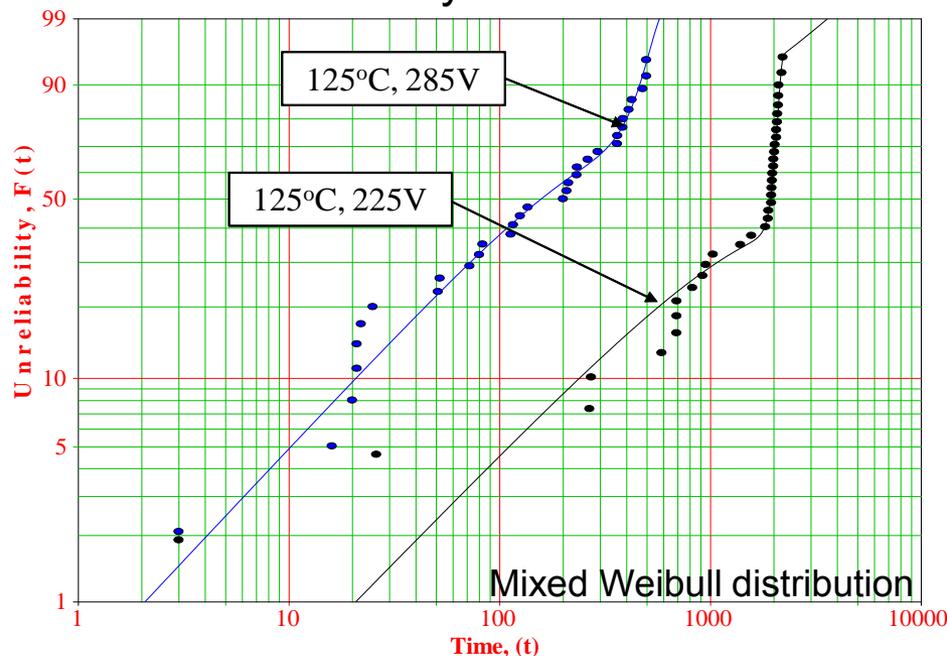
(125°C, Small capacitors, 8 μm dielectric thickness)

Probability distribution function

Unreliability vs. time-to-failure

Aging condition	Test duration (hrs)	Failed	Survived		MTTF (hrs)	β	η	P
125°C and 285V	500	32	1	Type I	130	1.0	130	0.7
				Type II	413	6.0	444	0.3
125°C and 225V	2300	35	1	Type I	935	1.0	935	0.4
				Type II	1996	22.0	2058	0.6

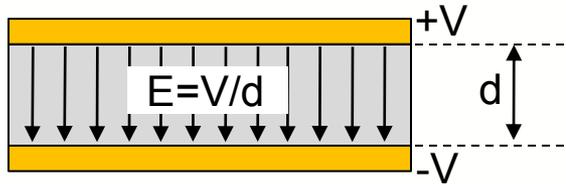
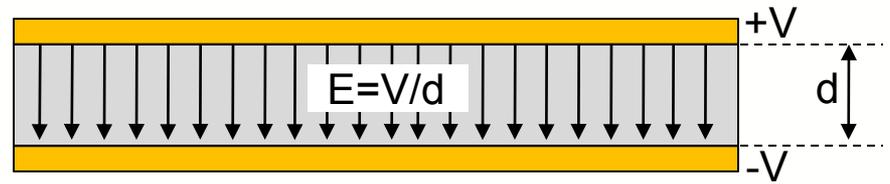
(125°C , 285 V , $8 \mu\text{m}$ dielectric thickness)

- All large capacitors failed within 10 hrs.
- Electric field experienced by the dielectric of small and large capacitor is same.

Group A

Group B

- A shorter time-to-failure of large capacitors implies that these failures are defect driven, whose probability increases with capacitor area.

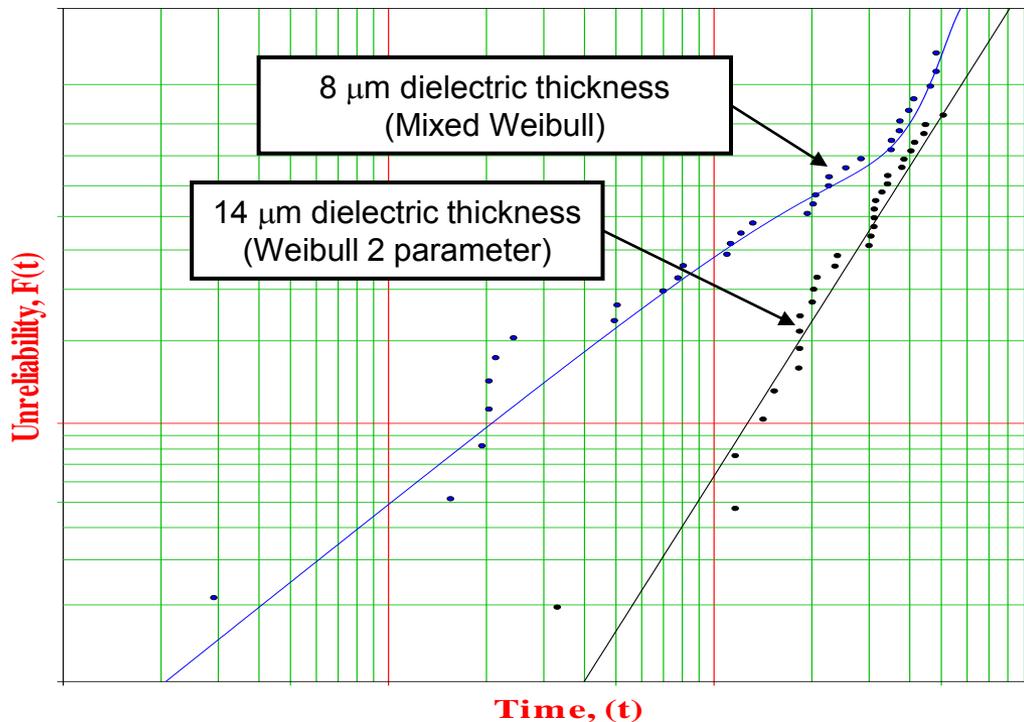
Effect of Dielectric Thickness (8 μm \rightarrow 14 μm) (125°C, 285 V, small capacitors)

With an increase in the dielectric thickness, Type I failures disappeared.

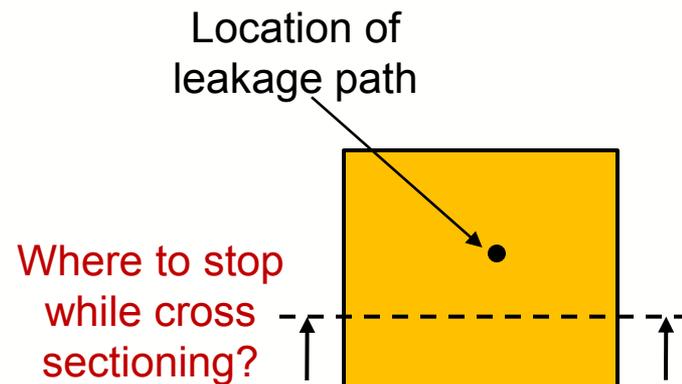
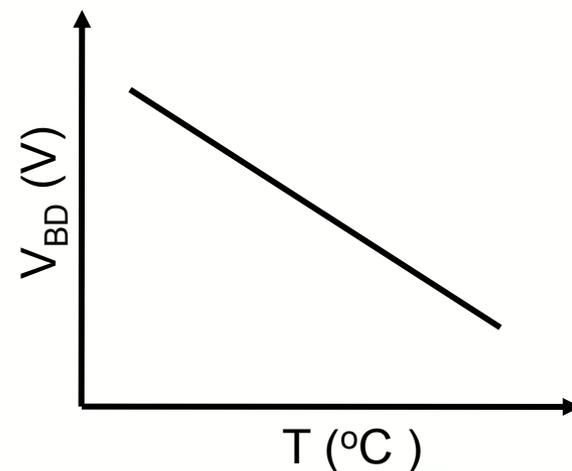
Failure Analysis

- Isolate a leakage path ($\sim 10^5 \Omega$) in a 4 layered PWB.
- Use of non-destructive techniques such as thermal imaging and SQUID (Superconducting Quantum Interference Device) microscopy can possibly be used to locate the failure site.
- However in this work a new technique was used to located the failure site:
 - similar failures were reproduced in a healthy capacitor at a predetermined failure site
 - The temperature dependent breakdown voltage (V_{BD}) property of this material was utilized^[1].
