Failure Mechanisms in Embedded Planar Capacitors during High Temperature Operating Life (HTOL) Testing

Mohammed A. Alam¹, Michael H. Azarian², Michael Osterman and Michael Pecht

Center for Advanced Life Cycle Engineering (CALCE)

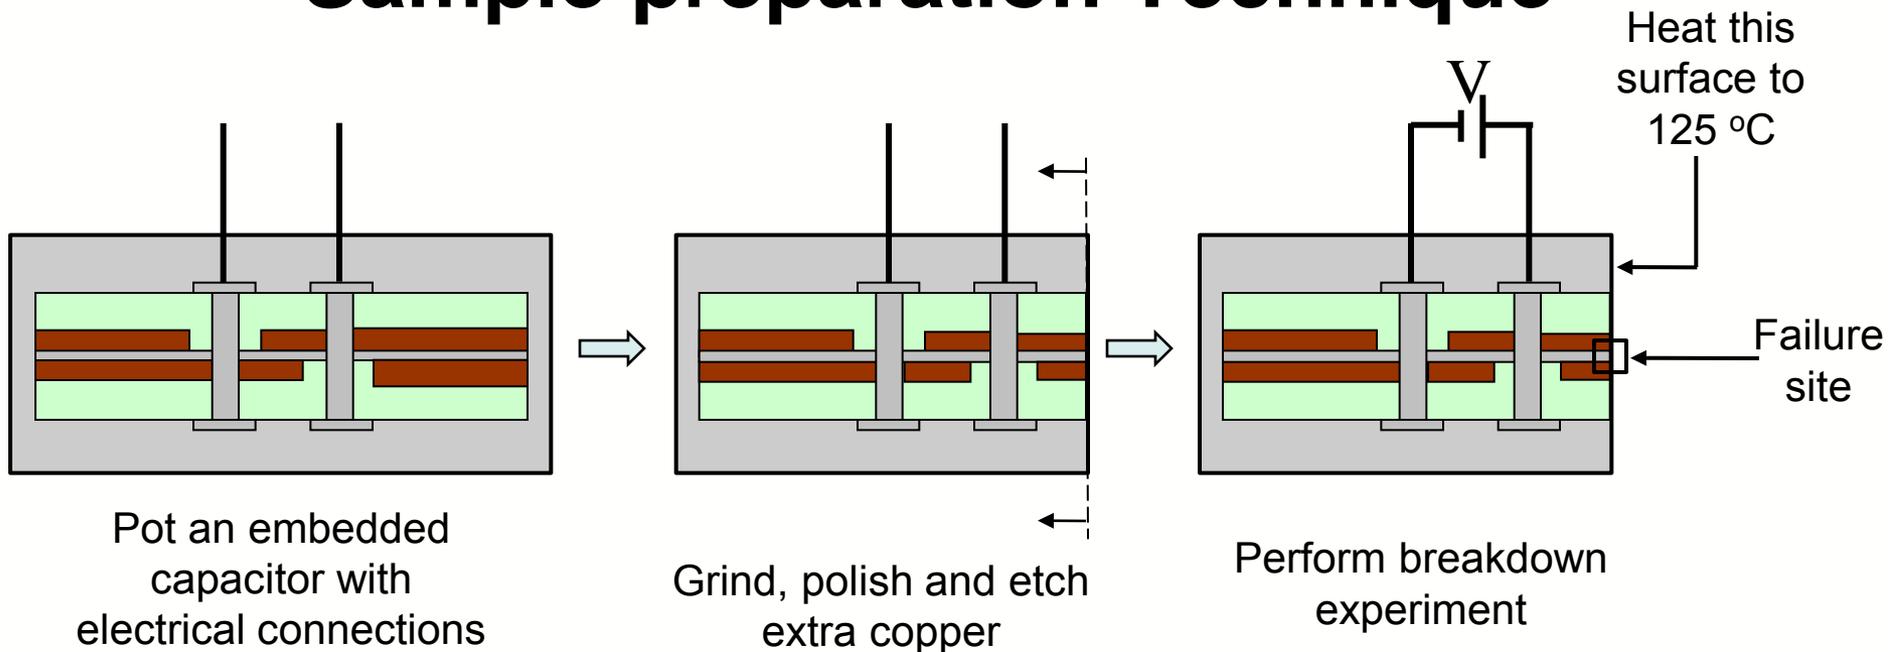
Sample preparation Technique

- The objective of fine polishing and etching was to reduce the number of defects created during grinding.
- The polished surface of the sample was heated to 125°C and the voltage between the capacitor plates was ramped from zero until the point of dielectric breakdown (V_{BD}).

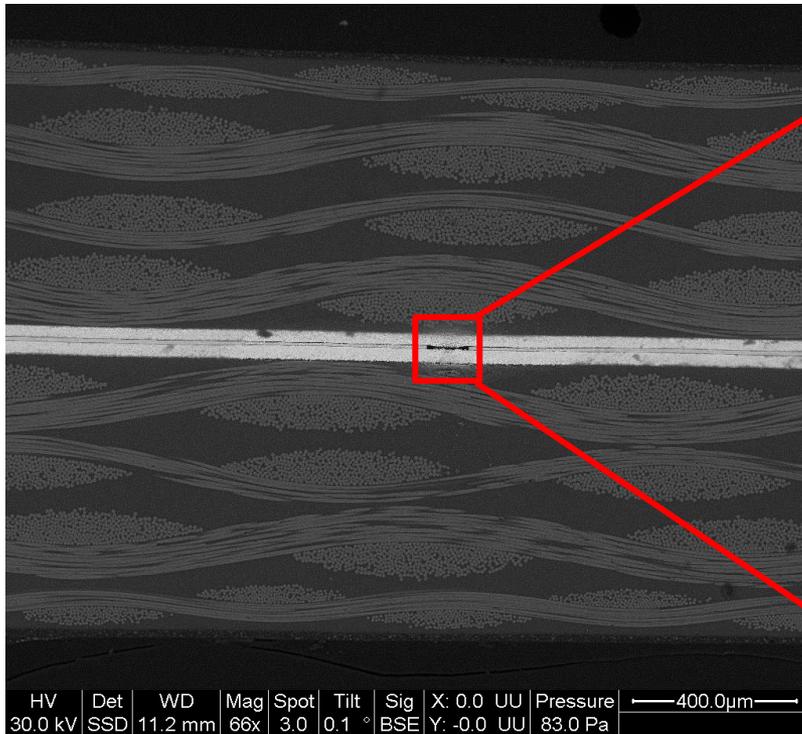
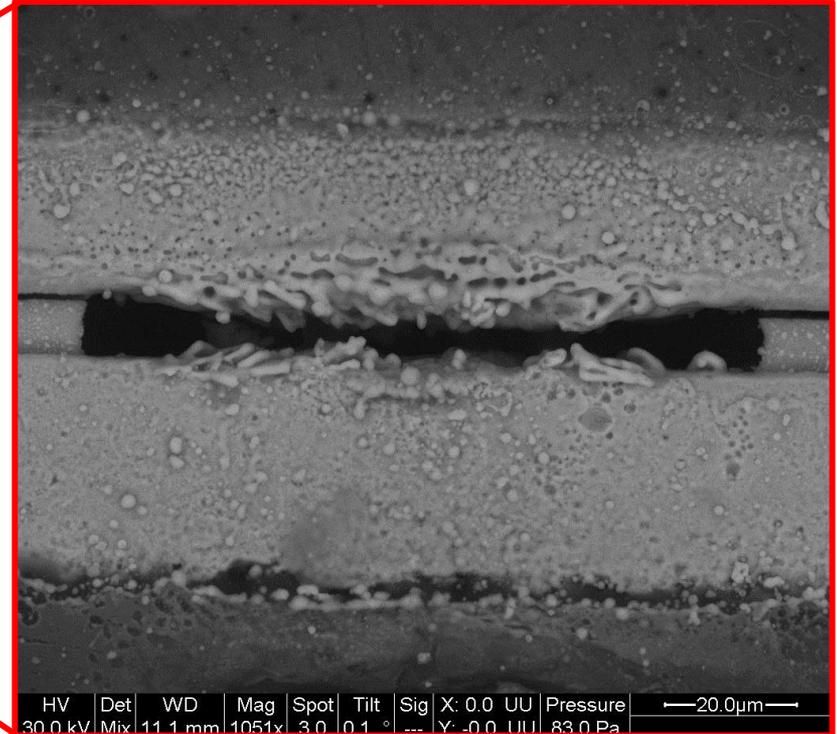
Site of Dielectric Breakdown

- The failure site (dark in color) was hollow and the Cu plates melted and moved towards each other.
- The sequence of events that led to this failure is under investigation.
