Latent Short Circuit Failure in High-rel PCBs Caused by Lack of Cleanliness of PCB Processes and Base Materials

Stan Heltzel, European Space Agency
Components Technology and Space Materials Division
Noordwijk, Netherlands
Stan.Heltzel@esa.int

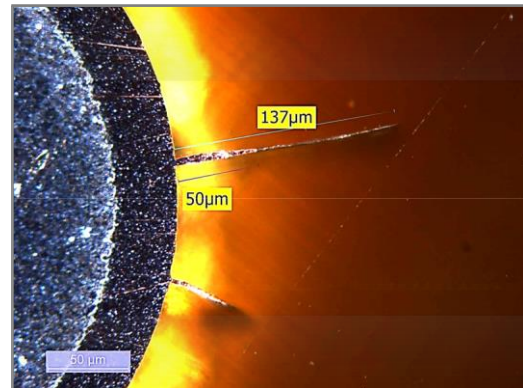
Fig. 5. In-plane section of a via without capture pad showing cracks and copper ingress caused by drilling in brittle resin.

Furthermore, the ECSS-Q-ST-70-12 specifies the presence of non-functional pads to mitigate the risk of drilling cracks in resin-rich areas and it specifies the use of two sheets of prepreg between copper layers as well as two layers of woven glass reinforcement in laminate, to mitigate the risk of contamination.

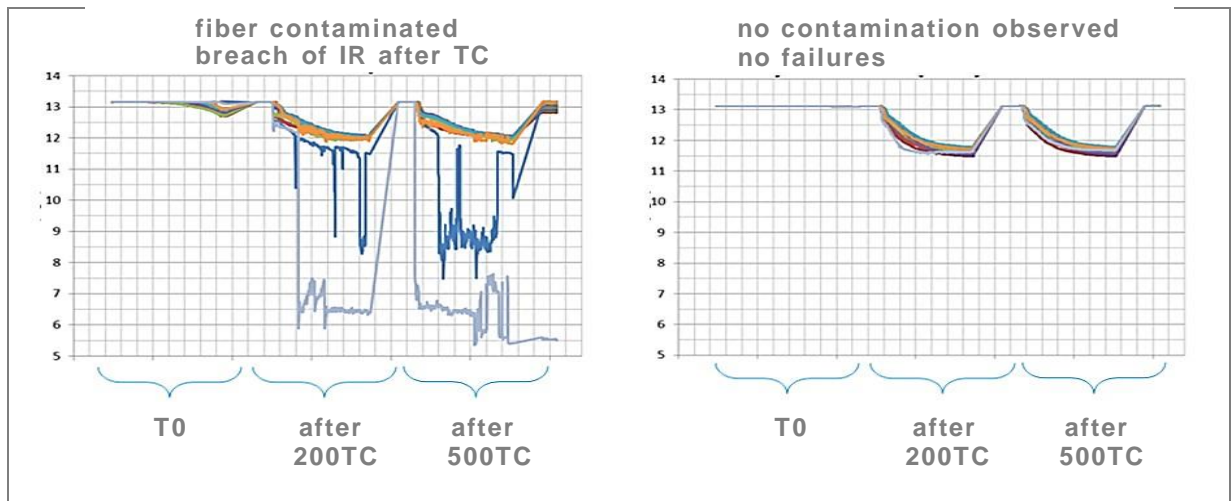
Fig. 6. Insulation resistance (log Ω) before and after thermal cycles (TC) from -65°C to $+135^{\circ}\text{C}$, showing two failed innerlayers of a comb pattern that appeared to be fiber contaminated.

An unexpected result of the test campaign was that one set of coupons appeared to be contaminated with fibers, which caused breach of insulation after thermal cycling. After the campaign, the short circuit was located using infrared thermography while applying a low current. Destructive Physical Analysis (DPA) was performed and progressive polishing finally revealed the fault location. In all cases for which the fault location could be identified in this manner, it was observed that the breach of insulation was associated with fiber contamination. In some cases it was evidenced that copper migrated from the comb pattern and re-deposited along the fiber. The fibers were observed in prepreg layers and therefore associated with the PCB manufacturing processes.

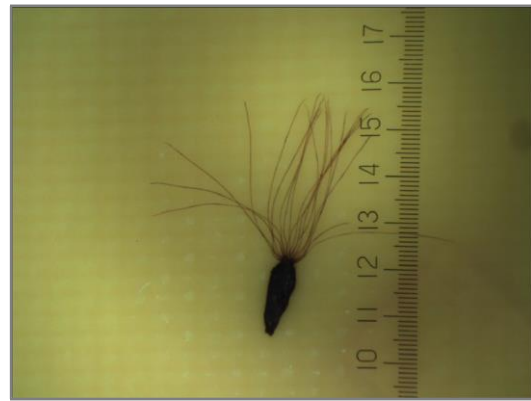
Fig. 8. Top view of a laminate after etching of copper cladding, showing a plant seed embedded in the dielectric material, probably carried into the clean room on clothes of personnel. The scale is in mm.

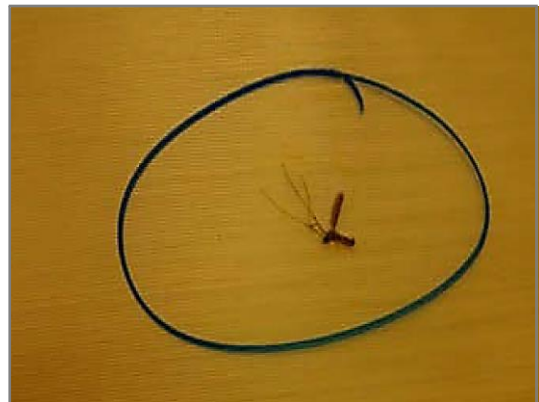
Fig. 9. Top view of a prepreg showing an embedded insect.

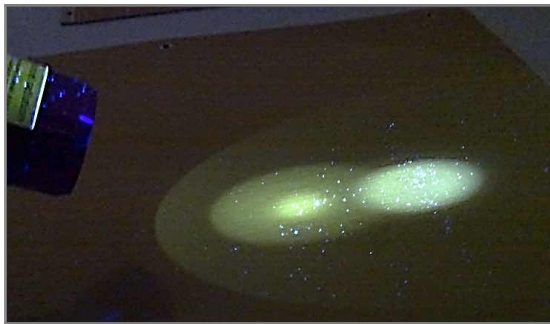
Fig. 12. Inspection of a sealed bag of polyimide prepreg showing UV fluorescence of particulate contamination.

Verification of the efficiency of the cleaning can be done by visual inspection under bright light and ultraviolet (UV) light. UV flash lights as well as bright lights are readily available in various wavelength ranges. Using UV light inspection it was shown that sealed bags of polyimide prepreg are occasionally contaminated as delivered from the base material supplier. Polyimide resin dust was shown not to be fluorescent, whereas epoxy resin as well as dust fibers do show UV fluorescence. Either source of contamination is unacceptable in polyimide production processes at high temperature.

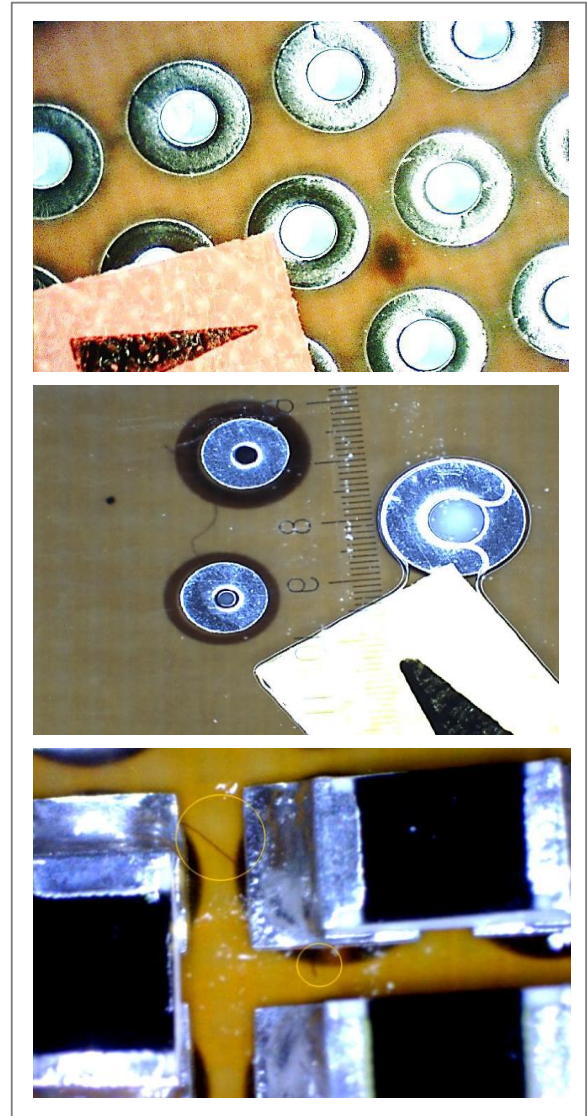
Fig. 13. Contamination embedded in base laminate on external layers bridging the insulation between pads, at outgoing inspection and after assembly.

In some recent cases, small but critical fiber contamination remained undetected at outgoing inspection as well as incoming inspection at the customer, which is described as NC#1 as part of ESA Alert EA-2014-EEE-3-A. Only after assembly and conformal coating, it was discovered that fiber

contamination was embedded within the outer layer laminate and bridging the gap between pads. Waiving such non-conformance by repair and testing under careful assessment by NRB was performed but requires high effort and cost, in particular when the delivery of the PCB assembly is on the critical path of satellite integration.
