# Pb-Free Reflow, PCB Degradation, and the Influence of Moisture Absorption

Kerin O'Toole, Bob Esser, Seth Binfield, and Craig Hillman, DfR Solutions, College Park, MD  
Joe Beers, Gold Circuits,

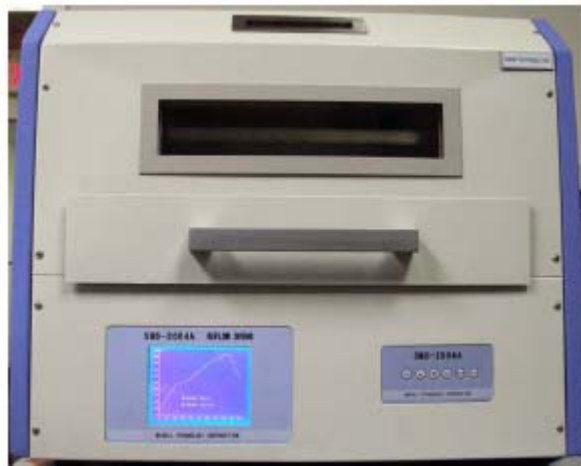
The reflow oven used was a bench top model pictured in Figure 8. The oven was calibrated using an external thermocouple to verify the accuracy of the oven's temperature as reported by the computer's software. To control for variability of the internal temperature of the reflow oven, the internal temperature sensor was tightly secured to the tested PCBs to make sure that the PCB surface temperature was what drove the ramp rate of the reflow cycle. This technique ensured that the PCBs reached the desired temperature throughout the cycle and eliminates the variability that would occur if the thermocouple was not consistently placed for each cycle.

**Figure 8: Benchtop reflow oven**

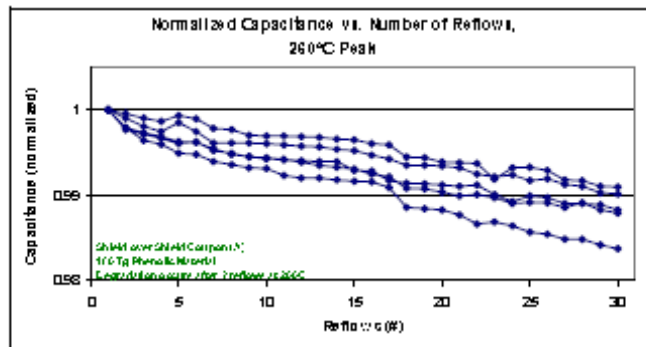
The data demonstrates that a steady decrease in shield-over-shield capacitance occurred in the boards subjected to the 260°C profile as the number of reflow cycles increased (Figure 12). Although there was no specific number of reflows at which the capacitance measurements dropped-off, the trend in the data suggests that this decrease would continue to occur as more reflow cycles were conducted.

**Figure 12: The relationship between the normalized capacitance and increasing reflow cycles, repeated 30 times with a peak temperature of 260°C preformed on 5 advanced coupons.**

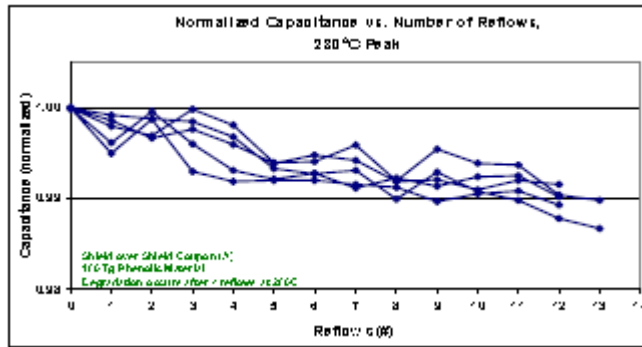
When the peak temperature of the reflow cycle was increased to a value of 280°C, the same general trend was observed although the degradation occurred about fifty times faster (Figure 13). This was shown by the fact that only 12-13 reflow cycles of the second profile were needed to cause a comparable decrease in capacitance to what was previously observed in the first profile with 30 reflow cycles. The normalized capacitance of the 280°C profile showed a marked decrease after 4 reflows equal to about 0.5% on average, and then capacitance decreased gradually with each additional reflow cycle. The data from both tests of phase 1 suggests that an inverse relationship exists between these two variables and as the peak reflow temperature is increased within the range tested, the amount of reflows necessary to cause a comparable decrease in capacitance is reduced.

Figure 13: The relationship between the changes in the normalized capacitance as a result of 12 reflow cycles with a peak temperature of 280°C performed on 5 advanced coupons.

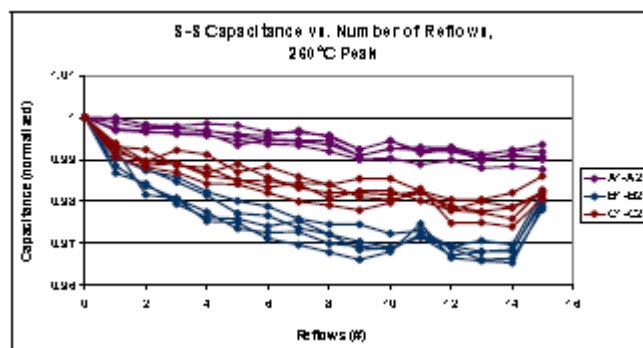
The results obtained showed that different test structures degrade at different rates as apparent in Figure 14. From these results, it is clear that test structure B degraded the most followed by test structure A and then test structure C. Test structure B had an average rate of degradation of almost five times that of test structure A, and test structure C had rate of degradation about three times that of test structure A. This suggests that some inherent difference with the design of these test structures resulted in differential rates of degradation.

Figure 14: The results of 5 standard boards through 15 reflow cycles with a peak temperature of 260°C. The shield over shield capacitance was measured before testing and after each cycle for test structures A, B and C.

The overall changes in shield-PTH capacitance (Figure 15) were much greater than the shield-over-shield capacitance changes across all test structures (Figure 14). After just one reflow cycle, the degradation observed in the PTH-shield nets was comparable to the degradation observed in shield-over-shield capacitance nets after 15 reflow cycles. The PTH-shield capacitance also decreased most dramatically after 4 reflows and continued to decrease as the boards were subjected to an increasing number of reflow cycles. The data for the shield-PTH capacitance changes also appeared much more variable compared to the shield-over-shield data, with one board showing a much larger decrease in capacitance on all PTH-shield nets compared to the others.

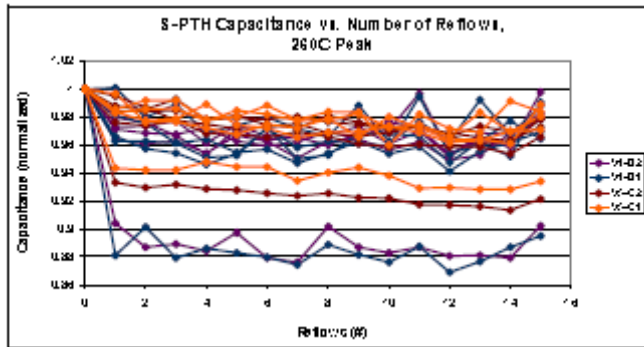
Figure 15: The relationship between the measured Shield-PTH normalized capacitance changes that occurred after 15 reflow cycles at a peak temperature of 260°C.

It was noted that the data for shield-PTH capacitance changes was extremely variable and that one board showed a significant decrease in capacitance measurements on all Shield-PTH nets. This was observed on both test structure B and C even though these structures were purportedly independent. There are several possible explanations for these abnormal results including that the capacitance measurements were taken at an elevated temperature, a shield-PTH short occurred, or the presence of extensive micro-cracking resulted in this accelerated degradation. Even with these proposed explanations this result cannot be fully explained. If the capacitance measurements happened to be taken at an elevated temperature or if it were due to extensive micro-cracking, this would have also affected the shield-over-shield measurement which wasn't the case. It is also unlikely for a short to occur in the PCB that would affect both test structure B and C simultaneously. Therefore at this point the results for the shield-PTH measurements are not clear and more data should be obtained before a conclusion can be made.

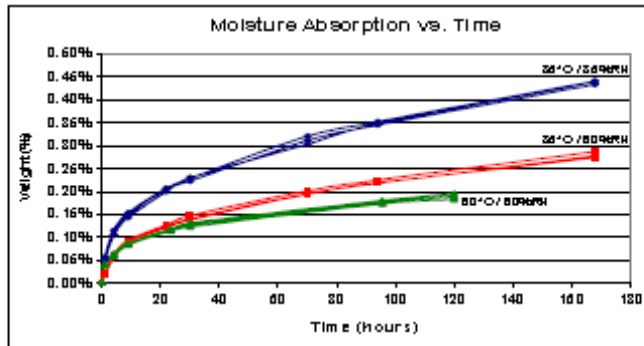
Moisture absorption was measured as the percent weight increase of the PCBs. This data was then used to measure the effect of increased moisture absorption on the capacitance of the test coupons after repeated reflows. Also, different moisture sensitivity profiles were utilized in order to observe which parameters would result in the greatest amount of moisture absorption. As shown in Figure 16, as either the relative humidity or temperature of the moisture sensitivity profile is increased, the percent weight gain by the PCBs is also increased. This is apparent because the PCBs subjected to the MSL1 profile had the largest percent weight gain of the three profiles. The MSL2 profile had a larger percent weight gain compared to MSL2a profile and since these profiles only differed by the temperature of the moisture sensitivity profile, it demonstrates that with increased temperature alone, more moisture absorption can be achieved. When subjected to any of the three conditions, the PCBs all behave the same way. There was a linear relationship between time of exposure and percent weight gain, but this began to level off as the PCBs became saturated, evident in Figure 16. Based on Figure 16, it is also clear that saturation of the PCBs began around 8 hours. When the data is represented as the percent weight gain versus the time in hours squared, a linear relationship appears as shown in Figure 17. This demonstrates that the percent weight gain is proportional to the square of the time in hours.

Figure 16: Representation of the relative moisture absorption of the boards subjected to different moisture sensitivity profiles. Increases in relative humidity and temperature both resulted in increased water absorption by the PCBs

From the data it was revealed that the 85°C/60%RH profile resulted in the greatest amount of water absorption although the precise reason why is unknown. It was also observed that test structures with PTHs showed a greater increase in capacitance for a given amount of water absorption. This difference could be due to damage that occurs during the drilling process to create the PTHs, which might result in tiny cracks or delamination that facilitated the absorptions of water. If this were the case it suggests that the assembly process for creating PTHs, not their inherent presence, accounts for the increase degradation rate that was observed.

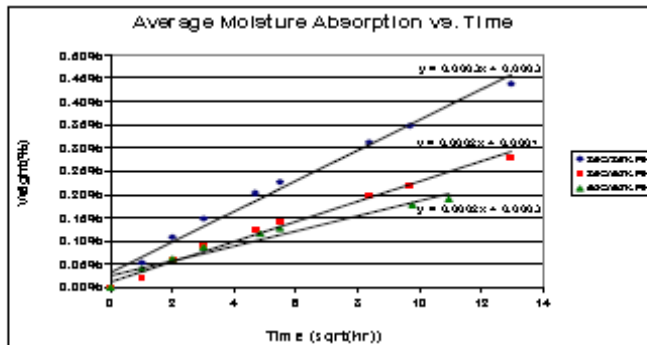
Figure 17: The plotted percent weight gain versus the time in hours squared, demonstrates that a linear relationship exists between these variables.

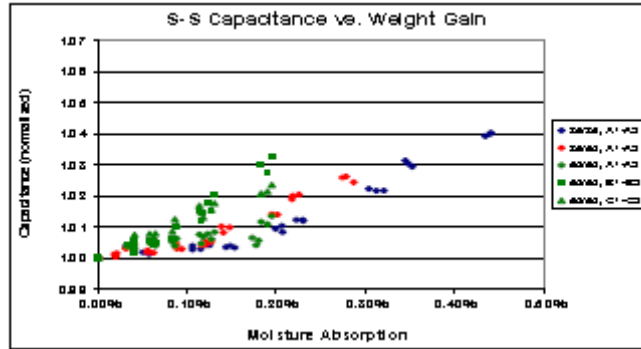
The three moisture sensitivity profiles resulted in similar changes in capacitance for all PCBs; however variation existed when comparing changes across individual test structures. The capacitance measurements of coupon sections containing only shield-over shield layers showed the smallest change with respect to moisture absorption. This relationship was observed by looking at the data from test structure A because up to approximately 0.15% weight gain, no significant changes in capacitance occurred. After this point however, the data appeared to linearize, and as percent moisture absorption increased, capacitance measurements also increased (Figure 18). The shield-over-shield capacitance in test structures B and C showed a larger increase in capacitance with respect to increased percent moisture absorption. This is apparent in Figure 19, where the 2 traces for capacitance measurements of net B1-B2 and C1-C2 show a much greater change at 0.20% moisture absorption compared to the test structure A. The PTH-shield results were much more variable and although it is apparent that a larger change in capacitance resulted relative to the percent of moisture absorption, no clear trend in the data for these test structures exists (Figure 19).

Figure 18: The normalized shield-over-shield capacitance is measured with the respect to the about of moisture absorption. As moisture absorption increases so does the increase in capacitance.

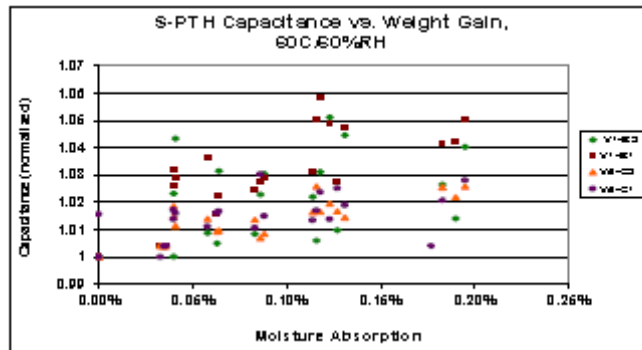
Figure 19: Normalized shield-PTH capacitance vs. weight gain for the MSL2 a moisture sensitivity profile. Capacitance measurements were obtained for both test structures B and C.

The relationship between shield-PTH capacitance and moisture absorption produced no clear trend. However there was a clear difference between test structure B and C when comparing this data across the same level of moisture exposure. It was shown that test structure B generally showed a greater increase in capacitance and then a subsequent greater decrease in capacitance after repeated reflows. Moisture exposure also caused the boards to degrade much faster during reflow cycling compared to boards which were not subjected to moisture exposure. This is supported by comparing the data from phase 1, which showed approximant 1% degradation in capacitance of test structure A after 15 reflows to samples from phase 2, which showed a comparable decrease in capacitance after about 3 reflows. This trend was also observed in all Shield-over shield and shield-PTH nets. The results of these experiments lead to the conclusion that the changes in capacitance that occurred after each reflow was due to material degradation and not an increase in resistance due to oxidation. However to further prove this; contact resistance should be quantified through ESR measurements in the next round of testing. Also the differences in degradation rates between test structures B and C, due to the presence of nonfunctional pads, is very interesting. This difference should be further characterized by focusing on the clearance and pad dimensions of future board designs. Overall this study was successful in characterizing the effect of heat and moisture exposure on the degradation of different PCBs and although it helped answer some of the questions regarding this process it also exposed new ones which will continue to guide future studies.

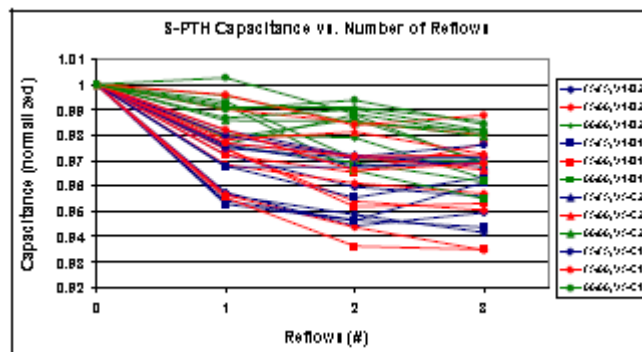
The normalized capacitance changes from phase 1 were noticeably less compared to the capacitance changes in the boards exposed to the moisture profiles in phase 2. This is true even when the boards were subjected to fewer reflow cycles. Within this subset of data, the same trends observed earlier regarding the different test structures were also observed. Test structure A showed the smallest change in capacitance measurements while test structure B had the greatest. This suggests that the presence of PTHs increases the rate of degradation and that shielded PTHs consistently perform worse than unshielded PTHs. This data also suggests that a difference in the capacitance changes exists because of the different moisture sensitivity profiles the PCBs were exposed to. The 60°C/60%RH profile had the smallest measured degradation and it was also the profile with the lowest temperature and RH value. The higher temperature profiles resulted in more moisture gain and a larger increase in capacitance before being subjected to reflow testing. However when this data was normalized, the PCBs also demonstrated a greater decrease in capacitance after repeated reflows (Figure 20). With all conditions, the PTH-shield capacitance measurements degraded quicker compared to shield-over-shield capacitance measurements (Figure 21). The same trend in the moisture sensitivity profiles was seen when testing shield-PTH capacitance, with MSL2a showing the least amount of degradation compared to the other two profiles. The data suggests that when PTHs are present the temperature of the profile becomes more of a factor in the amount of degradation that occurs.

**Figure 20: Shield-over-shield capacitance vs. number of reflows after being subjected to the respective moisture sensitivity profiles including MSL1, MSL2 and MSL2a. Capacitance was measured for test structures A, B and C.**

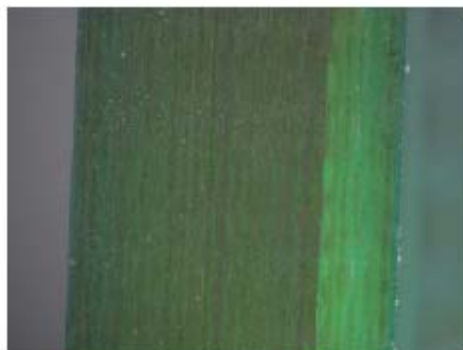
Besides the discussed changes in capacitance that occurred as a result of moisture exposure and repeated reflows, delamination was visible evidence for PCB degradation (Figure 22). Delamination was only observed in featureless areas (see Figure 23) and evidence for delamination was only observed in PCBs subjected to moisture sensitivity profile MSL1. This profile had both the highest temperature and highest relative humidity, resulting in the largest percent weight gain in the PCBs. No visible delamination occurred in the MSL2 or MSL2a profile nor in any of the “dry samples” from phase one, which suggests that increases in moisture content facilitates the process of delamination in these PCBs.

**Figure 22: Delamination observed in cross-section of a test coupon subjected to MSL1 exposure (85°C/85RH) and subjected to 3 reflows at a peak temperature of 260°C**
