# MICROSTRUCTURE AND RELIABILITY OF LOW AG, BI-CONTAINING SOLDER ALLOYS

Eva Kosiba, Simin Bagheri, Polina Snugovsky, Ph.D.  
Celestica Inc. Toronto,  
ON, Canada

## ABSTRACT:

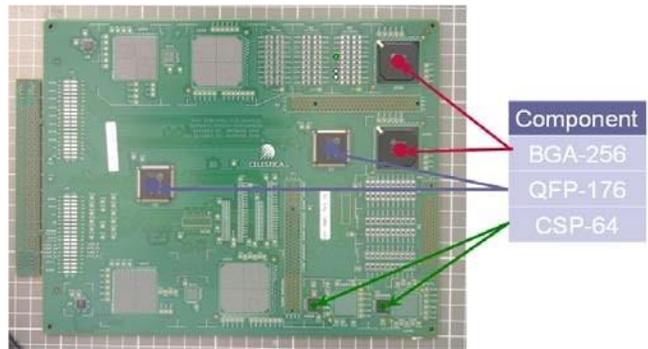
**Figure 1:** Test Vehicle used for ATC

It is a 12 layer 0.093" thick board with an organic solderability preservative (OSP) finish. It measures 8"x10". Two different board materials were used in this study: a high  $T_g$  board material 170°C and a low  $T_g$  board material 140°C. The following components were included on this test vehicle and monitored throughout the ATC: PBGA256, LQFP176 and CSP64. The PBGA256 was made up of SAC305 solder balls and the LQFP176 had a matte Sn finish on the leads. Figure 1 shows a RIA3 board populated with the above mentioned components.

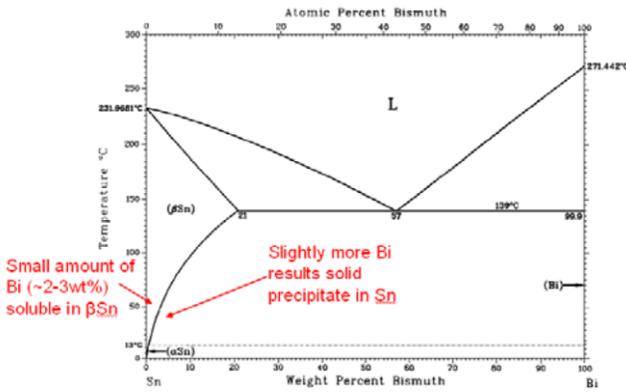
**Figure 2:** Sn-Bi Phase Diagram

The Bi content selected for the alloys falls within two categories; a small amount which remains dissolved in  $\beta$ -Sn and a slightly higher amount of Bi which is likely to precipitate out of the  $\beta$ -Sn as shown in Figure 2. While the primary motivation for including Bi in an alloy is to reduce the melting temperature, it is also believed that the presence of Bi in a minimal quantity will mitigate the formation of Sn whiskers.

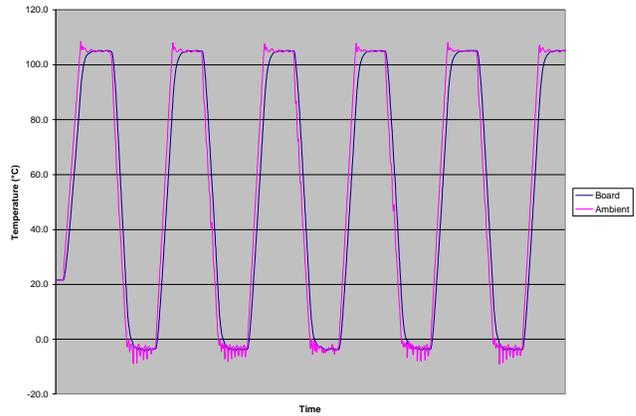
**Figure 3:** ATC Profile

A total of 35 test vehicles, including various alloy and board material combinations, were exposed to ATC as per Table 2. The ATC was performed to a target of 0°C to 100°C with a ramp rate of approximately 10°C /minute with a minimum soak time of 10 minutes. Figure 3 shows a sample of the ATC profile used in this test; the pink line represents the ambient temperature of the oven and the navy line represents the temperature as measured at the center of a board.

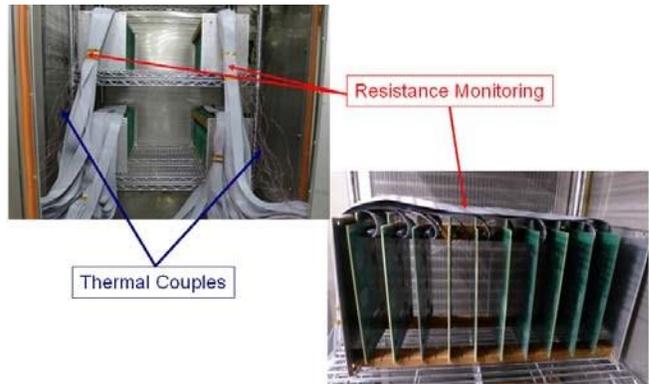
**Figure 4:** ATC Chamber Set Up

Figure 4 shows the cards inserted into fixtures and monitored from within the ATC chamber.

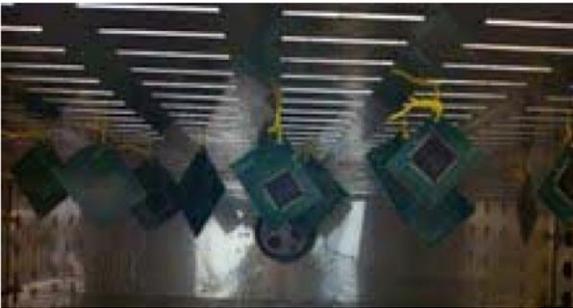
Figure 5: 85°C/85% RH Whisker Testing

Two QFP assembled with each of the four alloys (3 new alloys plus SAC305) were placed in a temperature humidity chamber set to 85°C and 85%RH. After 1000 hours the samples were removed and inspected, using a VP SEM, for the presence of whiskers. When not being inspected, the samples were stored in a nitrogen dry box. Where whiskers were found, the length and an estimate of quantity were recorded. Figure 5 shows the samples within the test chamber. The QFPs were selected for testing as they are known to produce whiskers. These are fine pitch components (0.4mm) with a copper lead frame and matte Sn finish.

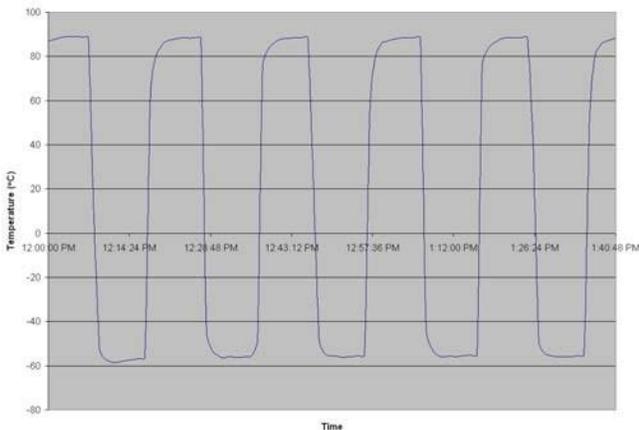
Figure 6: Thermal Shock Profile for Whisker Testing

Two QFP assemblies with each of the four alloys was also tested using thermal shock as specified in JESD201A from 55°C to 85°C air-to-air with a 10 minute soak. The samples were exposed to approximately 1600 cycles with a profile shown in Figure 6.

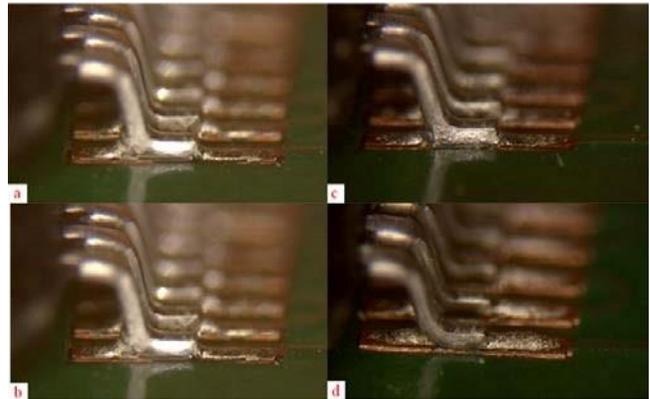
Figure 7: Solder Wetting to OSP Finish a)SAC305 b)Kester c)Sunrise d)Sunflower

Figure 7 illustrates the wetting properties of the four tested alloys. Picture d shows Sunflower – the no-Ag alloy has significantly poorer wettability as compared to the other, Ag containing alloys. All alloys did however pass a preliminary study of printability and wettability within a manufacturing setting.

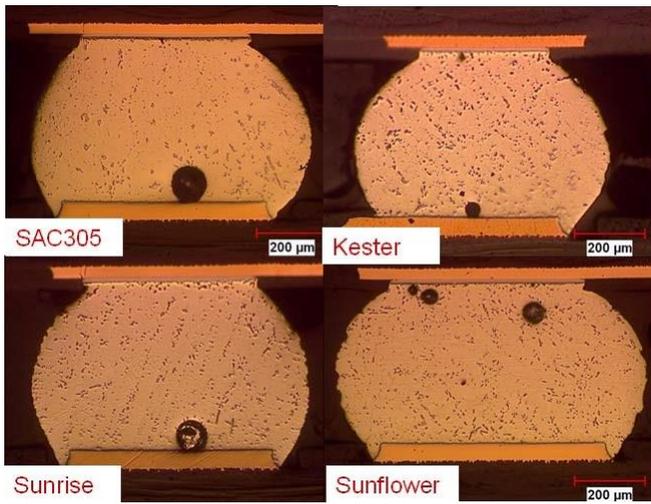
**Figure 8:** BGA Solder Joints after 3000 cycles ATC

After 3000 cycles of ATC exposure, the majority of the BGA solder joints remained completely intact as seen in Figure 8. There were however a number of BGA solder joints which showed signs of crack formation, as in Figure 9. This figure shows the crack initiating near the top of the solder joint in the region where stresses are concentrating. The stresses are generated from a number of sources including the difference in coefficient of thermal expansion between the interface materials, the growth of the brittle IMC layer caused by continuous thermal cycling and possibly by microstructural coarsening and recrystallisation in the thermally stressed region.<sup>8</sup> The IMC layer is both more brittle than the bulk solder material, and exhibits different thermal conductivity properties.

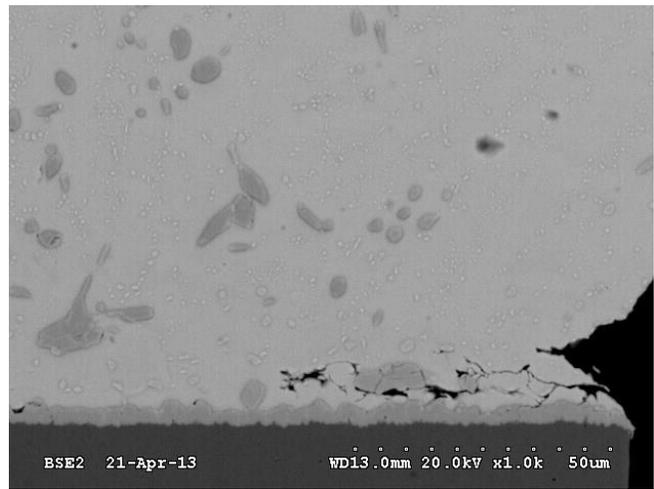
**Figure 11:** SEM Image (BSE) of Thermal Fatigue Crack Propagating Near Board Side IMC (Kester Alloy)

As illustrated in Figure 11, thermal fatigue cracks also formed near the board side IMC in the BGA components.

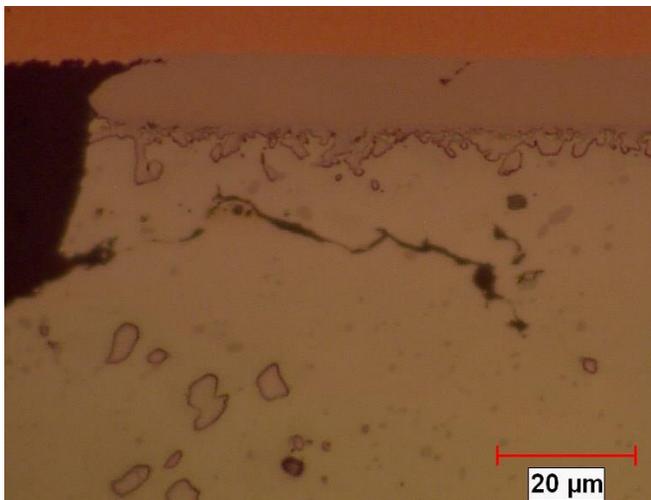
**Figure 9:** Optical Image of Incomplete Crack Propagating Through Solder Joints after 3000 hours ATC (Sunflower Alloy)

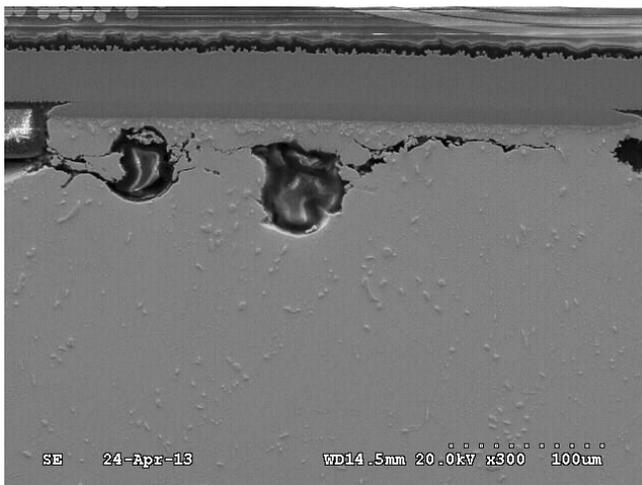
**Figure 10:** SEM Image of Incomplete Crack Propagating Through Solder Joint after 3000 hours ATC, near board side IMC (Sunrise Alloy)

Figure 10 shows a thermal fatigue crack which has propagated almost entirely across a solder joint.

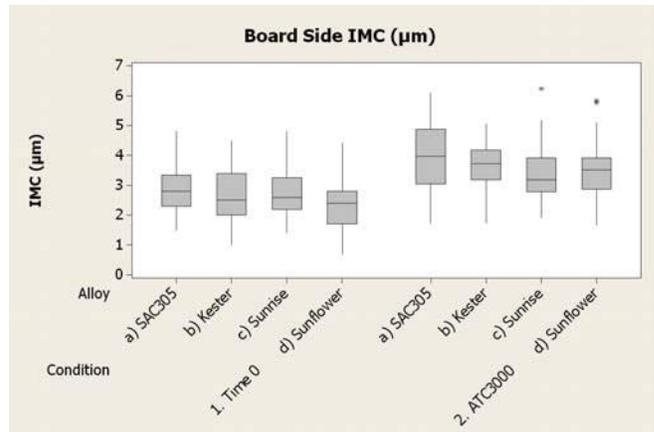
**Figure 12:** Plot of BGA Board Side IMC for Time Zero and after 3000 cycles ATC

The IMC which forms between the component and the copper pad on the board, referred to is the board side IMC contains the  $Cu_3Sn$  and  $Cu_6Sn_5$ . At Time 0, there was very little variation in the size of the Board Side IMC amongst the various alloys as shown in Figure 12. After 3000 cycles of ATC exposure however, it appears that the IMC attach layer grew in all samples.

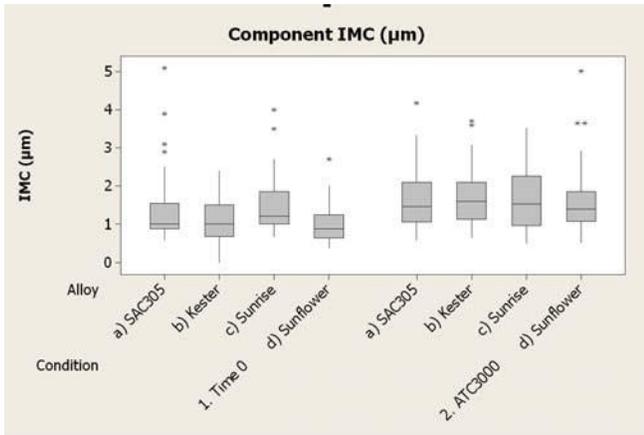
**Figure 13:** Plot of BGA Component Side IMC for Time Zero and after 3000 cycles ATC

The IMC which forms between the component body and the solder ball did showed the same tendency. In this case, IMC was formed between the solder alloy (mix of SAC305 solder ball and paste alloy) and the Ni interface. While there was an increase in the average size of the IMC after 3000 cycles of ATC exposure, it did not show any variation between the different alloys. This is illustrated in Figure 13.

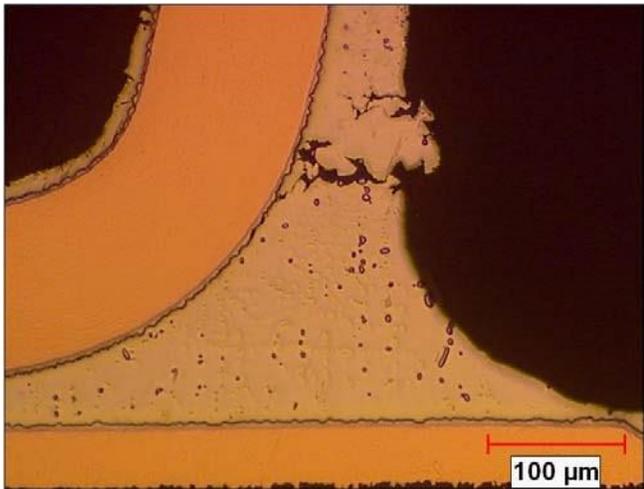
**Figure 14:** QFP after 3000 cycles ATC showing Thermal Fatigue Crack formation (Kester Alloy)

The QFPs showed similar crack formation as the BGAs. These thermal fatigue cracks did not lead to any component failures after 3000 cycles, but were present and were propagating along the IMC layer formed with the component lead. Figure 14 and Figure 15 show typical examples of crack propagation through the QFP solder joints.

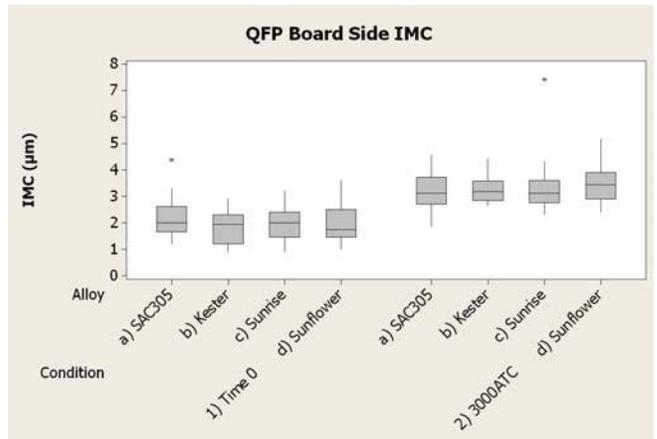
**Figure 16:** Plot of QFP Board Side IMC for Time 0 and after 3000 cycles ATC

A comparison of the IMC layers formed on the QFP components was also performed. This data is of interest because it looks at solder joints which are composed of approximately 100% solder paste alloy. Despite this fact, the IMC layer formed follows the same pattern as for the BGA components, there was an overall increase in the size of the IMC layer from the time 0 samples to the end of the 3000 cycles of ATC, however there was no significant difference between SAC305 and the other alloys. This can be seen in Figure 16 and Figure 17.

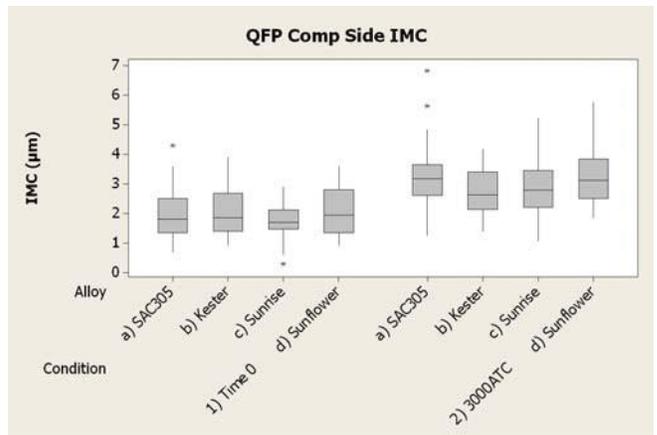
**Figure 17:** Plot of QFP Component Side IMC for Time 0 and after 3000 cycles ATC
