SERDP Tin Whisker Testing and Modeling: High Temperature/High Humidity Conditions

Stephan Meschter^{*}, Polina Snugovsky[#], Jeff Kennedy[#], Zohreh Bagheri[#], Eva Kosiba[#], and
Andre Delhaise^{##}

ABSTRACT

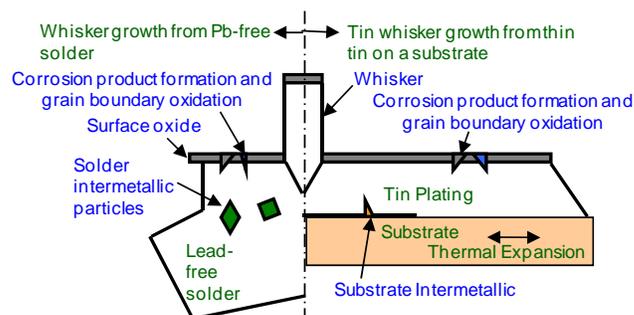
Figure 1: Sources of compressive stress contributing to whisker growth.

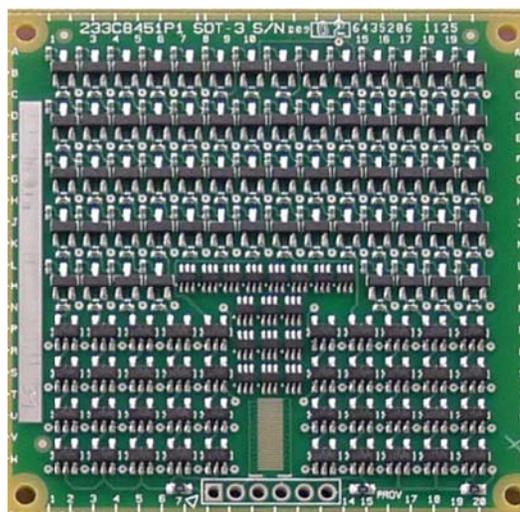
Figure 3: Test vehicle.

The test variables are given in Figure 2. The custom designed test board used for the lead-free soldered assembly whisker growth testing is shown in Figure 3 and the parts are summarized in Table 1. The printed circuit

board is a 6 cm x 6 cm x 2.36 mm thick double sided glass epoxy board with 1 ounce copper external base layers. The board surface finish is immersion tin. The test vehicles fit easily into the scanning electron microscope (SEM) sample chamber. The part placement area was limited to 5 cm x 5 cm to ensure all leads of interest were contained in a region that could be viewed by the SEM. Each board is designed with enough parts to have 50 to 100 leads for each part type.

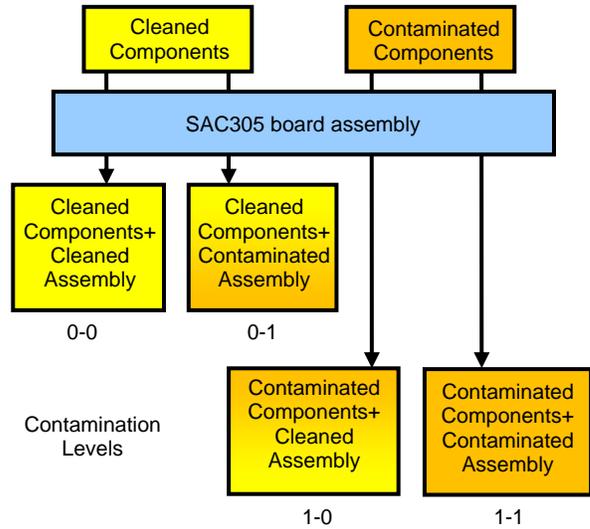
Figure 5: Experiment contamination levels

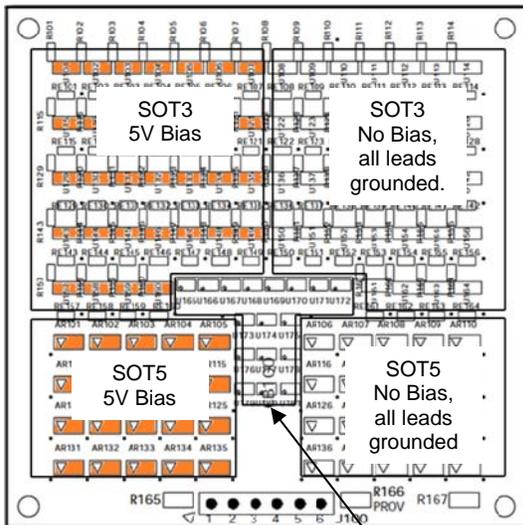
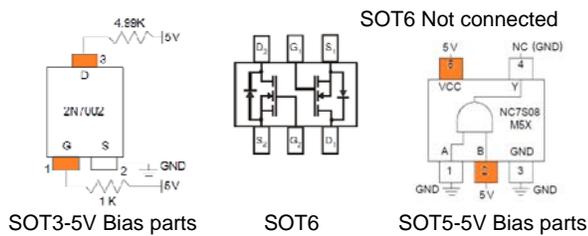
Figure 4: Electrical schematic

The electrical schematic for the test vehicle is shown in Figure 4. The SOT3 and SOT5 parts on the left half of the board are connected to 5V and on the right half are connected to ground. The SOT6 parts are not connected. The board current draw was 31 mA resulting in only 155 mW power dissipation with negligible self heating. There are two bias parameters used to define the voltage state on the parts (bias1) and leads (bias2). All SOT6 parts and pins are no-connects so bias1 is zero and bias2 is zero. For the SOT3 and SOT5 parts that are grounded (V=0), bias1 is zero. Since the grounded SOT3 and SOT5 parts have all leads connected to ground (0V), all leads are assigned a bias2 of zero. For the parts with power applied in accordance with the schematic, bias1 is five. For the powered parts, the leads SOT3-1, SOT3-3, SOT5-2 and SOT5-5, bias2 is five and for the remaining leads bias2 is zero.

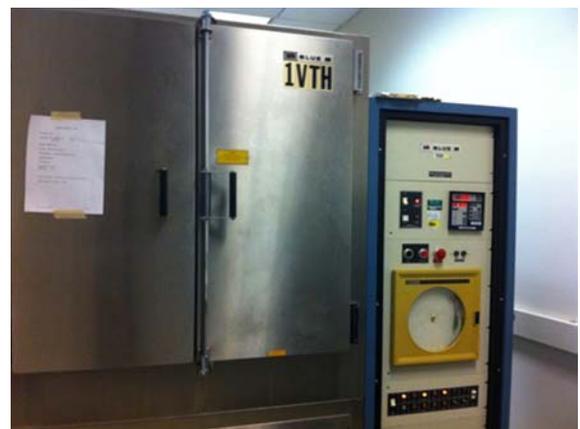
Figure 6: Temperature/humidity chamber

Three board replicates were tested at 85 °C/85 percent relative humidity in the chamber shown in Figure 6. The temperature control was performed using thermocouples and humidity was controlled using both dry bulb temperature and wet bulb temperatures. A sheet metal shield was placed above the samples to ensure no condensation would collect on the samples. As shown in Figure 7, the samples were hung in a vertical position

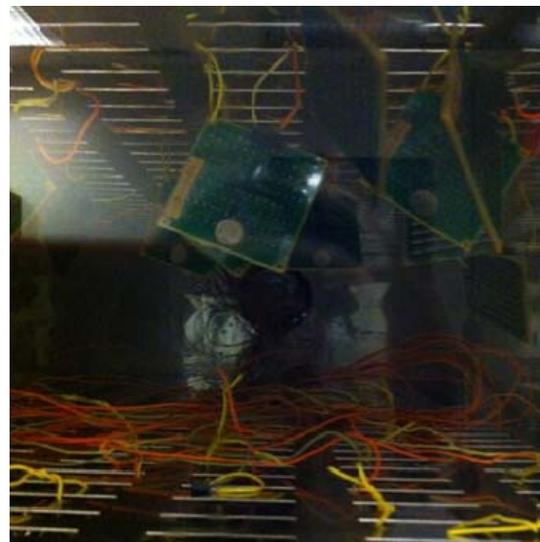
Figure 7: Sample orientation in the test chamber

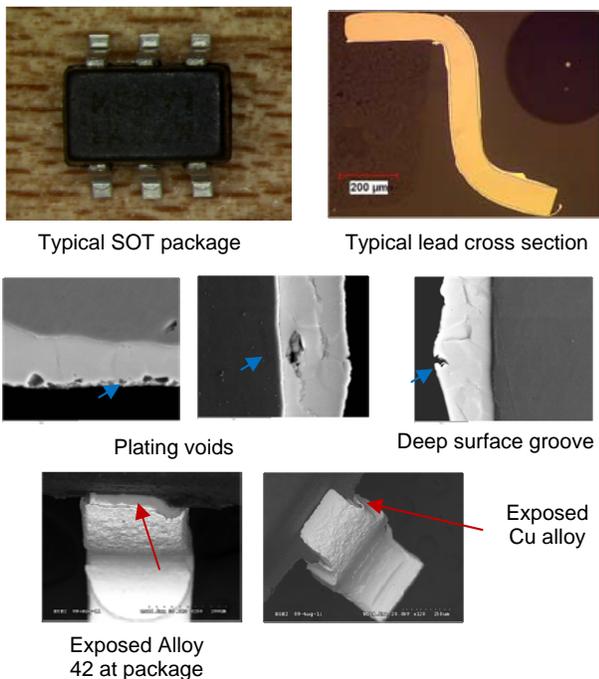
Figure 8: SEM and optical images of as-received part lead conditions contributing to whisker growth.

Summarizing the details previously reported [4], there were no significant anomalies in the plating that would influence assembly solder joint quality. However as shown in Figure 8, some lead conditions exist that would increase whisker risk such as exposed base metal that increases galvanic corrosion potential and plating features that could trap contamination and increase corrosion induced whiskering.

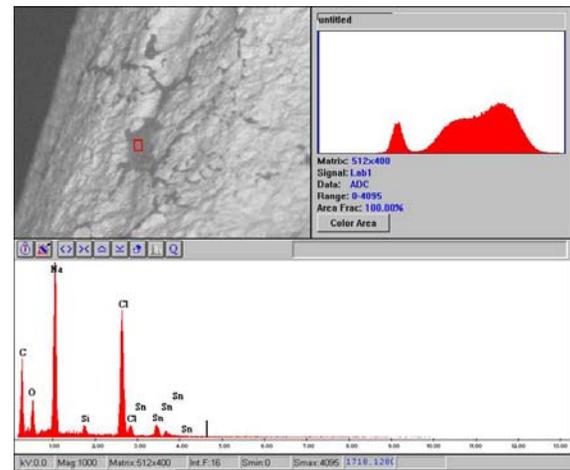
Figure 9: Contamination regions on recontaminated SOT5.

The part and assembly cleaning and contamination were done at the same time as was previously reported [4]. The cleaned part contamination levels are given in Table 2. The contamination levels of the purposely contaminated parts are shown in Table 3. The goal was to have the part level contamination equal to $3.0 \mu\text{g}/\text{in}^2$ Cl, but more contamination was trapped by SOT5 and SOT6 because they had rougher lead surfaces and greater numbers of gaps than the SOT3s. The contamination segregated on the tin surface to the rough regions, grain boundaries and plating gaps (see typical view in Figure 9).

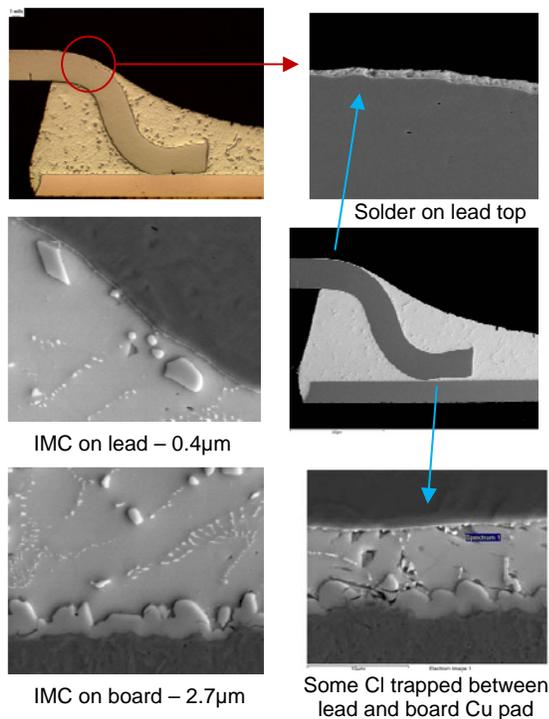
Figure 10: SEM and optical images of the SOT3 soldered assembly cross-section.

After soldering, the solder coverage and intermetallic compounds were characterized using cross-sectioning [4]. As shown in Figure 10, Figure 11 and Figure 12, the SOT3 and SOT6 leads were fully covered in solder, but the SOT5 leads were not. The thinnest intermetallic was observed on the alloy 42 leads. The SOT3 part was found to have Cl trapped at the thinnest part of the joint between the lead and Cu pad.

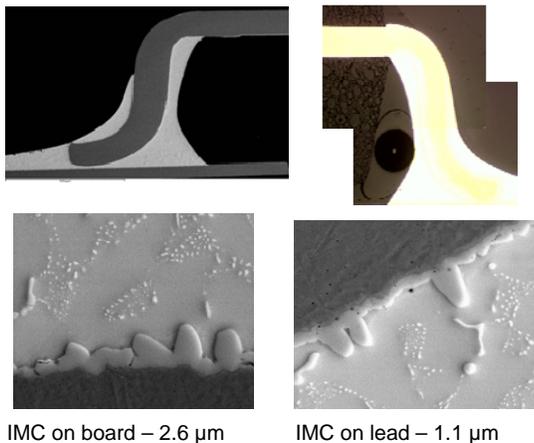
Figure 11: SEM and optical images of the SOT5 soldered assembly cross-section.

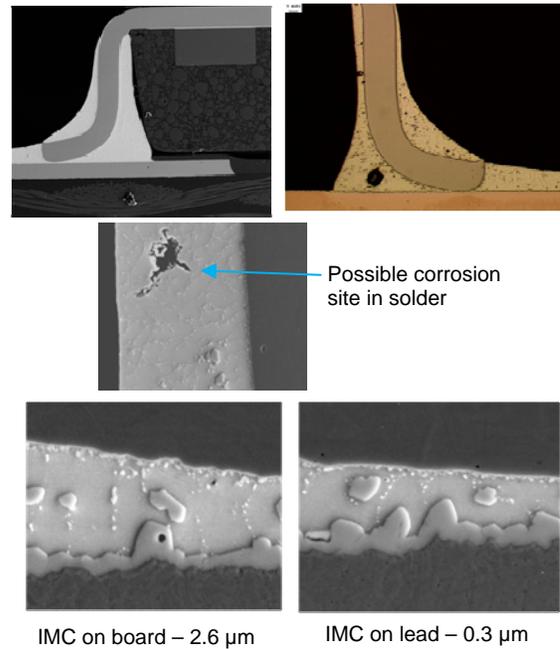
Figure 12: SEM and optical images of the SOT6 soldered assembly cross-section.

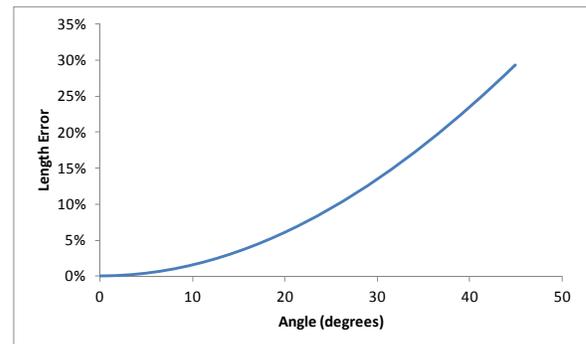
Figure 13: Whisker measurement error estimate.

In the present work, the reported whisker length measurements are conservative. During the length measurement procedure, the SEM inspection azimuth axis was adjusted to be aligned to within ~30 degrees from perpendicular to the whisker. The SEM axis misalignment from the whisker normal results in a potential whisker length under-reporting of up to 15 percent as shown in Figure 13.

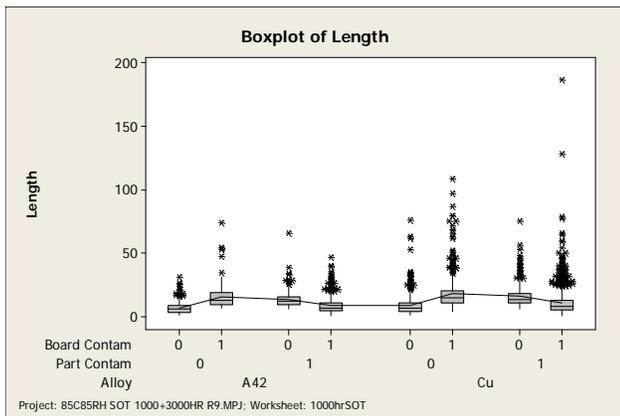
Figure 14: Box plot of whisker lengths after 1,000 hours at 85 °C/85 percent relative humidity broken down by lead alloy, part contamination, and board contamination levels (Note: Bias2=0).

A total of 15,564 whiskers were counted and 4,741 whiskers were measured (see Table 4 - Table 7). The whisker lengths were longer for copper than alloy 42 lead materials (see Figure 14). The longest whiskers were: SOT3 – 74 microns, SOT5 – 186 microns and SOT6 – 54 microns. As shown in Figure 15 and Figure 16, the majority of the whiskers grew from the thin solder fillet regions that were 3 to 25 microns thick near the printed circuit board copper pad and many were kinked.

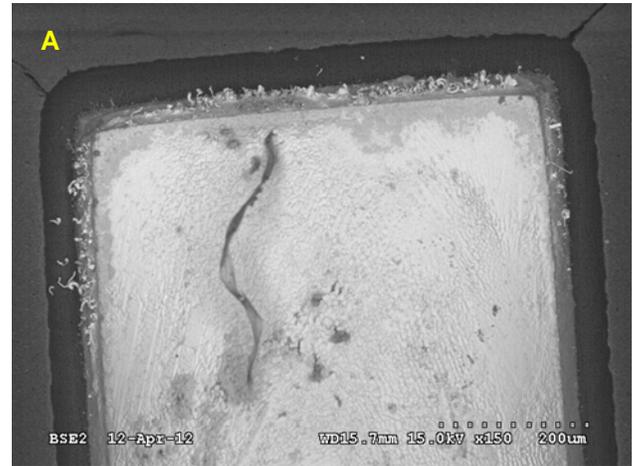
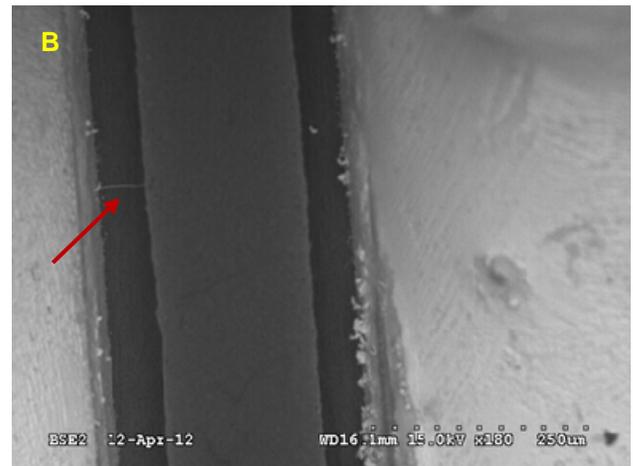
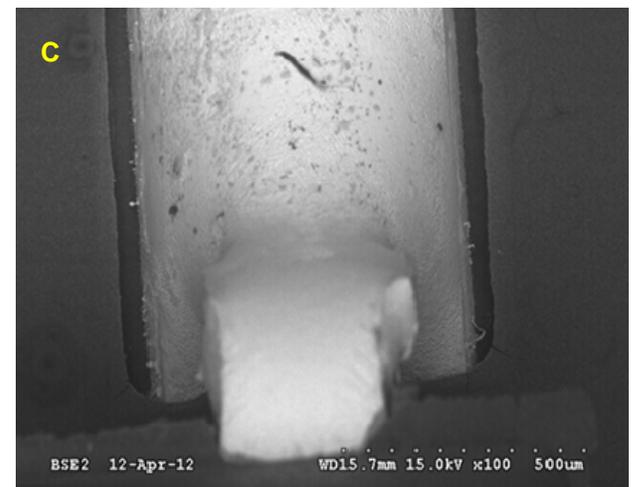
Figure 15: SEM images of copper lead frame SOT5 part with a 1-0 contamination level after 1,000 hours at 85 °C/85 percent relative humidity; (A) toe, (B) side, and (C) heel region of a typical solder joint. In (B), an arrow indicates the location of a lone straight whisker along the edge.

The majority of the whisker growth was observed on the sides of the board pads. The majority of the whiskers grow from SAC solder that has flowed around the board pad. The solder thickness in this region is 3 to 25 microns thick. Figure 15 and Figure 31 shows representative whisker growth from the board pad edge when a copper lead is present with a 1-0 and a 1-1 contamination level. These whiskers are similar to those formed when an alloy 42 lead is present (see Figure 32).

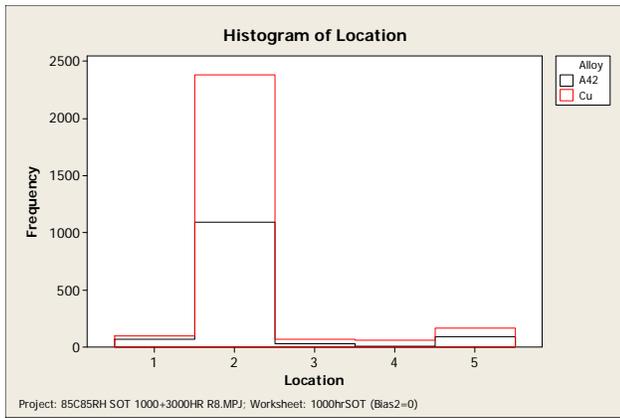
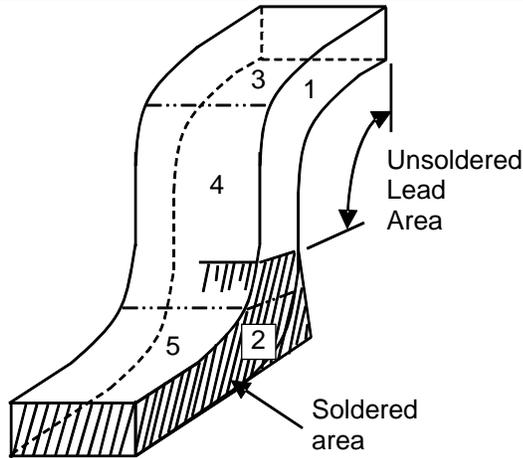
Figure 16: Whisker locations after 1,000 hours at 85 °C/85 percent relative humidity; histogram (top) and location definition (bottom)

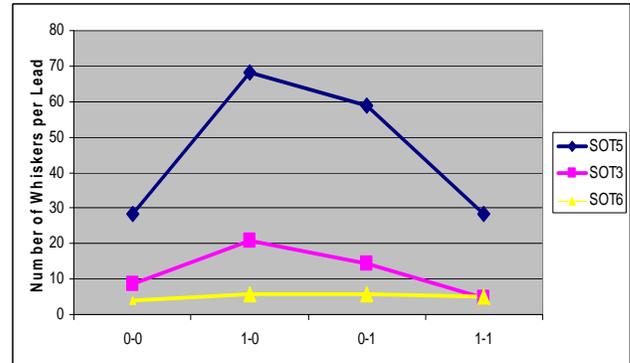
Figure 17: Whiskers per lead after 1,000 hours at 85 °C/85 percent relative humidity for various contamination levels. The SOT5 device has copper leads and the SOT3 and SOT6 devices have alloy 42 leads.

Lead material and contamination had the most significant influence on whiskering. The number of whiskers per lead was greater for the copper leads than the alloy 42 leads for all contamination levels (see Figure 17). The whisker density and whisker length depended upon contamination level. The intermediate 0-1 and 1-0 (part-board) contamination levels exhibited the greatest whisker density and longest 50th percentile whisker length (see Figure 17, Figure 18 and Figure 19). However, for the copper leads, the longest whiskers were observed with the 1-1 contamination level.

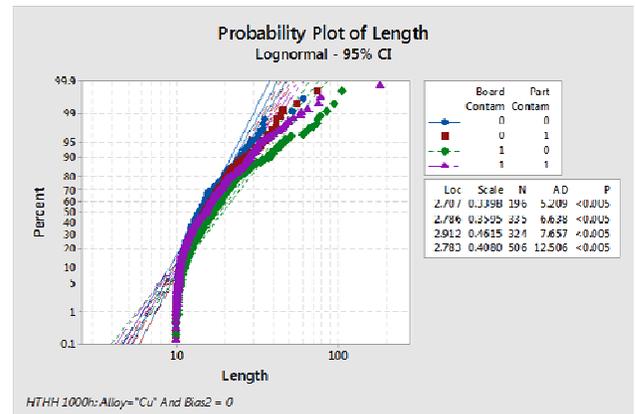
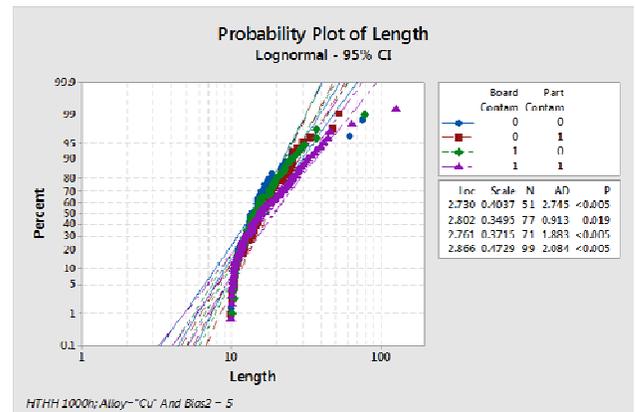
Figure 18: Probability plot of tin whisker lengths longer than 10 microns from copper part lead terminations after 1,000 hours at 85 °C/85 percent relative humidity; bias2= 0 (top) and bias2 =5 (bottom) levels broken down by part contamination, and board contamination.

The lognormal curve fit [16][17][18] seem to represent many of the whiskers length distributions reasonably well. Unfortunately some of the longest whiskers did not seem match the lognormal characteristic of the shorter whiskers [19].

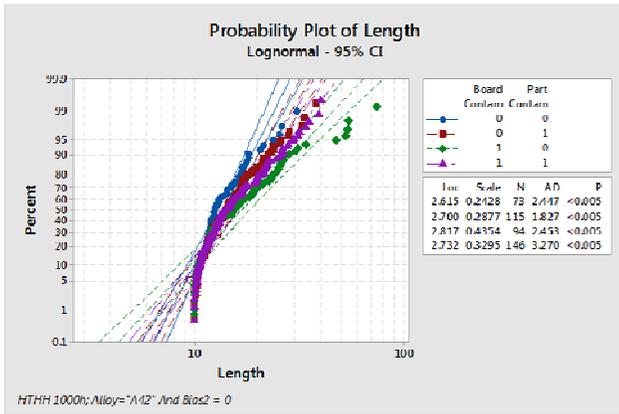
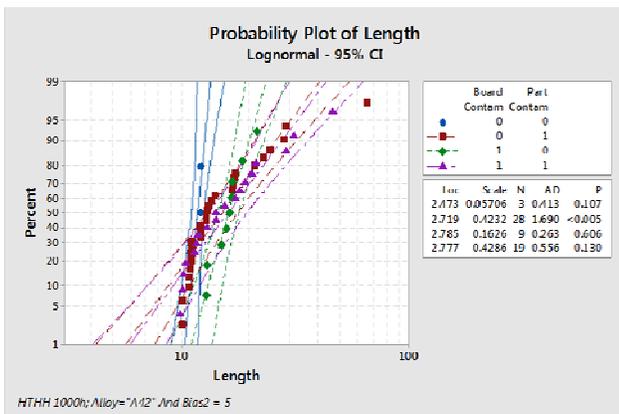
Figure 19: Probability plot of tin whisker lengths longer than 10 microns from alloy 42 part lead terminations after 1,000 hours at 85 °C/85 percent relative humidity; bias2=0 (top) and bias2=5 (bottom) levels broken down by part contamination, and board contamination.

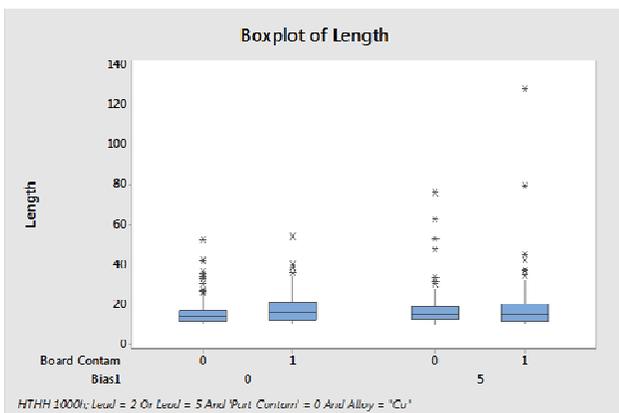
Figure 20: Box plot of tin whisker lengths longer than 10 microns from copper part lead terminations after 1000 hours showing the effect of board contamination and bias1 with no part contamination.

Regarding bias voltage, there was no appreciable change in whisker length with applied bias (see Figure 20 through Figure 23). Since the contamination levels were low enough to ensure that there would be no dendrite formation risk, the electrochemical bias effect may not significantly influence whiskering.

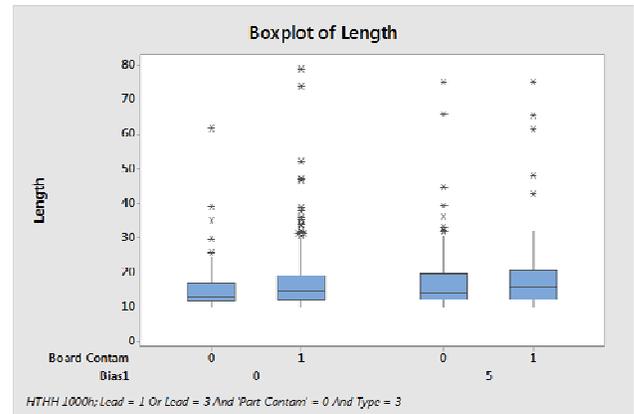
Figure 21: Box plot of tin whisker lengths longer than 10 microns from alloy 42 part lead terminations (SOT3 device) after 1000 hours showing the effect of board contamination and bias1 with no part contamination

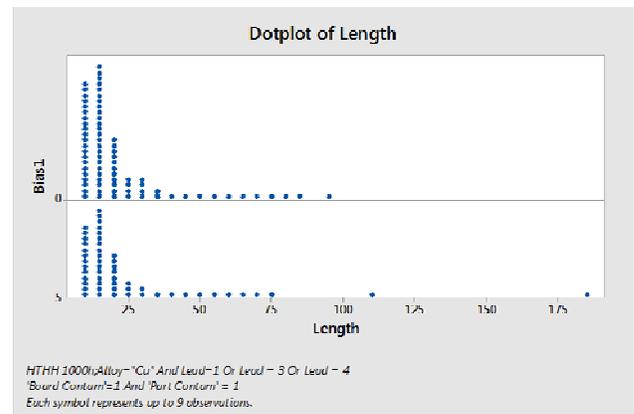
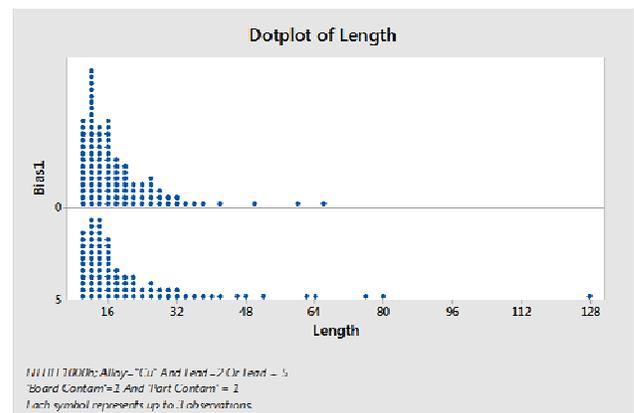
Figure 22: Dot plot of whisker lengths longer than 10 microns from copper part lead terminations (SOT5) at a 1-1 contamination level after 1,000 at 85 °C/85 percent relative humidity; ground leads (top) and 5V leads (bottom) with and without 5V part bias applied (e.g. bias1=0 and 5).

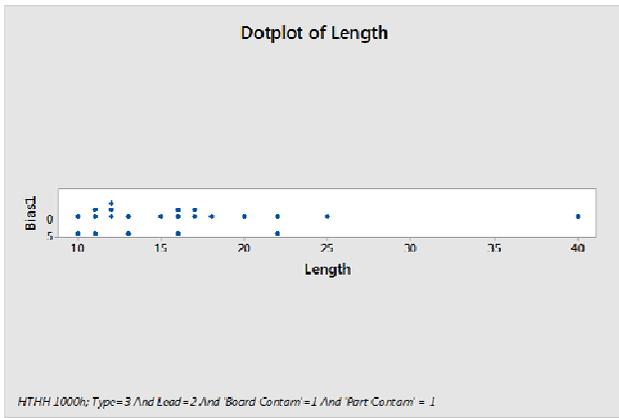
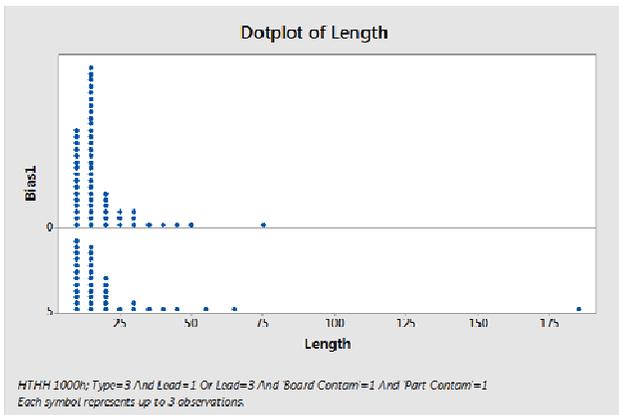
Figure 23: Dot plot of whisker length for alloy 42 leads (SOT3) at a 1-1 contamination level after 1,000 at 85 °C/85 percent relative humidity; ground leads (top) and 5V leads (bottom) with and without 5V part bias applied (e.g. bias1=0 and 5).

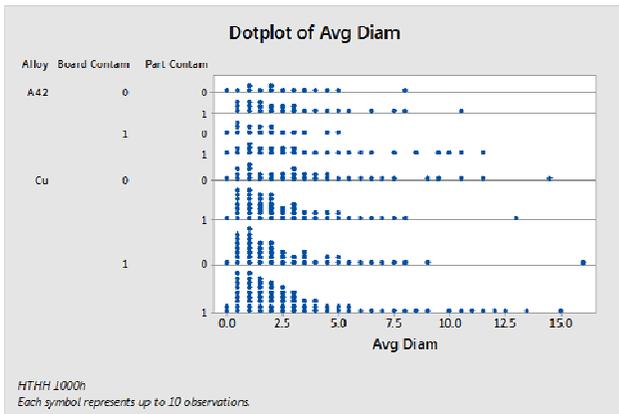
Figure 24: Dot plot of whisker diameter of whiskers longer than 10 microns after 1,000 hours at 85 °C/85 percent relative humidity broken down by lead material, part contamination and board contamination.

As far as whisker diameter is concerned, as shown in Figure 24 and Figure 25, the majority of whiskers were between 1 and 5 microns regardless of alloy or contamination level. In addition, the longer whiskers tended to be smaller in diameter while the largest diameter whiskers tended to be short.

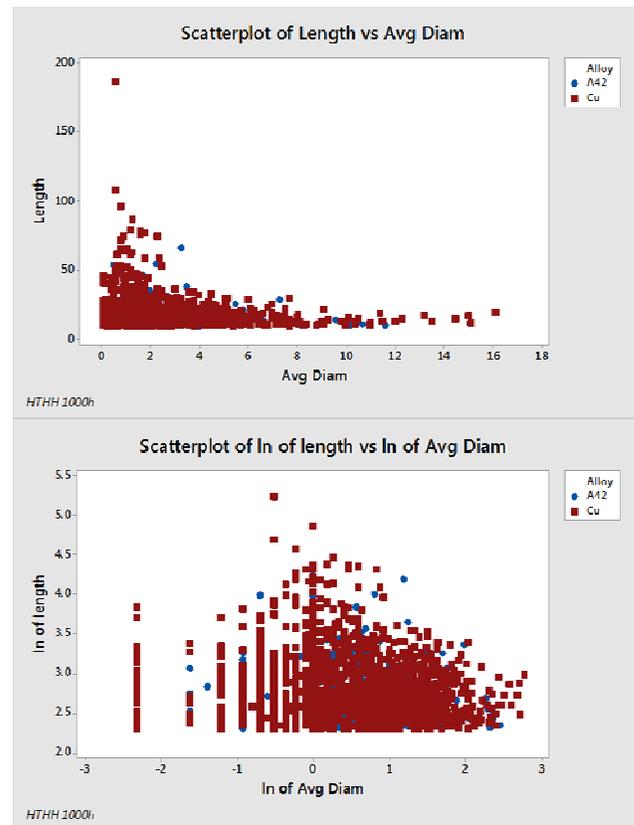
Figure 25: Scatterplot of whisker length versus diameter of whiskers longer than 10 microns for copper and alloy 42 leads after 1,000 at 85 °C/85 percent relative humidity. Bottom image shows the ln(length) versus ln(diameter) plotted.

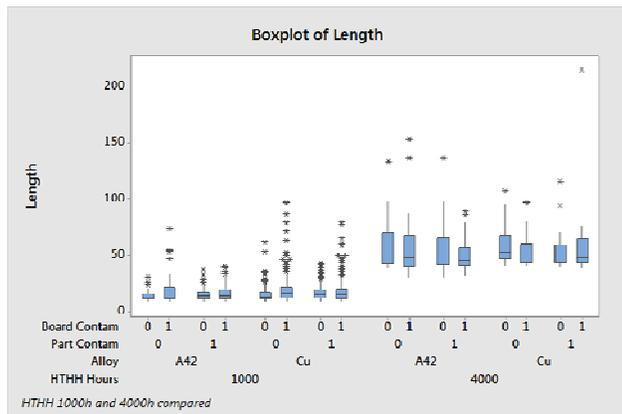
Figure 26: Box plot of whisker length showing the difference between 1,000 and 4,000 hours at 85 °C/85 percent relative humidity. Only whiskers longer than 40 microns were measured in the 4,000 hour data set.

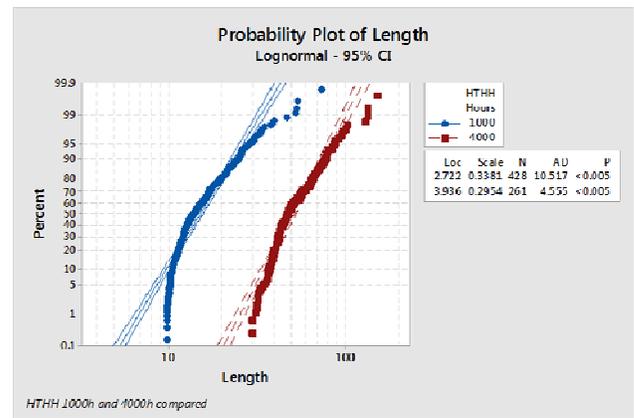
Figure 27: Probability plot of comparing whisker lengths after 1000 hours and 4000 hours at 85 °C/85 percent relative humidity. The 1000 hour data includes whiskers longer than 10 microns and the 1000 hour data includes whiskers longer than approximately 40 microns.

The longest whiskers were: SOT3 – 142 microns, SOT6 – 153 microns, and SOT5 - 214.6 microns. Note that for the 4,000 hour inspection interval, no whiskers shorter than 30 microns were measured in an effort to focus inspection resources on the longest whiskers. The individual value plot in Figure 26 shows that more “whiskers longer than 40 microns” and longer whiskers were observed after 4,000 hours as compared to 1,000 hours. As with the 1,000 hour observation, copper leads grew longer whiskers than alloy 42 leads. The probability plot shown in Figure 27 compares the whiskers observed at 1,000 and 4,000 hours. The lognormal location and scale parameter vary considerably. The box plot of whiskers per lead

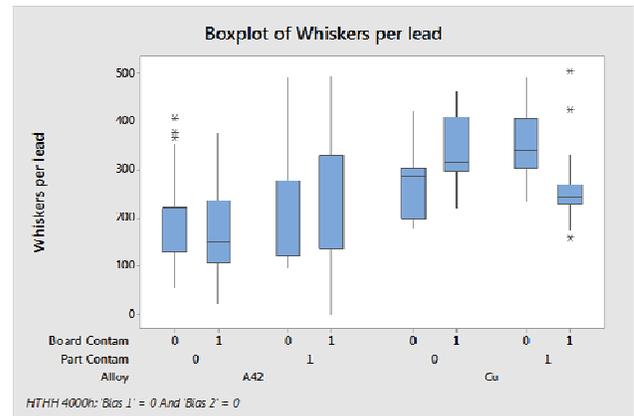
Figure 28: Box plot of whiskers per lead after 4,000 hours at 85 °C/85 percent relative humidity broken down by lead alloy, part contamination and board contamination.

shown in Figure 28 indicates that the mean number of whiskers per lead was greater with the copper leads.

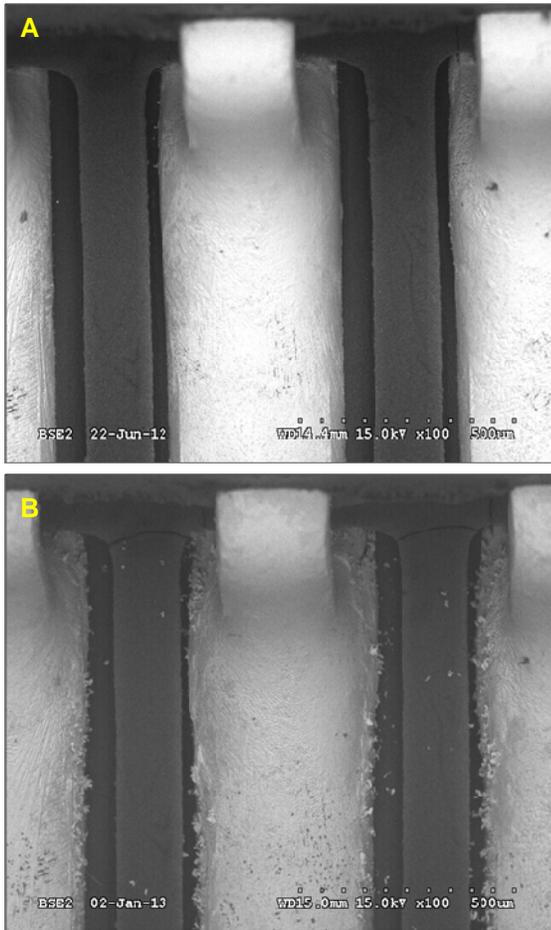
Figure 29: SEM images of an alloy 42 SOT6 at a 0-0 contamination level, U65, lead 4 (A) 1,000 hours and (B) 4,000 hours at 85 °C/85 percent relative humidity.

Another consideration in the whisker growth process is whisker nucleation time. If a long time is required to nucleate the whiskers, then the fraction of time that they are growing is reduced. Figure 29 reveals that more than 1,000 hours was needed for whisker nucleation with the alloy 42 lead in the 85 °C/85 percent relative humidity environment with SAC305 solder.

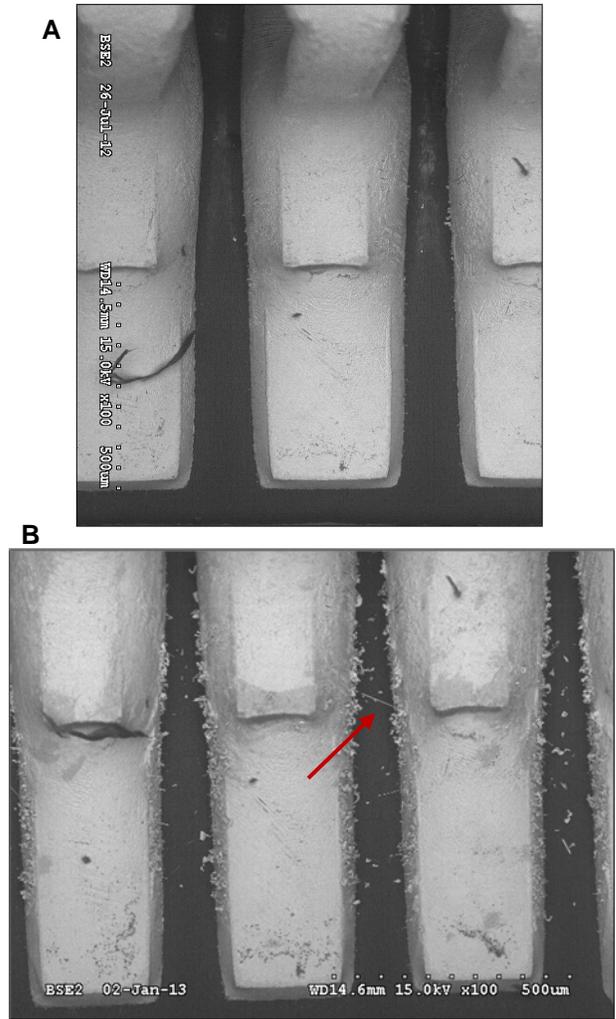
Figure 30: SEM images of a copper alloy lead 64 pin quad flat pack (QFP64 U08, lead 28) with a 0-0 contamination level after (A) 1,000 hours and (B) 4,000 hours at 85 °C/85 percent relative humidity. Arrow indicates a broken whisker that has nearly bridged between the printed wiring board pads. (Practical Components part number LQFP64 A-LQFP64-.7mm-.4mm-2.0-DC-Sn (0.4 mm pitch) C7025 Lead composition: Cu2.2-4.2Ni0.25-1.2Si0.05-0.3Mg).

Another important consideration is that other copper leaded parts included in the humidity test also have exhibited significant whisker growth at the 4,000 hour inspection interval. While not part of the main design of experiments, the QFP64 in Figure 30 exhibited a significant increase in whisker growth. While small whiskers were observed at 1,000 hours, at 4,000 hours it had whiskers long enough to nearly bridge between the printed circuit board pads.

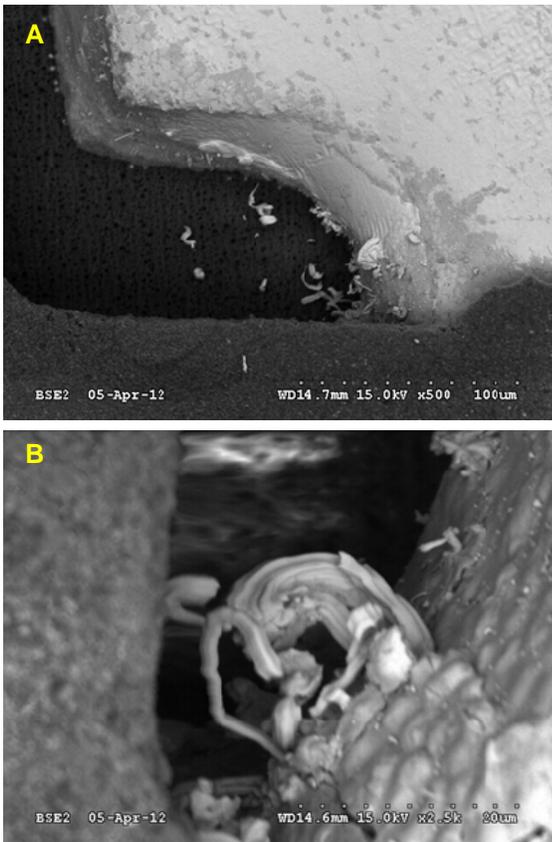
Figure 31: SEM images of a copper (SOT5) leaded part with a 1-1 contamination level after 1,000 hours at 85 °C/85 percent relative humidity. Increasing magnification views shown from top to bottom.

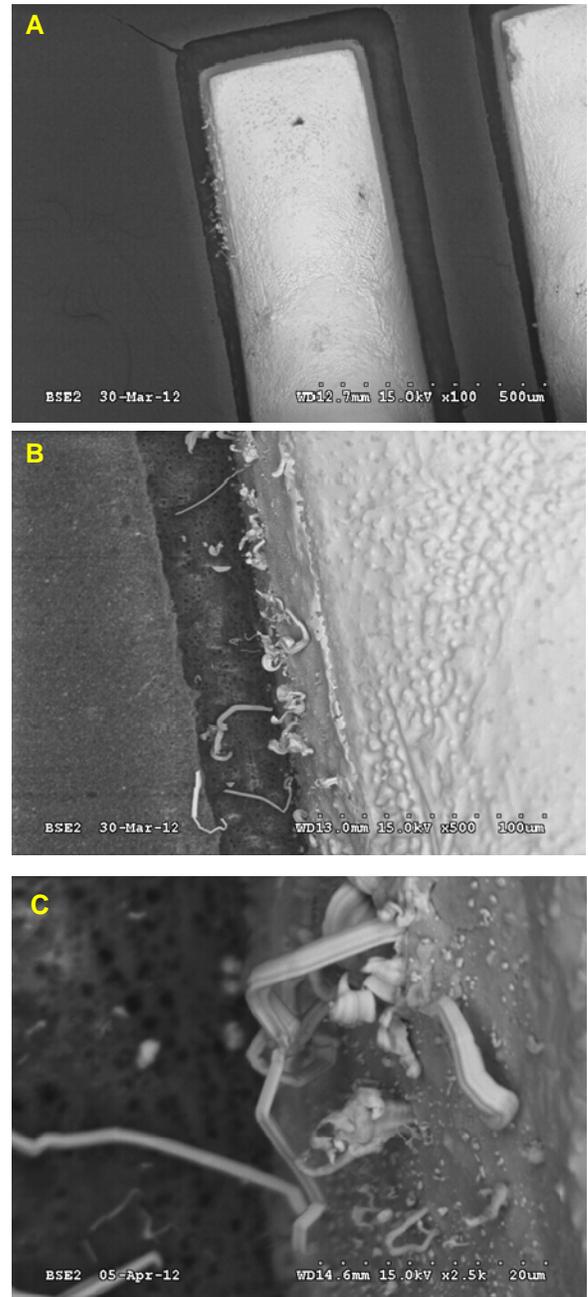
Figure 32: SEM images of an alloy 42 (SOT6) leaded part with a 1-1 contamination level after 1,000 hours at 85 °C/85 percent relative humidity. Increasing magnification views shown from top to bottom.

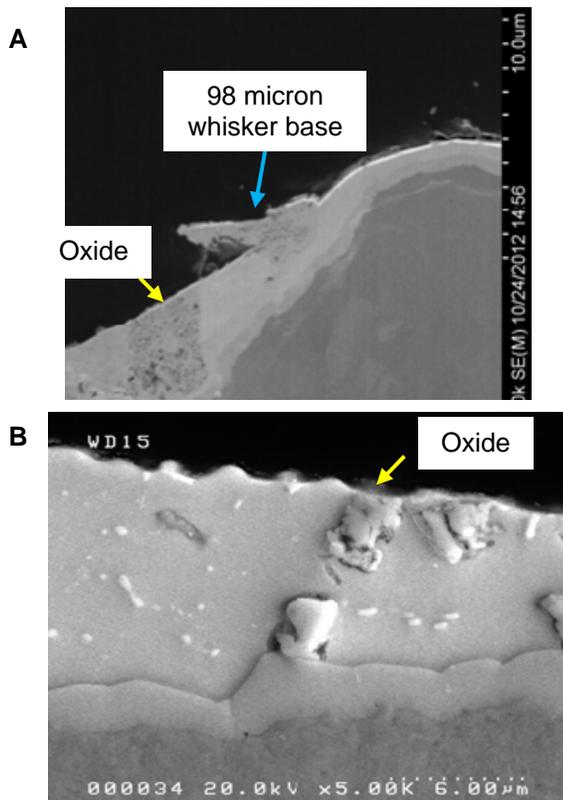
Figure 33: Partial oxidation of SAC solder with copper leaded part (SOT5) and 1-1 contamination. (A) SEM image of oxide near whisker, (B) SEM image of oxide in a thicker region of the SAC solder, (C) optical image of oxidation near solder to base metal wetting line, and (D) SEM image of region shown in (C).

The solder was observed to be partially oxidized (see Figure 33). The compressive stress caused by the 29~34 percent volume increase of the Sn oxides as compared with the β Sn promotes whisker growth. These findings are consistent with other investigators assessing the role of humidity on tin whisker growth on electronic component leads [20][21][22] and on lead-free assemblies [23].

Two possible explanations for the large amount of broken whiskers were found during the cross section examination. In Figure 33, the thin regions of solder were completely oxidized and had no whiskers on the surface. This suggests that oxidation/corrosion propagating under a whisker can make the whisker attachment to the base more brittle. In another section of a whisker through its base, voids and a crack were observed (see Figure 34).

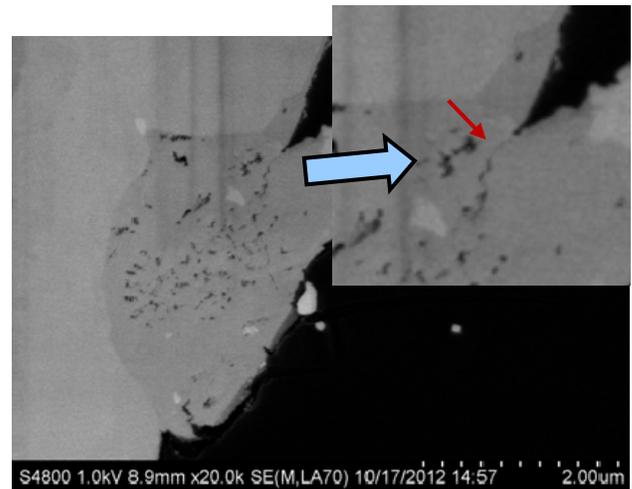
Figure 34: SEM image of voids and cracks observed in whisker base. Crack is highlighted by the arrow. A large number of voids are observed in the root of the whisker.

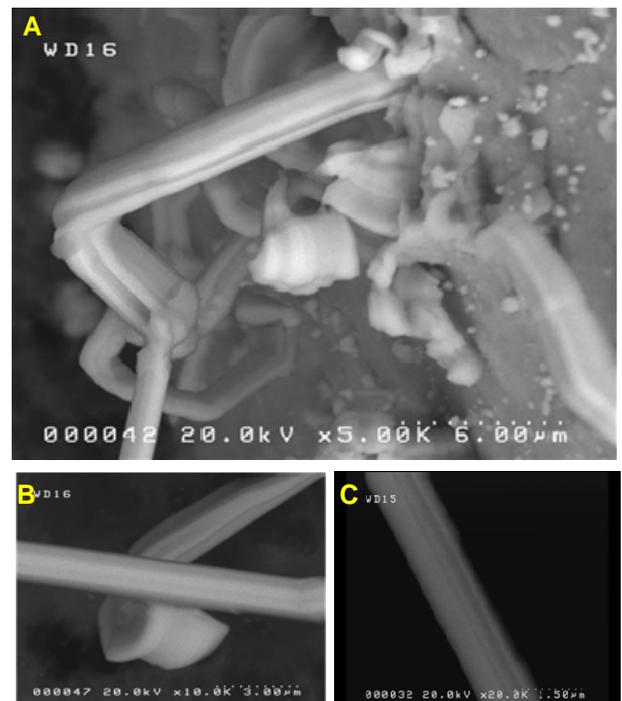
Figure 35: SEM images of vertical striations observed on smaller diameter whiskers. SEM images (A), (B) and (C) show increasing magnification views of typical striations.

Whisker striations were also observed similar to those found by other researchers [24]. Vertical striations were on smaller diameter whiskers (see Figure 35) while both vertical and horizontal striations were observed on thicker whiskers (see Figure 36).

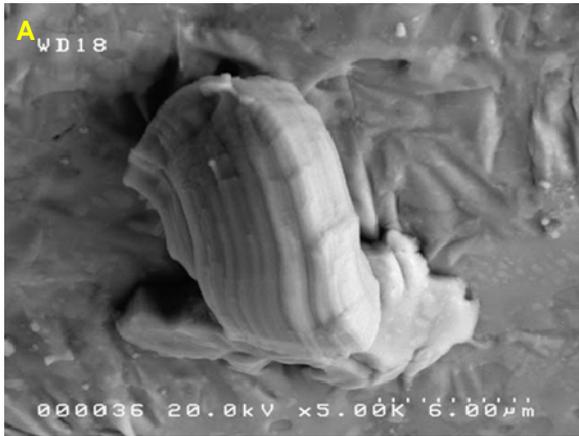
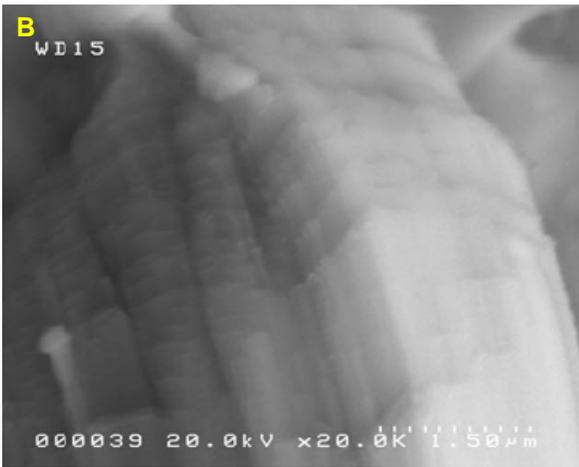
Figure 36: SEM images of vertical and horizontal striations observed on thicker whiskers. SEM images (A) and (B) show increasing magnification views of typical striations.
