Comparative Study for Solder Joint Performance Under Shock for ENIG and ENEPIG Surface Plated Tester PCBs

Agustin A. Vasquez, Ph.D., P.E., Raiyo F. Aspandiar, Ph.D.,
Pubudu Goonetilleke, Lavanya Ashok Swaminathan
Intel Corporation
OR, USA
agustin.a.vasquez@intel.com

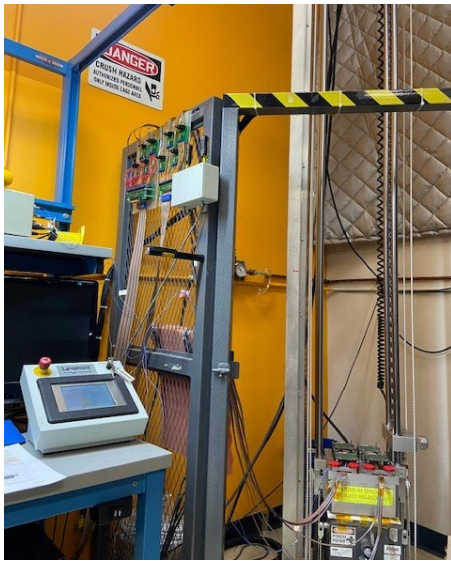
Figure 8. Shock stress for JEDEC TVs (a) Board TVs are mounted on a shock stress machine. (b) A calibrated shock stress machine is used to test TV boards.

The JEDEC Test Vehicles (TVs) were tested with a stress profile documented in JESD22-B11A [10]. The stress profile includes impact acceleration of 1500 Gs and a duration of 0.5 msec. The experimental shock machine was calibrated to ensure the spec stress profile follows the spec requirements. The shock experiments were conducted by specialized Engineers at Intel Stress Labs located at Hawthorn Farms Campus in Hillsboro, OR. Figure 8 includes the lab setup for the Mechanical Shock Test. Resistance measurements were taken after each drop by a data acquisition system. The resistance threshold for failure was 1000 Ohms, as required by JESD22-B111A.

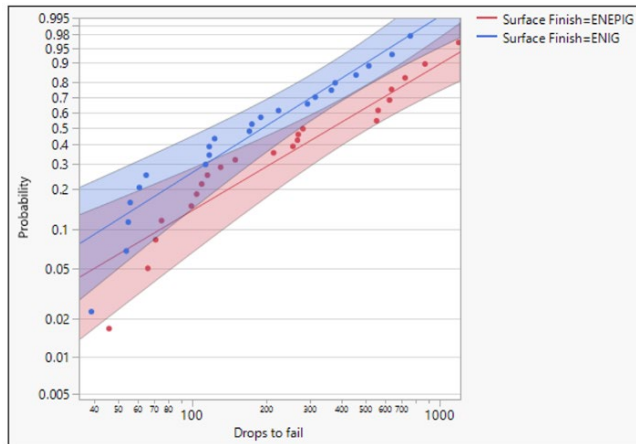
Figure 9. Solder Joint life distribution for ENIG and ENEPIG solder joints by land design. (a) NSMD land designs. (b) SMD land design.

The solder joint life distribution or NSMD pads is shown in Figure 9a. The red line represents life distribution for ENEPIG plating. The blue line represents ENIG solder joint life distribution for ENIG plating. It requires ~ 40 drops to observe the first solder joint failure with ENIG and ENEPIG. The solder joint performance is summarized in Table 1. There is significant difference in the characteristic life of solder joints with ENIG and ENEPIG for NSMD lands. Data is clear that ENEPIG solder joint outperforms ENIG solder joints performance under mechanical shock stress for NSMD lands.

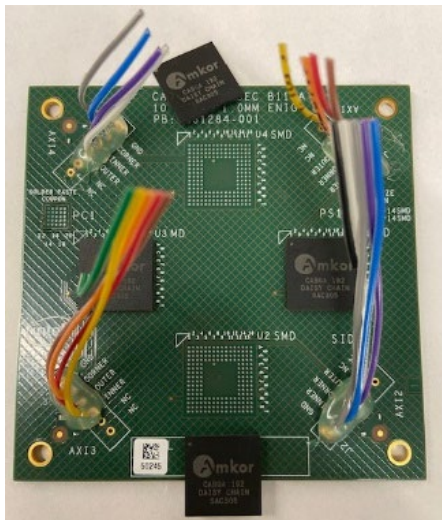
Figure 10. ENIG BGA dummy components were de-attached from board at first drop (for SMD pads). This is a catastrophic solder joint failure.

Furthermore, the daisy chained CABGA192 components soldered on SMD lands with ENIG surface finish were completely de-attached from the board after the first drop cycle. These detached components are shown in Figure 10. This signifies that all 192 solder joints of the component were full cracked after the first drop cycle. On the other hand, 63% of all the ENIG plated solder joints – on NSMD lands – failed after 258 drops. The conclusion was that solder joints on ENIG MD lands outperforms solder joints on ENIG SMD lands under shock. ENEPIG solder joints outperform ENIG solder joints for both lands’ designs (NSMD and SMD) under shock. The differences on solder joint performance for NSMD and SMD are due to solder joint formation for both land designs as explained earlier on this paper and as concluded in [1].

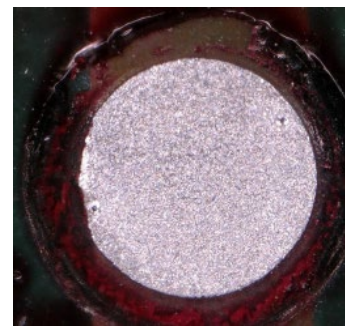
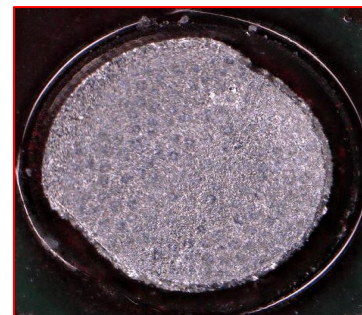
Figure 11. Solder Joint crack surface analysis at T3 interface for SMD Pads Pad surface analysis for ENEPIG and ENIG pads. (a) ENEPIG plated solder joint without P-rich spots. No P-rich spots on ENEPIG T3 interface. (b) ENIG plated solder joint shows P-rich spots.

A closer examination of T3 solder joint crack surfaces – for SMD pads for the JEDEC TVs under shock – was conducted to understand root causes for the differences in solder joint performance between ENIG and ENEPIG plated solder joints. Figure 11a shows the crack surface of solder joint at T3 interface with ENEPIG plating. The surface does not show abnormalities. The surface is covered by solder material, which is the signature expected for a robust solder joint. In contrast, Figure 11b shows the cracked surface of the solder joint at T3 interface with ENIG plating. The crack is seen at T3 Ni-IMC interface. The cracked surface shows a dot like signature, with P-rich dots deposited on the Ni(P) surface. The observed dot-like signature, on the TV solder joint cracked surface, is like that observed on T3 cracked surface for solder joints on SMD Pads with ENIG for production ENIG HDBI MB boards.

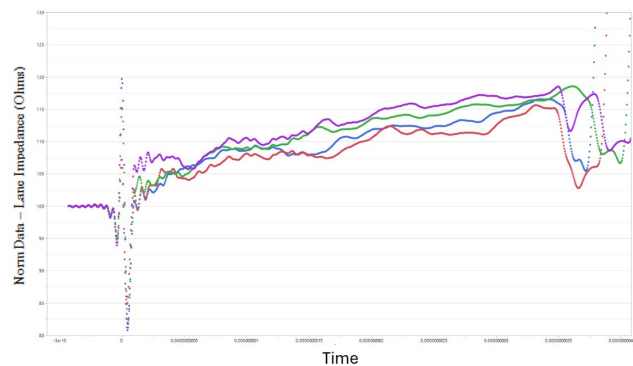
Figure 13. TDR plots for two lanes. There are no major differences in TDR plots for ENEPIG and ENIG boards on two suspected lanes – with differences in eyes diagrams.

- a) Read/Write margin data showed similar behavior between ENEPIG and ENIG boards with ENEPIG showing a better margin on almost all interfaces.
- b) High speed transceiver revealed normal behavior based on eye diagrams captured on all lanes with the ENEPIG board. This applies to all lanes except two lanes which showed a narrowed eye.
- c) To further evaluate the performance of the two lanes, a TDR analysis was completed for the two lanes. The TDR plots do not display major concerns. Figure 13 depicts these TDR plots. The different colored plots are impedances from the various data lanes.
