## Drop/Shock Behavior of Low Temperature Solder BGA

Sufyan Tahat, Sa'd Hamasha, Ph.D.  
Auburn University  
Al, USA  
Sat0063@auburn.edu

### ABSTRACT

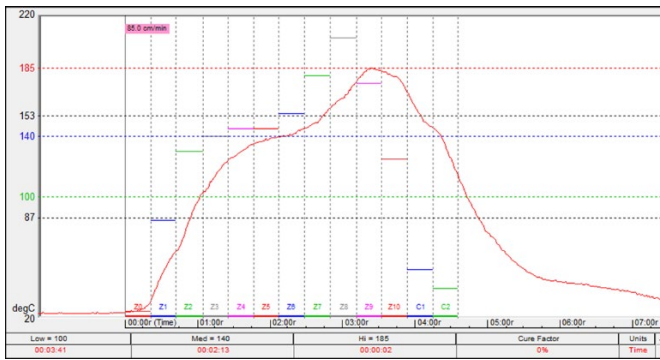
**Figure 2.** L29 Reflow Profile

Two assembly processes were used to create the test vehicles. The SAC305 samples were assembled using a no-clean SAC305 solder paste and a convective oven reflow process in which the samples were heated to 243°C with a time above liquidus (217°C) of 63 seconds as measured near the BGA solder joints. The L29 samples were assembled using a no-clean L29 solder paste and a convective oven reflow process in which the samples were heated 185°C with a time above liquidus (140°C) of 73seconds as measured near the BGA solder joints.

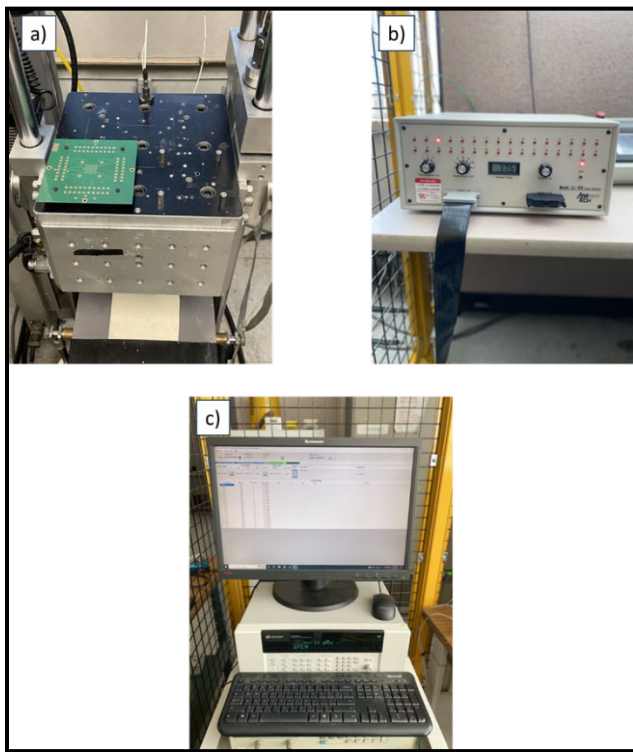
**Figure 2.** Experimental setup with a.) Lansmont Model 23 Drop table, b.) Anatech event detector and c.) Keysight Data logger

Drop/shock testing was used to assess the reliability of the solder joints. Figure 3 shows the drop table that was used for the experiment as well as the monitoring equipment. The test boards were mounted to the drop table with the BGA side facing downward using the four corner-most tooling holes to bolt the boards to 12mm hex standoffs. Input acceleration during each drop event was measured with an accelerometer that was mounted directly to the drop table.

For solder failure detection an Analysis Tech Model 32-106 was employed with the failure resistance threshold set to 150 Ohm and the event duration set to 1  $\mu$ s while using a 10mA current supply. A Keysight 34980A data logger was also used for voltage monitoring of the 80-joint loop voltage and individual corner joint voltages. Sample failure was defined

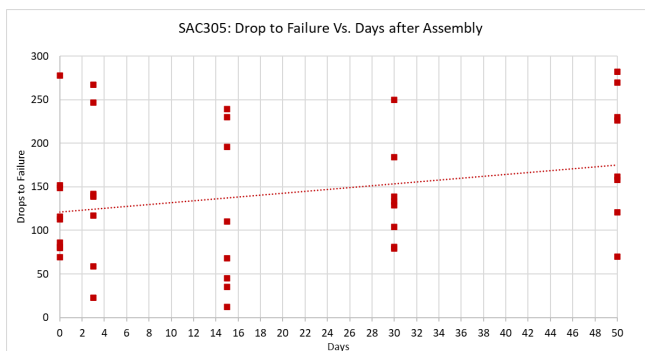
**Figure 4.** Scatter plot showing SAC305 drop data (340-G input)

SAC305 samples subjected to drop testing at 340-G input shocks failed between 12 and 282 drops. Figure 4 provides a scatter plot of the SAC305 drop test data. The scatter plot indicates a slight trend of increasing reliability with time, but the effect appears to be small given the large variability in drop test performance from part to part. In fact, two sample T-tests comparing the means of the populations indicates that there is no significant difference between the sample sets at 95% confidence. Thus, it was concluded that up to 50 days after reflow at room temperature had little effect on SAC305 BGA performance for the drop test condition utilized.

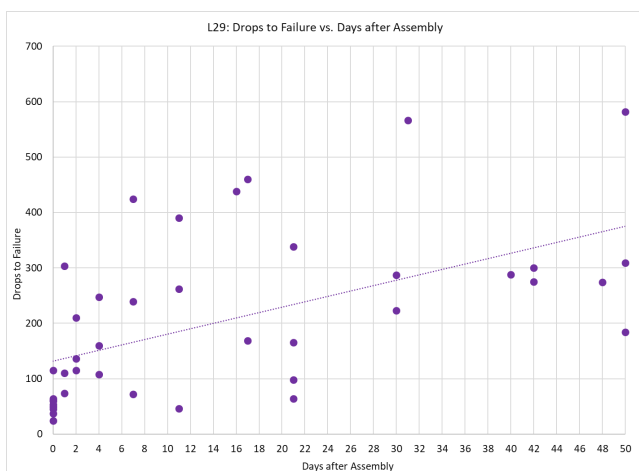
**Figure 5.** Scatter plot showing L29 drop data (200-G input)

Now, as shown in Figure 5, the L29 samples subjected to 200-G input shocks failed between 24 and 582 drops while demonstrating a measurable increase in shock survivability as aging time increased. For example, L29 samples subjected to drop testing within 60 minutes or less of reflow soldering failed in an average of 56 drops while those subjected to 40 or more days of aging survived an average of 316 drops, or a 5.6X increase in average life.

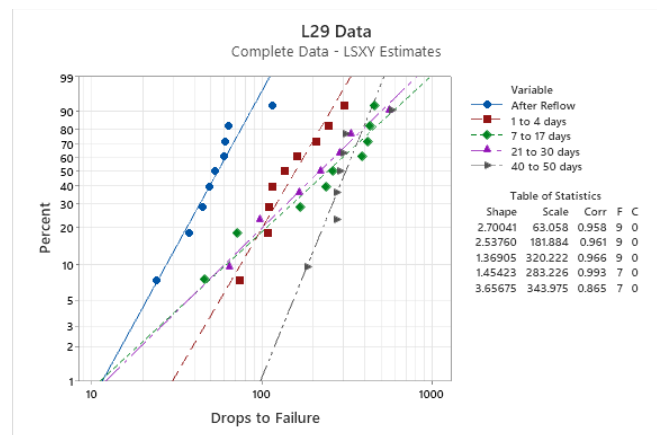
**Figure 6.** Weibull plots showing L29 drop data (200-G input)

The L29 populations were separated into five groups in order to produce 2-parameter Weibull plots due to the small sample sizes at each test interval. These Weibull plots are found in Figure 6. Examination of the plots shows that the least reliable condition was the After Reflow population which produced a characteristic lifetime of 63 drops. In comparison, the 1 to 4 day aging population produced a characteristic lifetime that was 3X greater than the After Reflow group (i.e. 181 drops) while the 7 to 17 day, 21 to 30 day and 40 to 50 day populations show 4.5 to 5.5X improvement over the After Reflow results.

Much like the SAC305 populations, the L29 populations show significant part to part variability in terms of drop performance. In this case, the 7 to 17 and 21 to 30 day L29 populations each have two failures that occurred slightly early in test and which result in low Shape factors on the Weibull plots. It is likely that these early failures are typical for drop testing the L29 alloy and may occur somewhat randomly due to individual solder joint formation characteristics that can negatively impact reliability or from drop test variability (i.e. industry standard JESD22.B110B.01 allows +/-10% tolerance for shock test acceleration pulse). If these early failures are excluded from the analysis, the Weibull plots would strongly support the notion that L29 solder joint durability significantly increases over the first seven or so days following reflow.

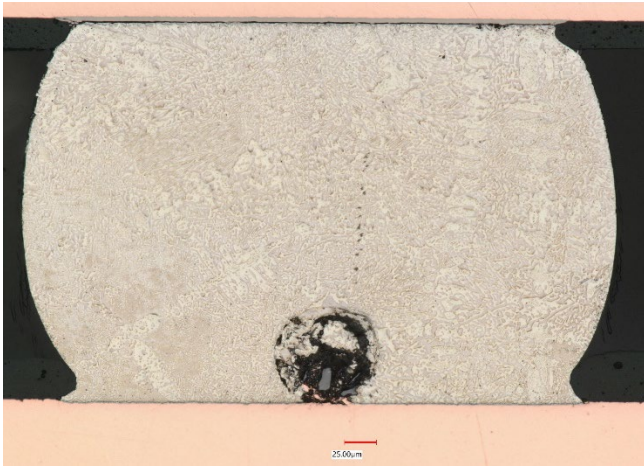
**Figure 10.** L29 solder joint from the After Reflow population. This joint failed at drop #46. There appears to be a clean separation between the BGA nickel layer and the IMC.

The most common L29 failure mode for the After Reflow population appeared to be a separation of the IMC from the BGA nickel layer as shown in Figures 10 and 11. This failure mode is presumably a brittle-type failure and explains why the After Reflow L29 population produced poor drop test results. This failure mode would also be observed among the aged populations (see Figure 12), but was not as common. However, when this failure mode occurred in the aged specimens, it was typically associated with earlier failures.

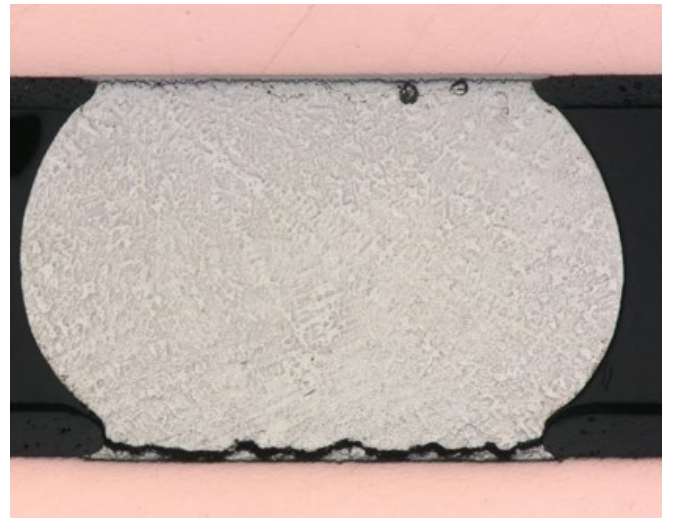
**Figure 14.** L29 solder joint from the 50 day population. This joint failed at drop #311. Crack growth occurred through the bulk solder above the PCB side IMC region.

Bulk solder fatigue cracks were observed in many L29 samples and it was found that such fatigue could occur near

either attachment pad as shown in Figure 13 and Figure 14. The fact that bulk solder fatigue could occur on either side of the solder joints was likely due to the fact that both sides of the joints were SMD with similarly sized mask openings. Overall, it appeared that bulk solder fatigue was more commonly found on the PCB side of the solder joint, which makes sense given that stresses from drop testing are generated through the flexing of the PCB. There was some evidence suggesting bulk solder fatigue was more common in longer aged samples -indicating that increasing time after reflow may have improved the IMC-to-pad robustness which ultimately shifted the failure from the IMC region and into the bulk solder.
