UNDERSTANDING PCB DESIGN VARIABLES THAT CONTRIBUTE TO WARPAGE DURING MODULE-CARRIER ATTACHMENT

Donald Adams, Todd MacFadden, & Rafael Maradiaga
Bose Corporation
Framingham, MA, USA
donald_adams@bose.com

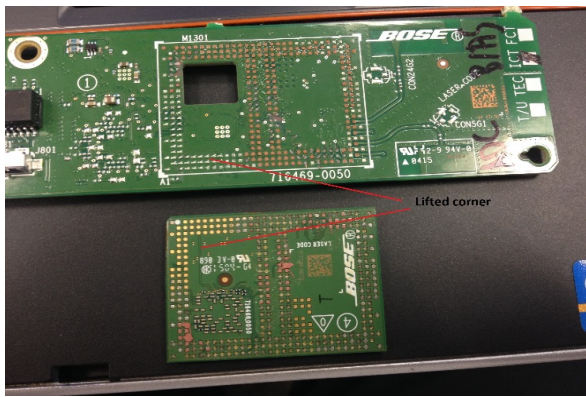
Figure 2. A failed module-carrier assembly after separation showing no solder on the pads in the lifted corner of the module.

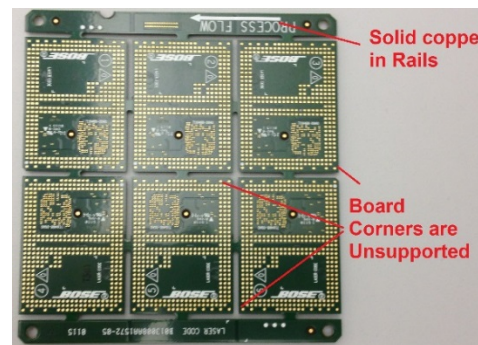
One observation was that while the module copper had etches and reliefs the rails had unbroken planes. This is commonly done to stiffen panels and prevent sag in the reflow process. The team questioned whether it might impart stress during heating or in the lamination process. Another observation was that the corners where the defects occur were not tied in to the panel. Breaks had been placed in the center to minimize tabs and reduce routing time.

Figure 6. Module Rails and Break Tabs

Boards with more tabs located in the PCB corners were seen to have the largest impact to the carrier attachment success. Being a simple change to the panel this change can be easily implemented and monitored in larger lot sizes.

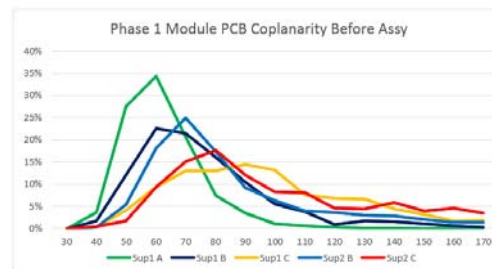
**Figure 10.** Unprocessed Module Measurement Distribution

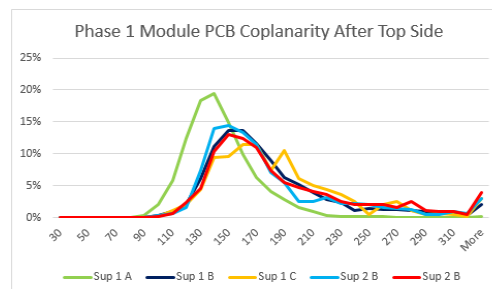
Figure 11. Post Top Side Module Measurement Distribution

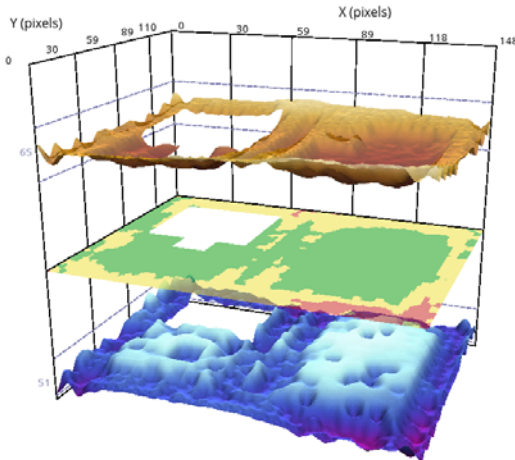
Given that the paste thickness was roughly 165 microns, and this collapsed to roughly half that height at liquidus, a gap fail and warning map was created at 82 microns and 50 microns, respectively. After analyzing the 4-up carrier panel and 6-up module panel, statistical surfaces representing the part behavior at eleven temperature points were created. Figures 12 and 13 below show the average and maximum case at peak temperature respectively. Gap failures were noted prominently in one corner, and correlate well with open failures seen in production.

Figure 32. Average Plot at Peak Reflow Temperature

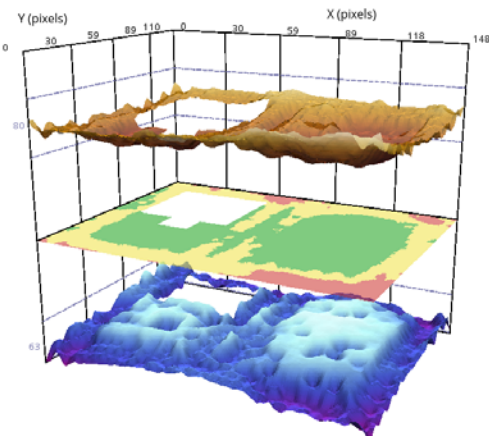
Figure 13. Maximum Plot at Peak Reflow Temperature

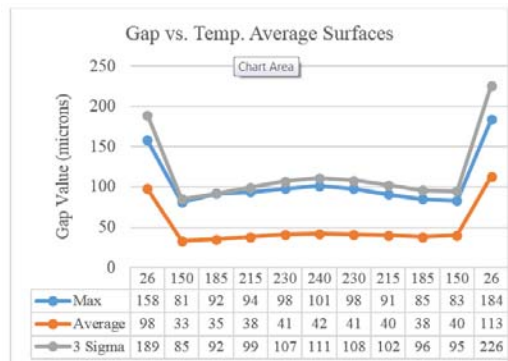
26	150	185	215	230	240	230	215	185	150	26
Max	158	81	92	94	98	101	98	91	85	83	184
Average	98	33	35	38	41	42	41	40	38	40	113
3 Sigma	189	85	92	99	107	111	108	102	96	95	226

Figure 14. Average Gap vs Temperature

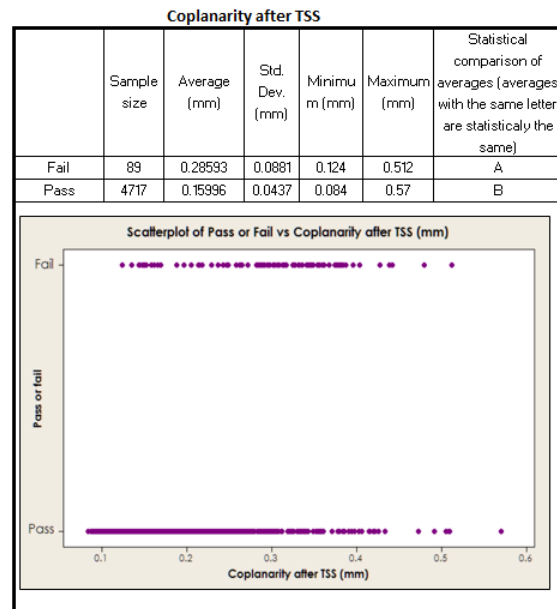
Comparing the coplanarity averages of the failed modules with those of passing modules there was a difference between them as illustrated in the graph and table in Figure 17 below.

Figure 17. Defect Relationship to Coplanarity

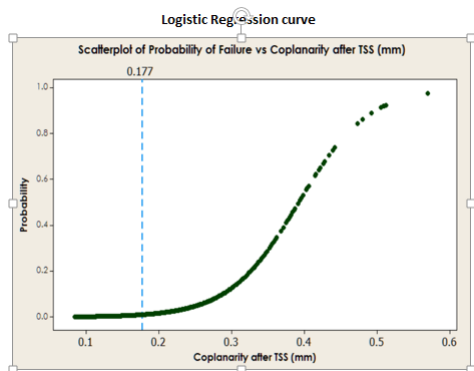
Running a Logistic Regression Analysis to determine the likelihood of defects at a given flatness revealed the defect rate could be predicted and that there was a relationship between flatness and board opens at carrier assembly. The graph in Figure 18 shows that at .177mm coplanarity there is a 1.08% chance of a solder open defect. This correlates closely with the production yields of 1% less defects.

Figure 18. Failure Probability Curve

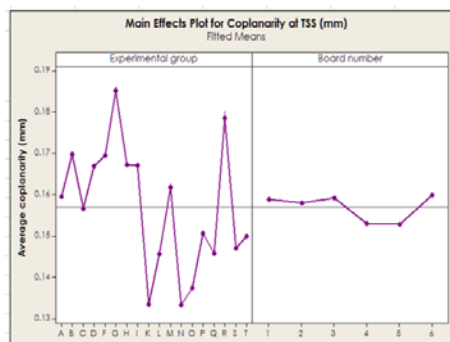
leading candidates changed. This occurred after both bottom side and top side assembly. The results of the analysis after top side are shown in Table 8 and graphed in Figure 19. After top side processing groups K, N and O showed the best resulting average coplanarity. These variations were all from supplier one, used the existing material. Group K was from a working panel non corner, Group N had the additional board breaks at the corners and Group O had balanced copper top and bottom.

Figure 19. Plot of Average Flatness by Group

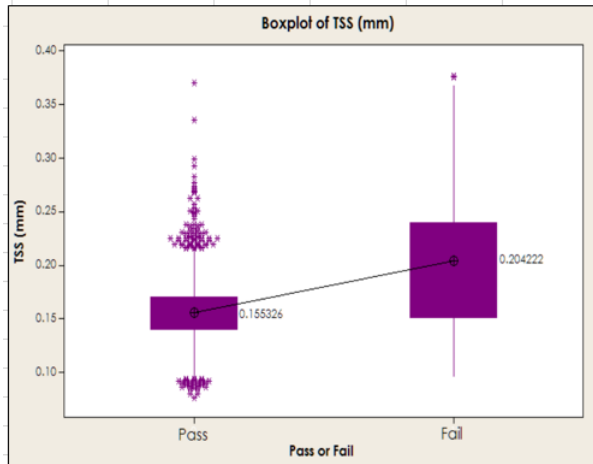
Looking at a plot of the coplanarity averages for passing and failing boards revealed that the passing boards had a smaller average and standard deviation but also had a significant number of points outside the box as shown in Figure 20 below. This would make it difficult to point to a specific coplanarity as needed to produce a passing result.

| Pass or fail	Sample size	Average (mm)	Std. Dev. (mm)	Minimum (mm)	Maximum (mm)
Fail	36	0.2042	0.074	0.096	0.377
Pass	3192	0.15533	0.02734	0.076	0.37

Figure 20. Plot of Coplanarity vs Test Result
