An Interesting Approach to Yield Improvement

Keith Bryant, Technology and Business Consultant
keith@keithbryant.net
and Milan Popovics, Enics Elva.

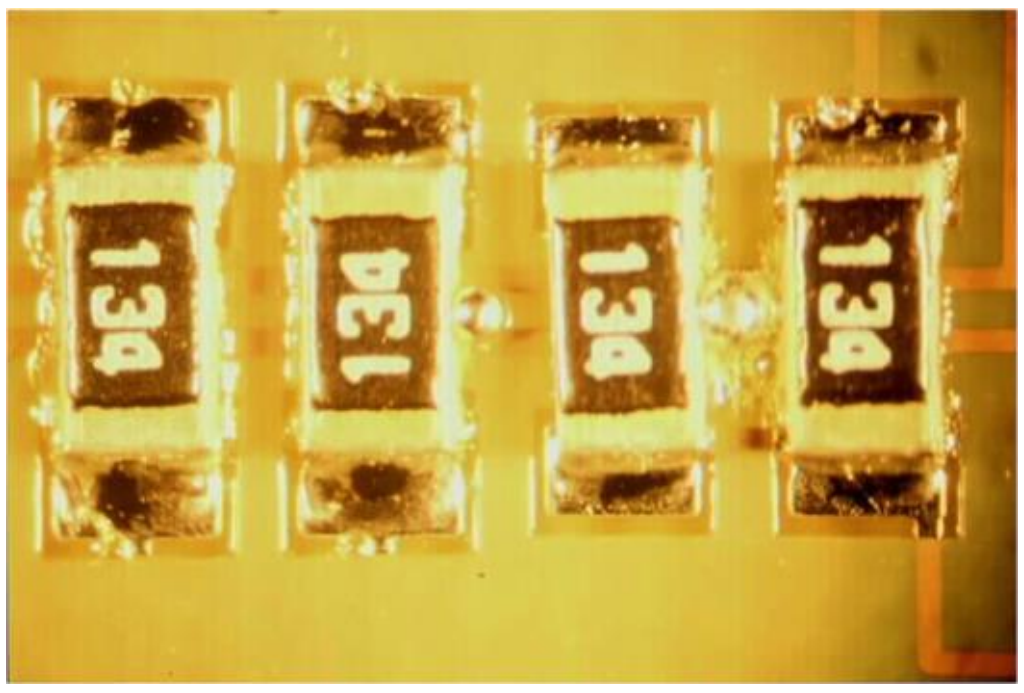
More enlightened companies will invest some time, effort and cost to overcome some of the failures which repeatedly appear during the assembly of the boards. Redesigning pads to reduce solder balls, repeatedly seen at the same components as in Figure 2 where a short circuit can be seen between the two right hand chip components. This is caused by a large solder ball actually connecting the two components during the reflow process. There is also a large single ball in the centre, which, if not removed, could move around the board causing a short circuit.

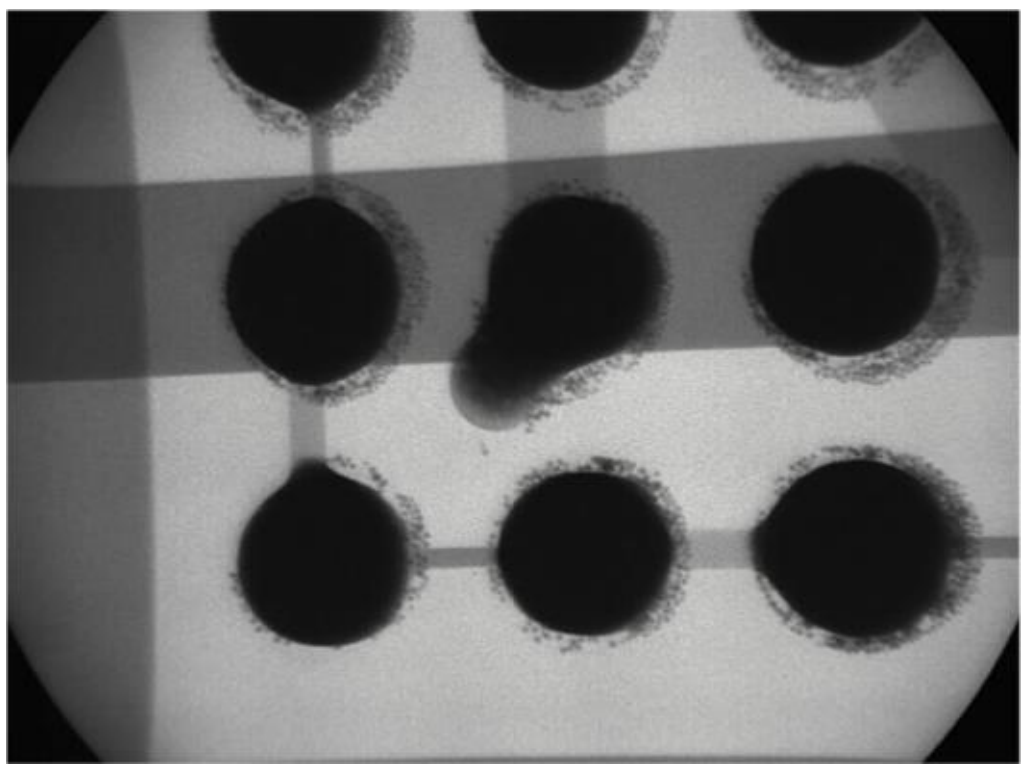
In addition to visible faults that can be found by AOI or skilled inspectors, there are some faults that need x-ray to find them. Figure 5 below shows a case of severe solder balling under a BGA; it is easy to see a huge number of very small balls around the solder connections. This phenomenon is often referred to as spattering, there are several causes including too much solder paste on the pads. Effectively after the joint has coalesced and formed there is solder material left over which cannot flow into the joint. This material then forms very small balls and attach themselves to each other or the side of the pad.

With a good x-ray system this fault is easy to see and with some diagnostic work can be fixed by reducing the apertures while ensuring there is enough solder paste to allow a good strong joint to form.

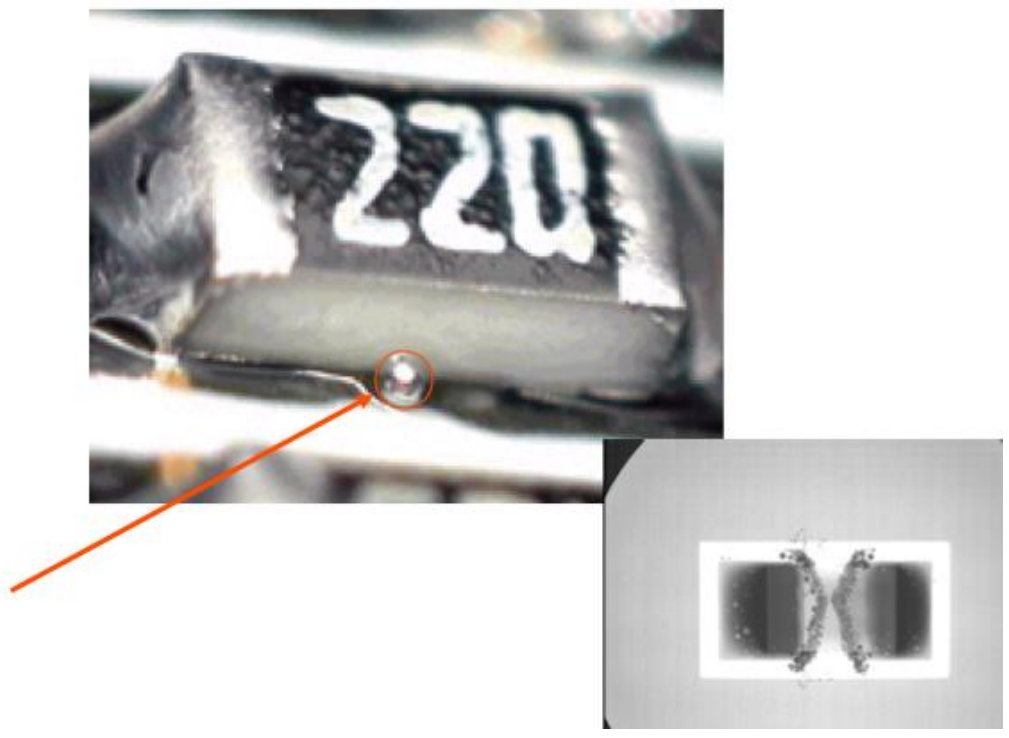
Figure 9

0603, SOT89 and C1206 components were chosen for the experiments in aperture design as these were exhibiting the most issues related to soldering. The standard reductions in aperture sizes were giving problems in production; both mid chip solder balling and spatter. Figure 9, below, shows good examples of both faults, please note that most of the spatter is under the chip and can only be seen by this x-ray image, as it is mostly between the pads not around the component which is the more common case.

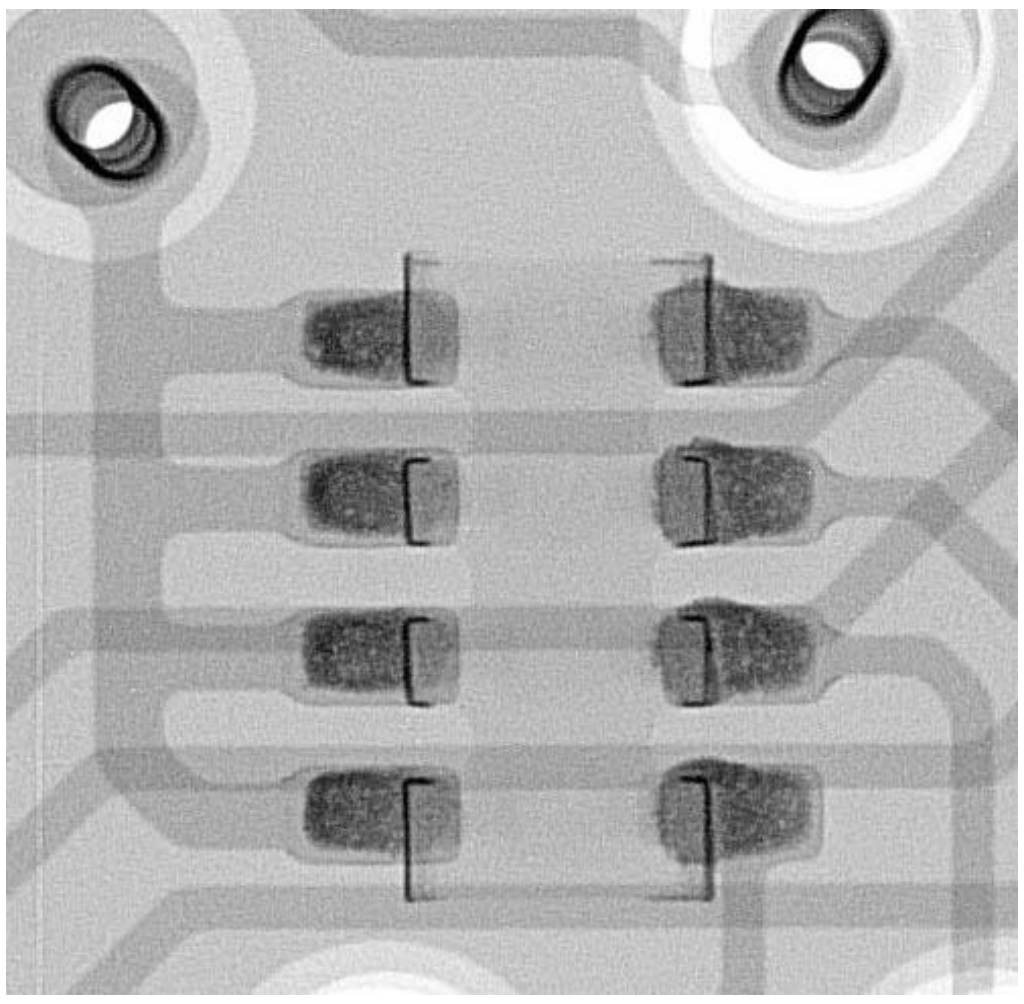
Figure 10

The image below (Figure 10) shows some of the other challenges, which can be faced in assembly caused by a design that is less than perfect. The pad design allows for a very large area behind the terminations that can lead to a thin joint as the paste is spread over a larger area. An effort to cover the pad area may lead to excess solder and spatter, but if the pad is bare copper it needs to be covered in solder for long-term reliability.

The tracking on the left of the components is wider than the tracking on the right and, it seems without reason, this means that heat is absorbed by the solder paste at differing rates on each side of the components and this can lead to tomb stoning or component lift

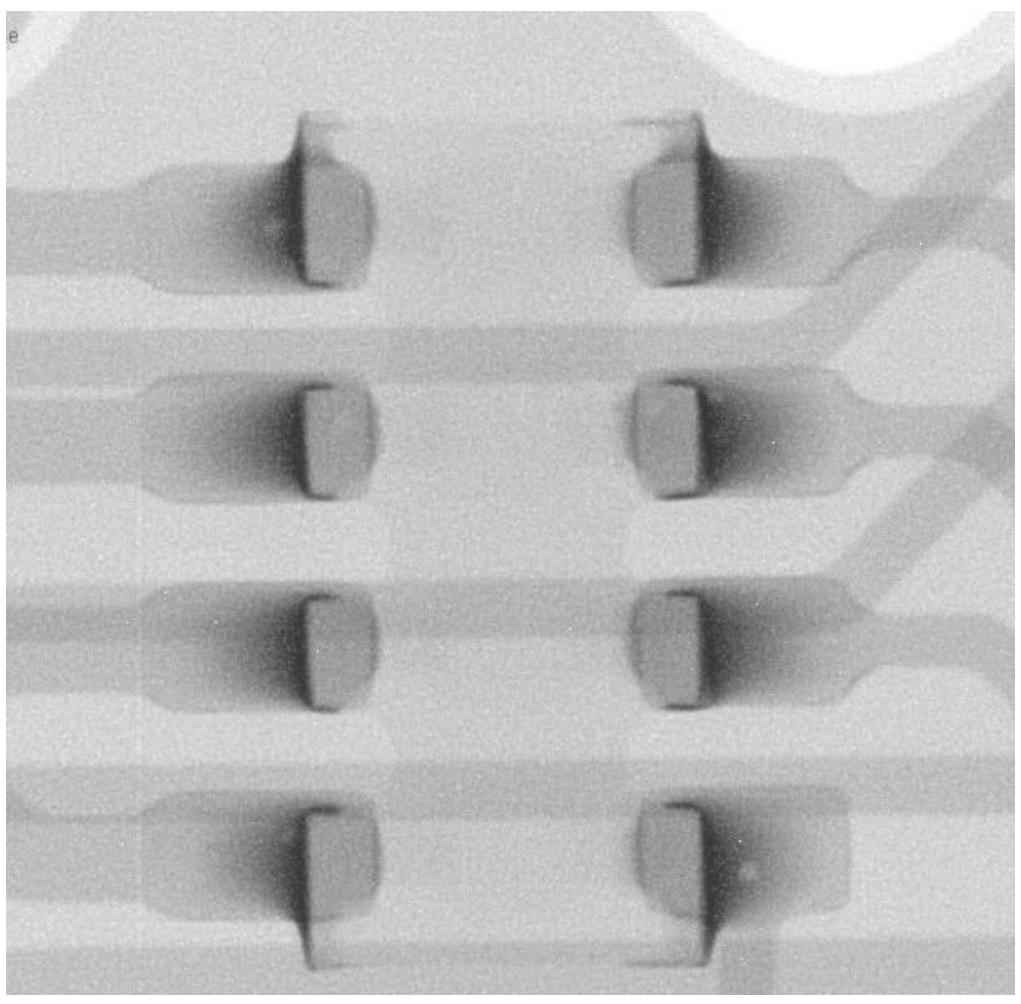
Figure 11 shows the resultant image after reflow and a large area of untinned pad is visible.

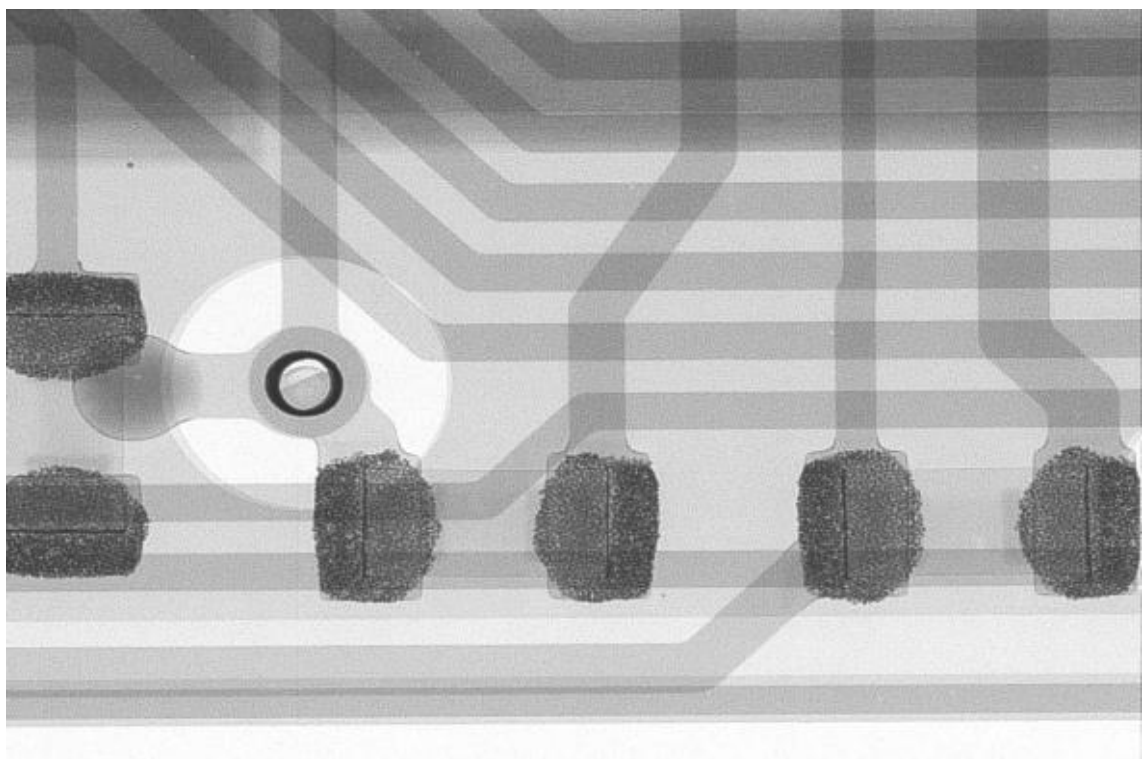
Figure 12

The first amended aperture design trialled on a range of 0603 components (Figure 12) was an Arrowhead profile similar to the one in Figure 8 as can be seen in the x-ray images below it still allowed paste to spill over the edges between the pads when the components were placed and also over the sides of the pad where the components had been placed. When reflowed this exhibited mid chip solder balling and was not a success.

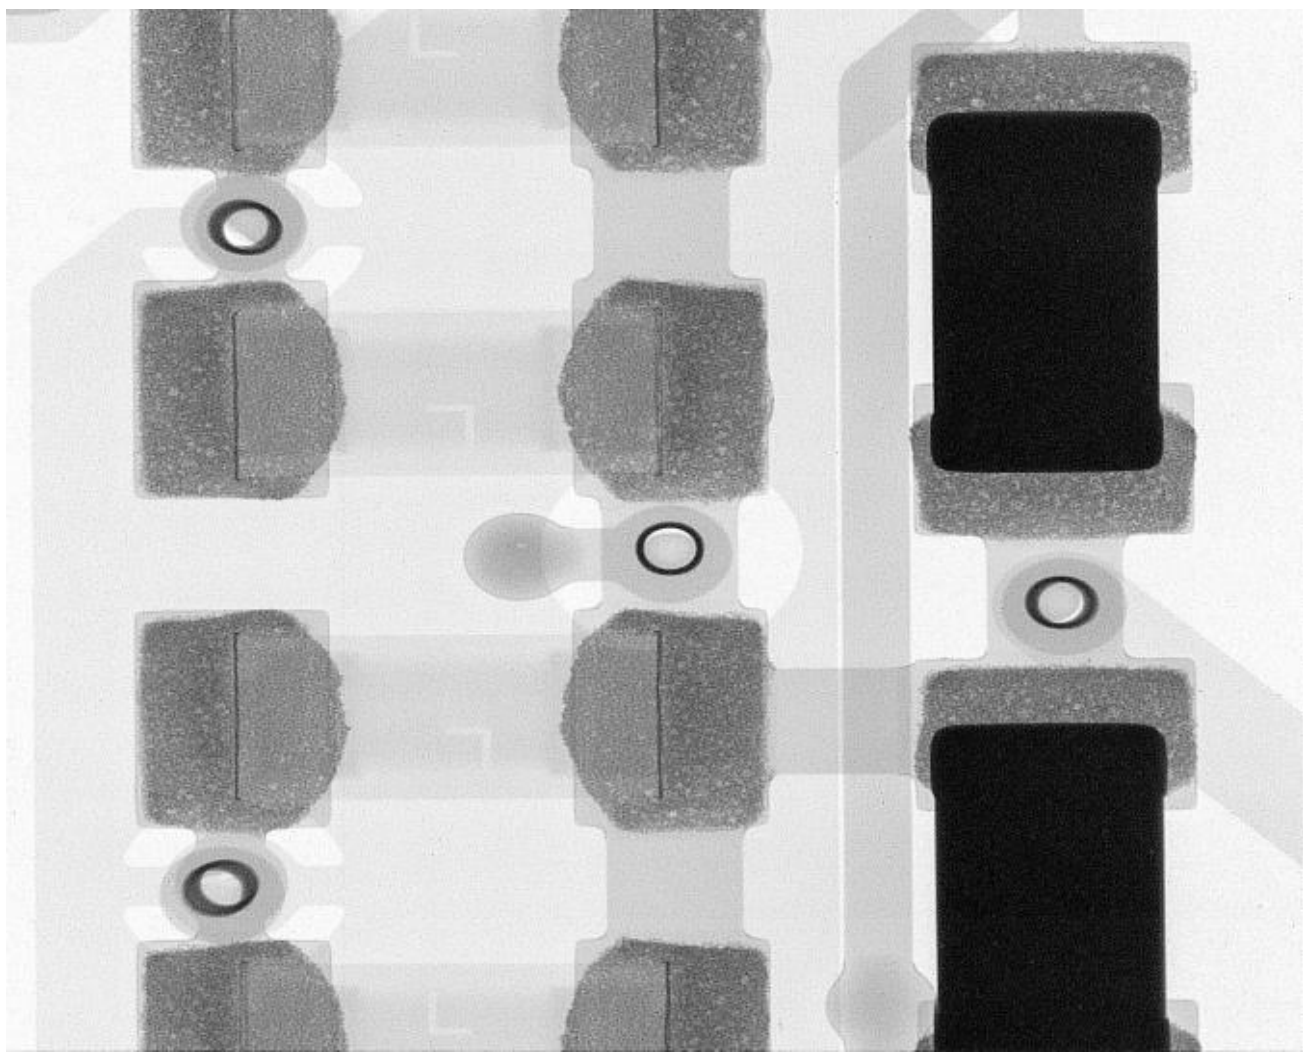
The next shape trialled was the Wendy House or Home Plate as in Figure 8, this can offer advantages over the Arrowhead as it does not have a point on the internal edge, and this can reduce the chance of mid chip balls. However, the volume of solder paste tends to be higher and can lead to spattering. It can be seen from Figure 13 that the solder paste has remained within the pad boundaries except under the component where there is a slight encroachment.

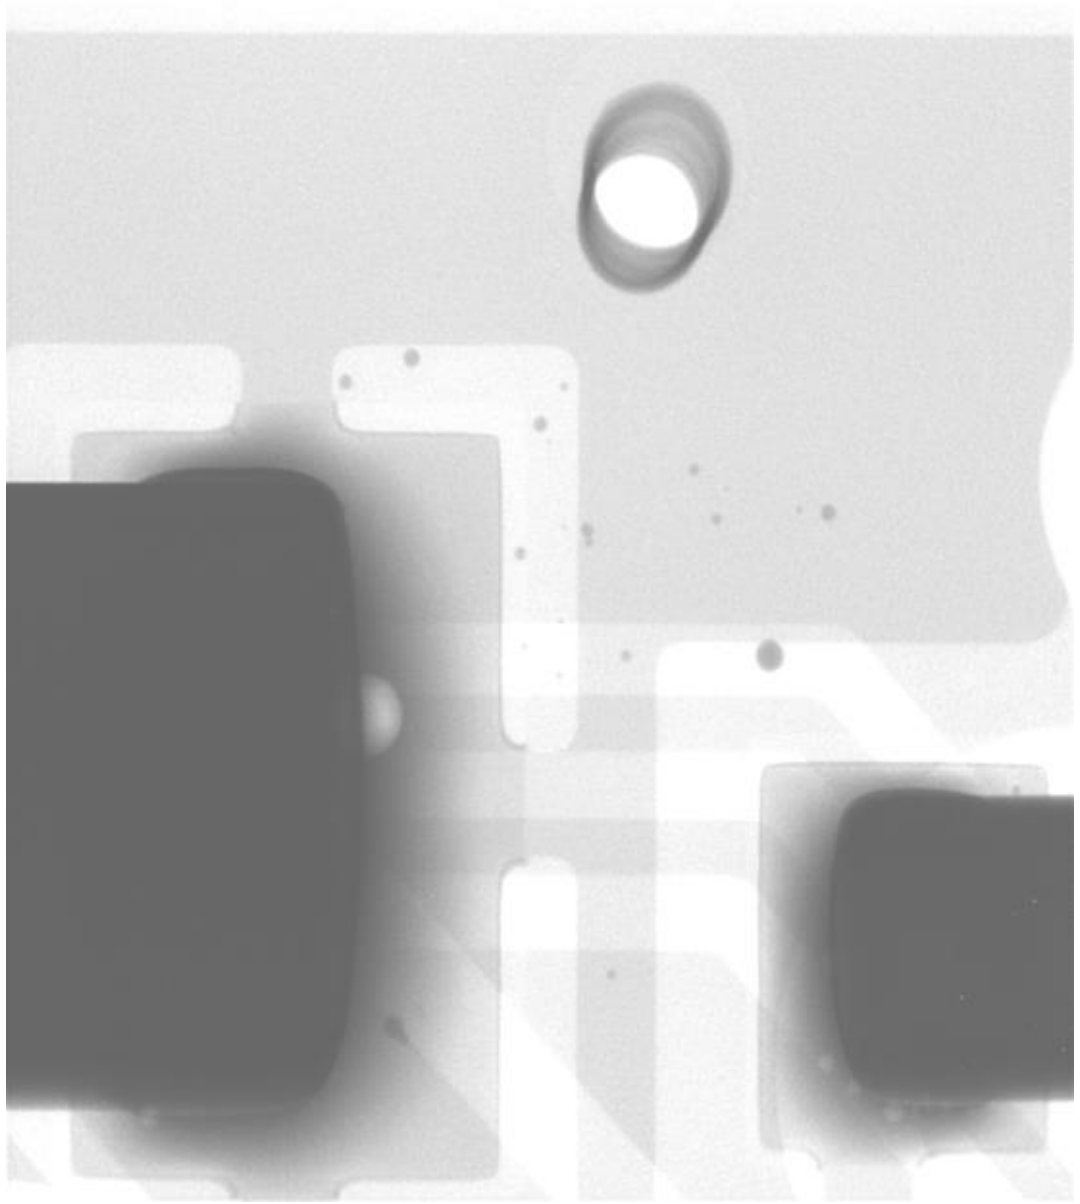
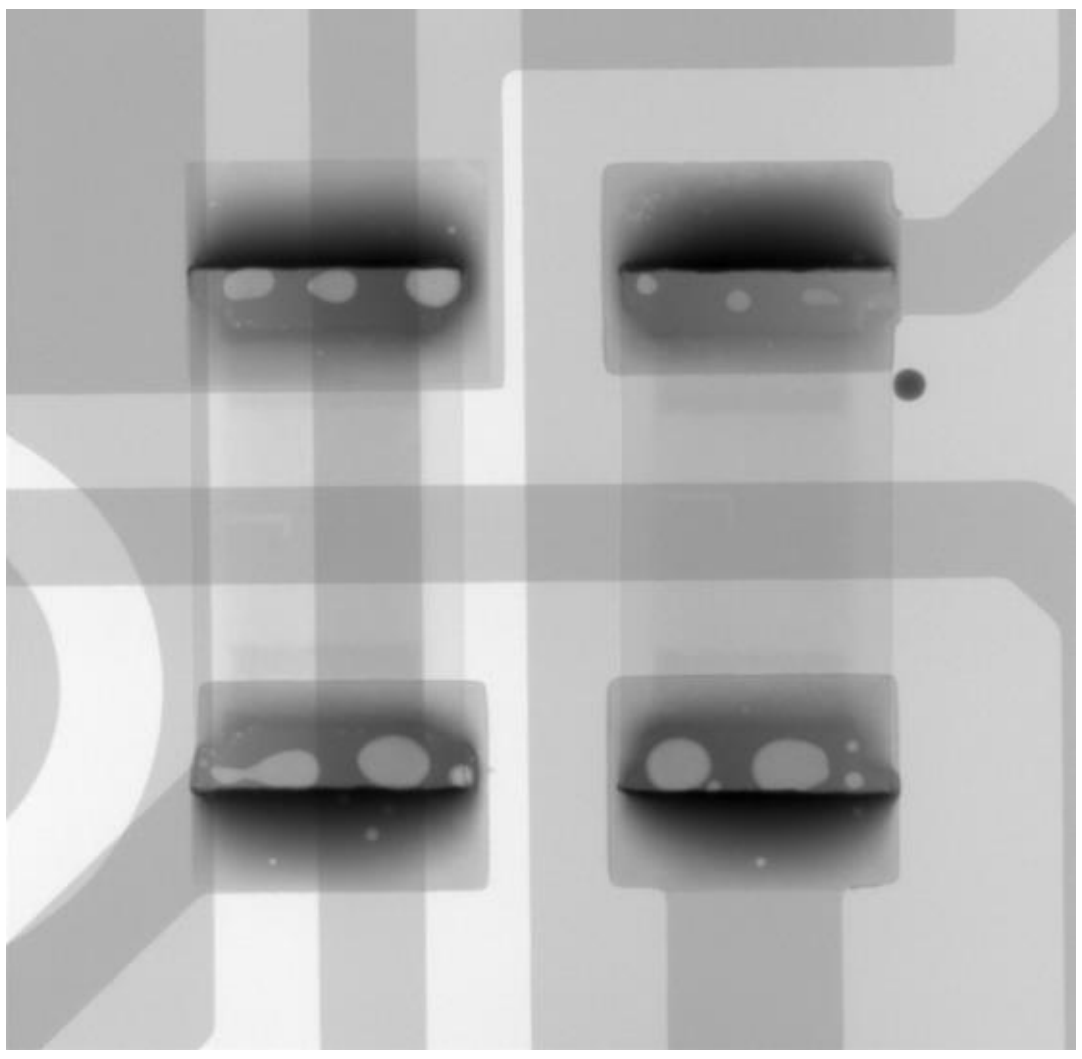
Figure 14-1

The resultant x-ray image below shows that the higher volume of solder paste did have a negative effect on the finished joint causing spatter outside of several of the components. This is an unacceptable process defect as the solder balls are free to move around the assembly where they can easily create shorts. Figure 14 shows one example of this failure mechanism and also mid chip solder balling which was also seen as a result of this aperture design

The best result was achieved by reducing the width of the Wendy House shape by a further 5%. This gave consistently good results, a good joint shape with no solder balling or spattering, for all 0603 components this aperture design was adopted, and Figure 15 shows a typical result. Nice solid dark coloured joints, very little voiding, good pad coverage with no solder balling.

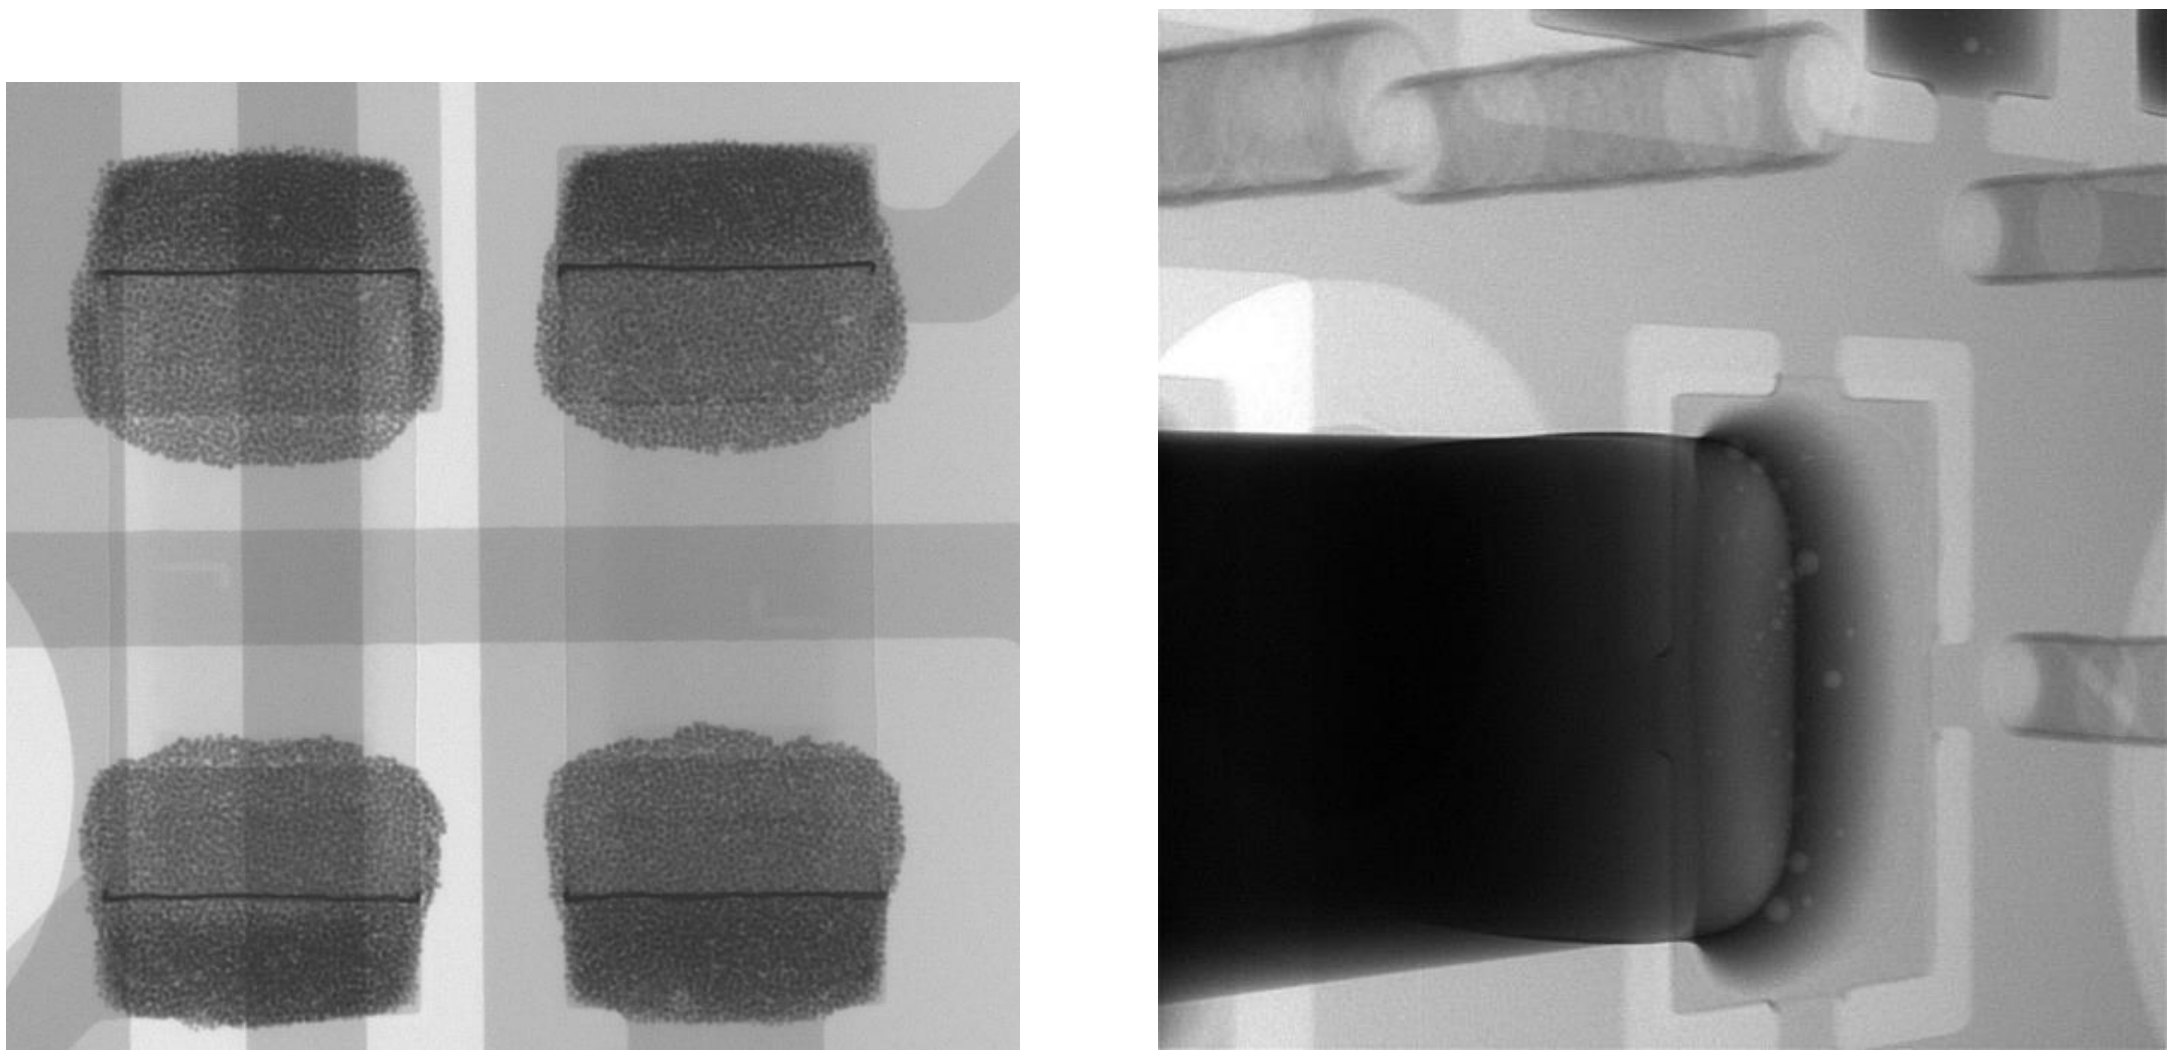
When investigating the larger 1206n components the situation was very similar. Simple aperture reduction produced very poor results both with mid chip solder balls and spattering. Figure 16 shows the extent of this spread when the components are placed into the solder paste. The pad design here is also quite tight which adds to the problems for the manufacturer

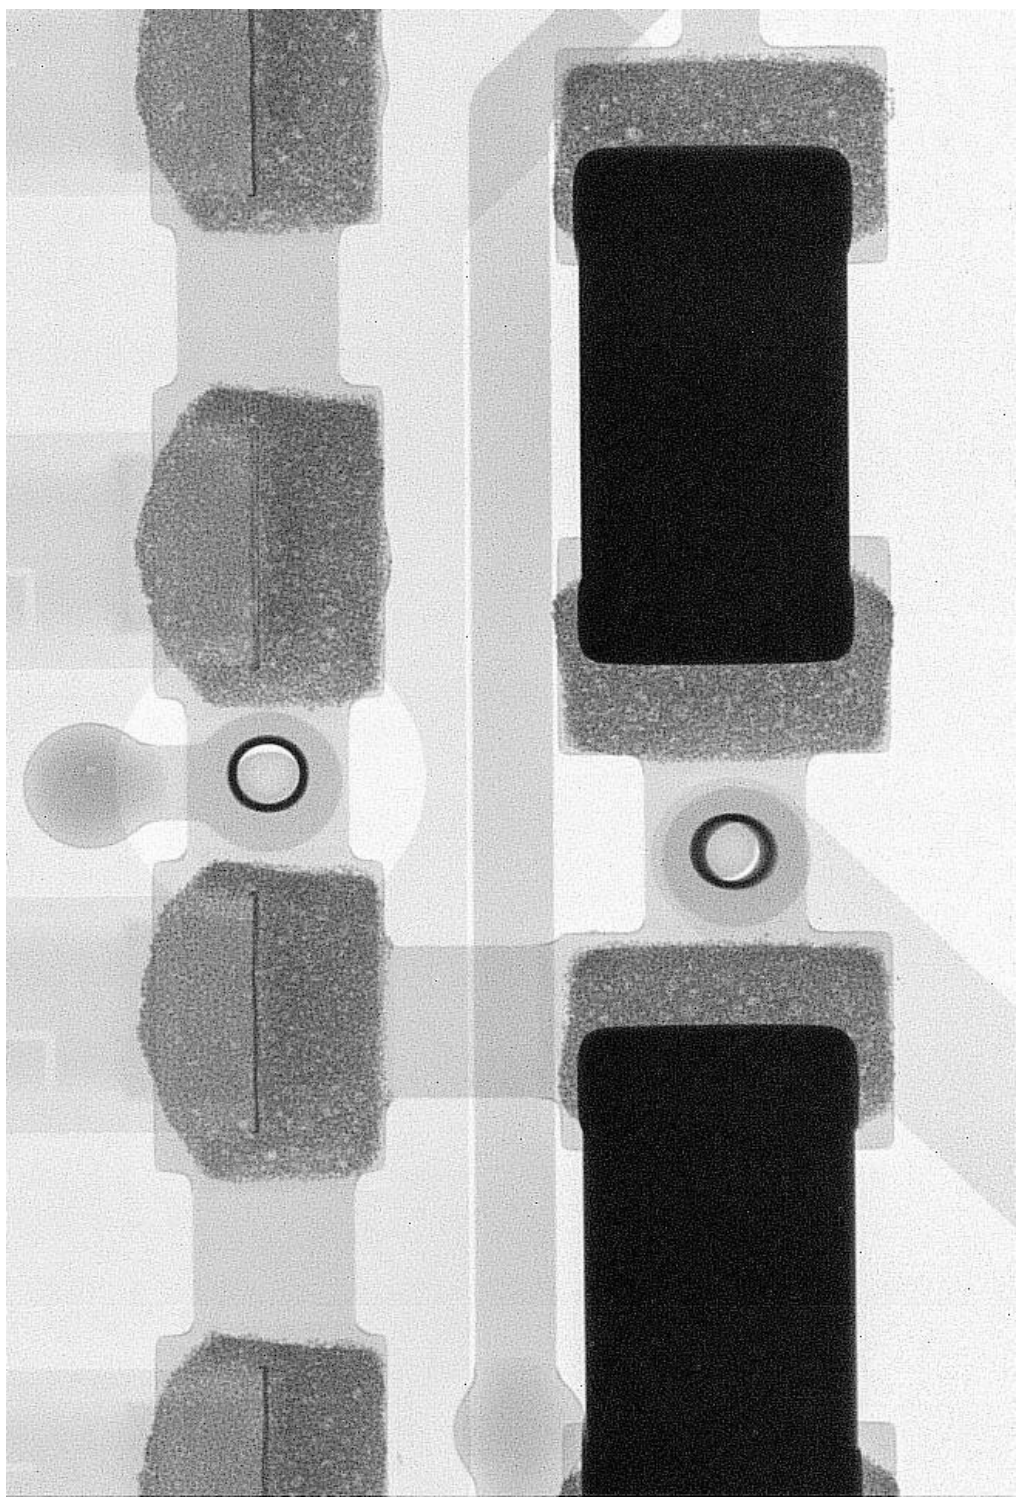
Figure 17

Using the Home Plate or Wendy House aperture shape on this pad gave some improvement, as can be seen in figure 17 this shape is better suited to the two components on the right-hand side (1206's) rather than the 0603 components on the left-hand side of the image. Pad design and the volume of solder required to make a good joint have a major effect on this. The larger components needing more solder to achieve a good joint fillet than the smaller 0603. Therefore, there is no excess solder to form solder balls or splatter around the components.

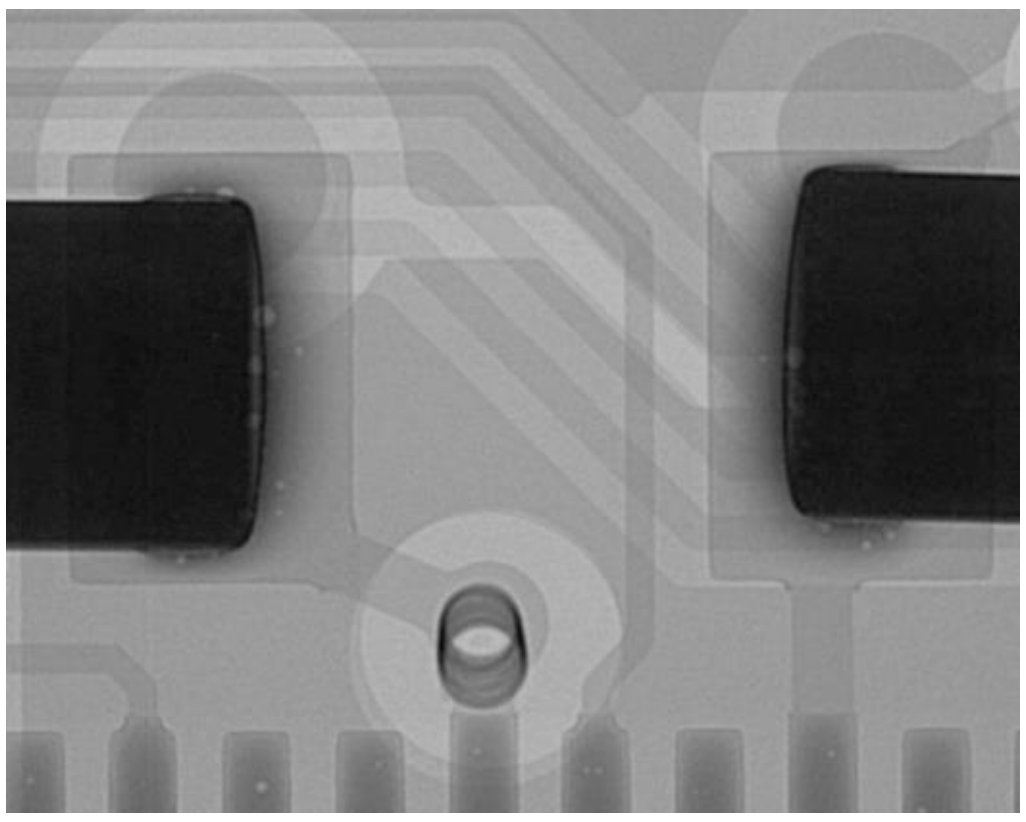
Figure 18

This shape and volume on the 1206 components produced consistently good results with joints as can be seen in Figure 18. Once more a good strong joint, a well-covered pad and no evidence of solder balls.

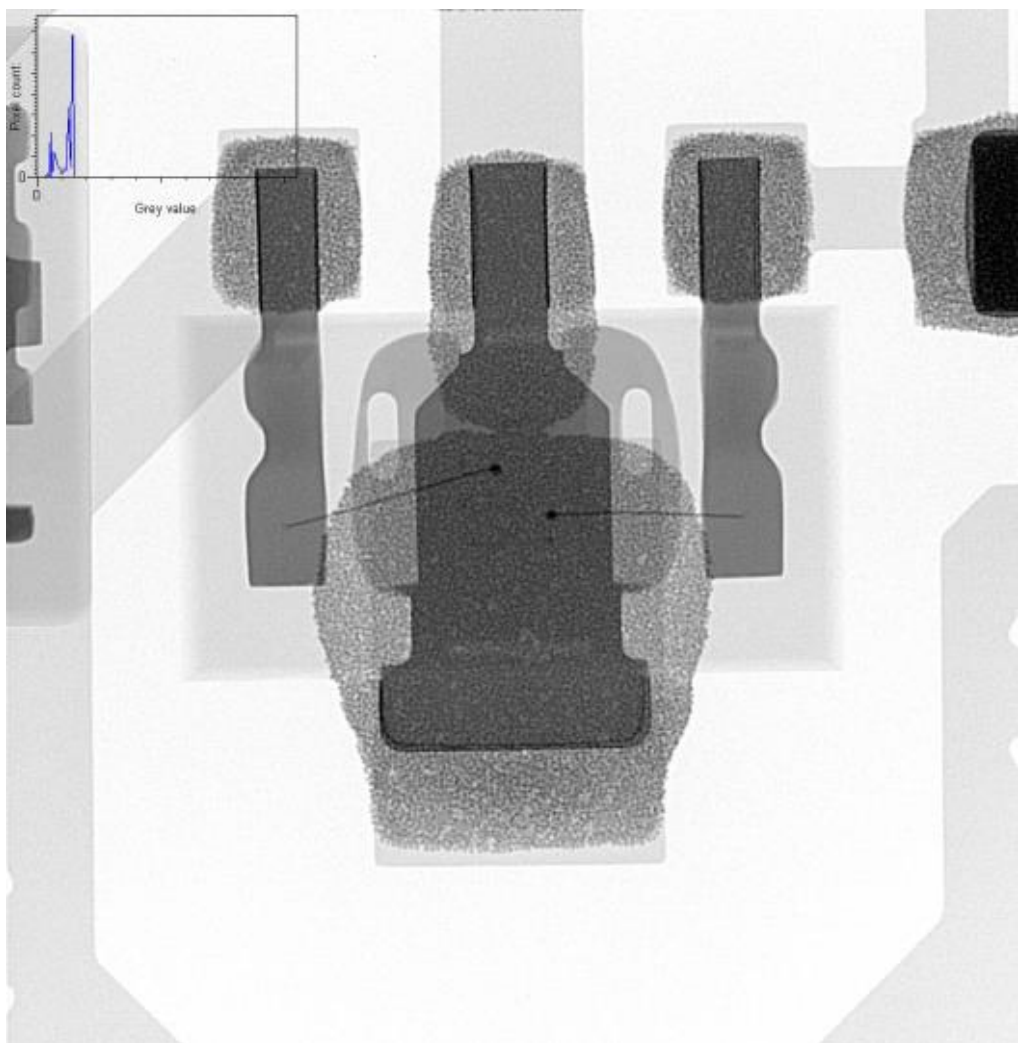
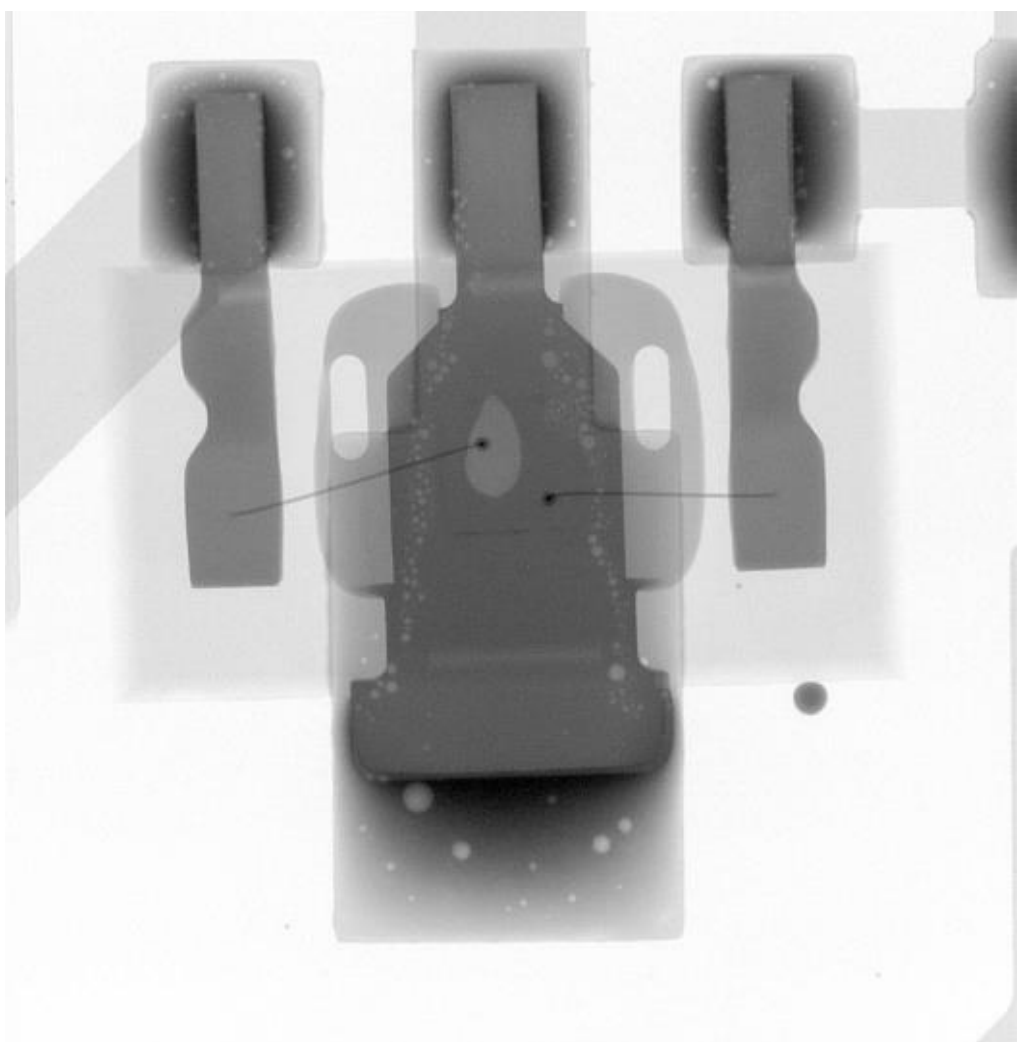
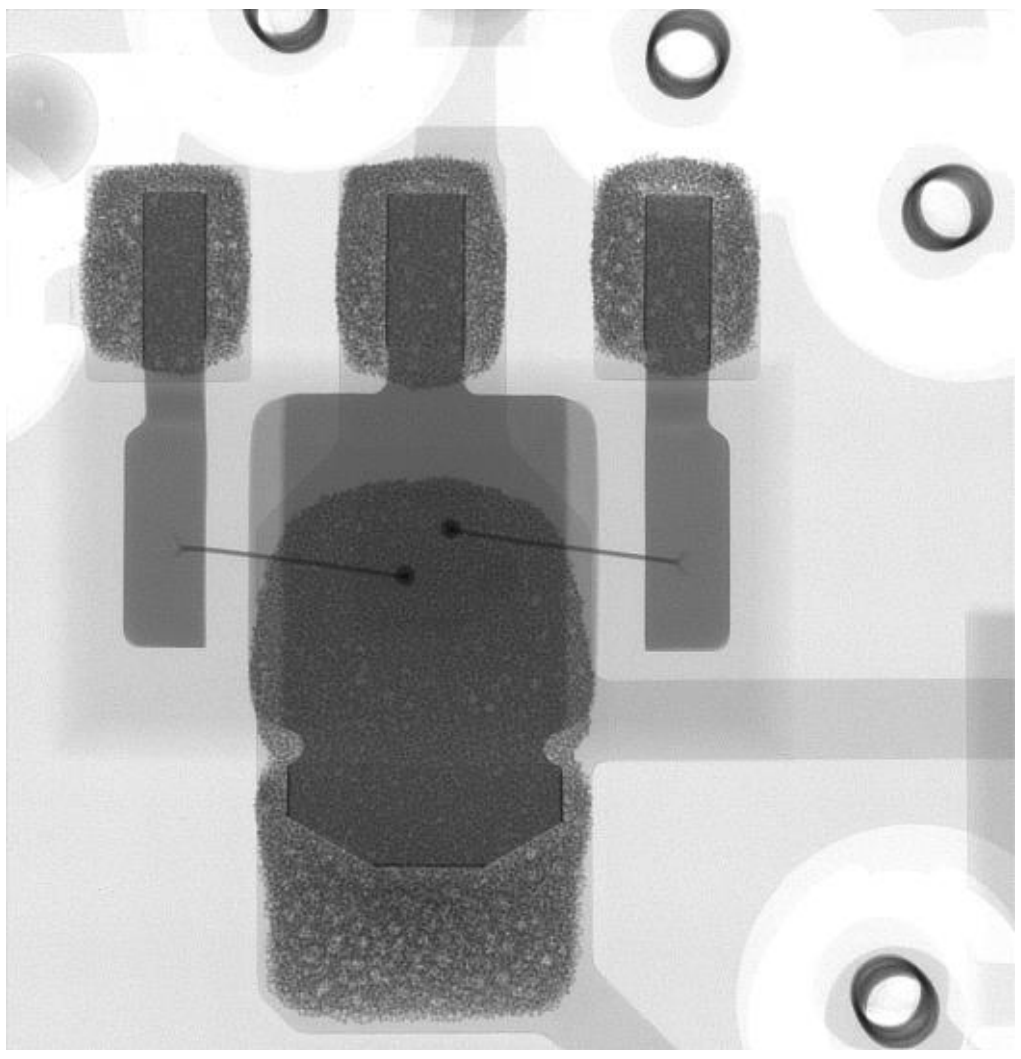
Figure 19

The SOT 89 components presented more complex challenges due to the number, shape and size of the legs and potential issues of co-planarity which are normally countered by having extra solder paste volume to allow for any differences in height, which would be caused by the 3 smaller component legs not being parallel to each other or in line with the larger thermal pad, allowing them to rest flat onto the 4 pads of the device. It can be easily seen from the top x-ray picture in figure 19 that the solder paste is spread well outside the large pad of the device. This led to the formation of the large solder ball visible in the next picture down. To overcome this issue the pad width was reduced still further, and a Wendy House shape was used at the front of the pad. This achieved the satisfactory result seen in the bottom picture of Figure 19; no failures were seen after this shape was adopted for the SOT89 devices
