TIN FLAKES/SPLASHES IN SMT

Jose M. Servin, Miguel Dominguez, Tabata Nöthel, Indira Vazquez,
Pedro Juarez, Ivan Roman
Continental

ABSTRACT

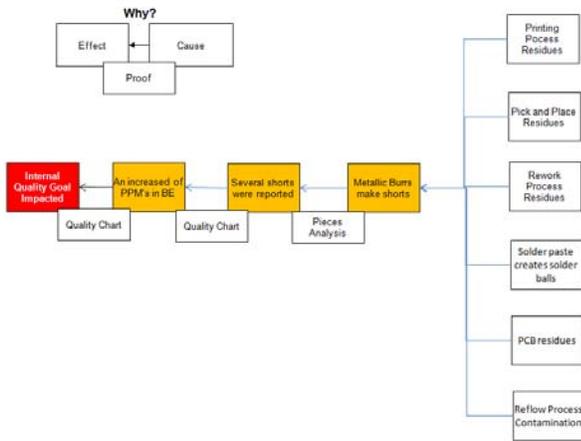
Figure 6. Initial Cause-Effect Tree (CET).

In order to find the root cause, a Cause-Effect Tree (CET) was proposed and done from an initial brainstorming, Figure 6. In this methodology, one put the effects on the left of the causes. Two important modifications are done, first, the brainstorming is only to find the first causes, as scientific approach, and no energy is spend to name further causes. Second, in order to advance, every first cause has to be proved or disprove with objective facts, not only by guessing or logical views.

Following the effect-cause chart, several sources of metallic burrs, or particles are pointed to. If we apply the procedure correctly, every possible cause has to be proved with objective proof; otherwise they cannot be discarded.

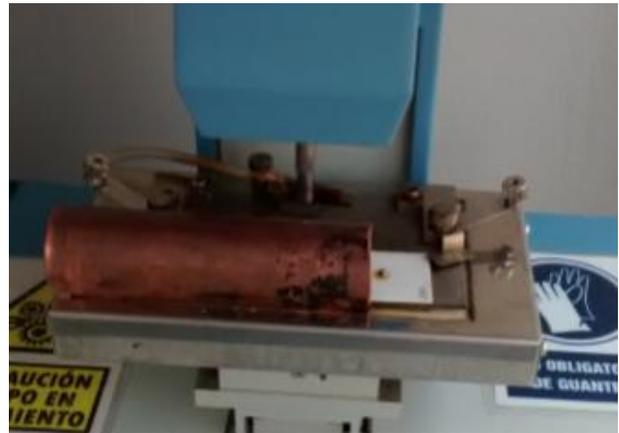
Figure 20. Solder paste analysis for ball forming

Below you will see how the experiment was set. In Figure 20, the ceramic slide, half copper pipe, and the hot plate are observed. In the Figure 21, the half copper pipe and the ceramic slide are observed.

The residues adhered on the copper found can be divided into two groups: flux and solder balls. The flux residues can be in Figure 22 and is only flux splashing and not causing any issue. The solder balls of similar size to solder powder are shown in the Figure 23 and are too small to cause any issue. They are not similar to the problematic metallic burrs. This cause is ruled out too.

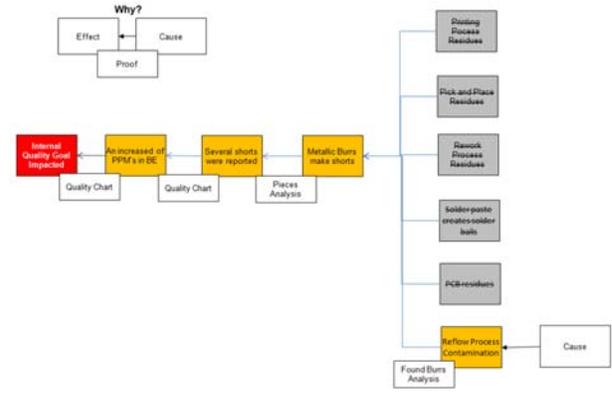
Figure 27. CET with new cause

Continuing with the CET analysis, see Figure 27, we found the most probable burrs that have made shorts coming from inside of the reflow oven. However, the oven itself cannot make the burrs.

Modifying the profile was discarded due to the fact we don't know where the burrs come from.

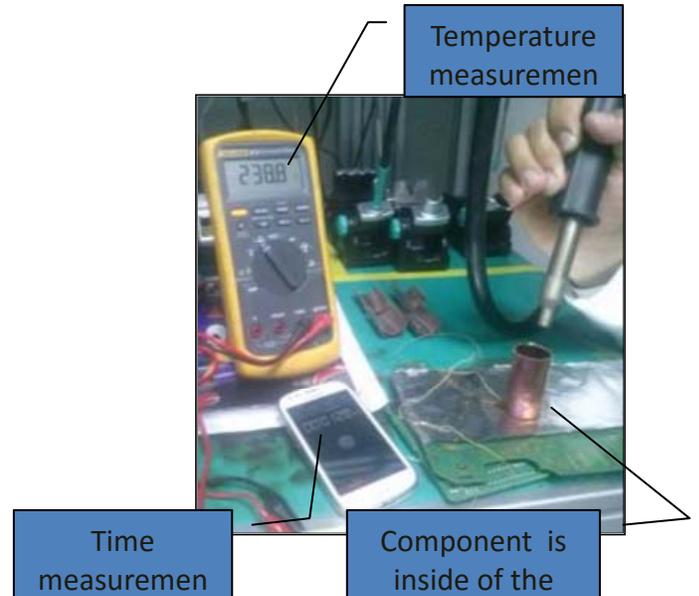
Figure 31. Arrangement of Test 2

catch any possible material detaching or jumping in the test. A thermocouple was used in order to monitor and control the reflow temperatures. The heating time was similar to the reflow profiles. You see the arrangement in the below image.

Several metallic burrs were also found in the second test. Most of them were found close to the component on the aluminum tape, but some also were found on the copper pipe surfaces.

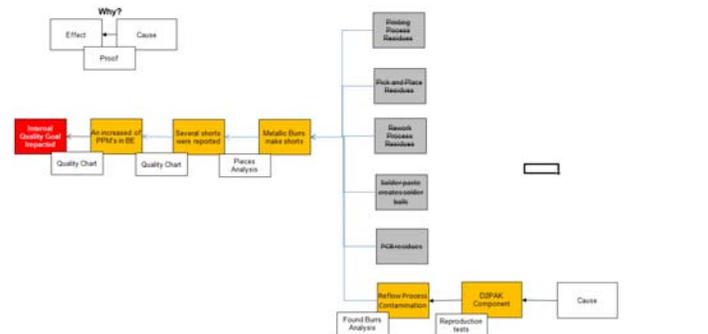
Figure 34. CET with new causes, version 3

The source of the flakes is the D2PAK component metallization. In order to reduce the non-conformities a containment action was set: the suspicious date code was removed.

A complaining was delivered to the supplier in order to get the root cause of these flakes and the CET was modified to add the possible root cause, see Figure 34.
