Bare Board Material Performance after Pb-Free Reflow

Abstract:

The High Density Packaging Users Group (HDPUG) consortia completed an extensive study of 29 different bare board material and stackup combinations and their associated performance after 6X Pb-free reflow at 260°C. Data presented will focus on the air-air thermal cycling, IST testing and material survivability after Pb-free assembly reflow portions of this testing. Test board design aspects, manufacturing processes, Weibull analysis, and failure analysis data will be presented. The impact of plated through hole pitch on laminate integrity and how material properties relate to the results will be discussed.

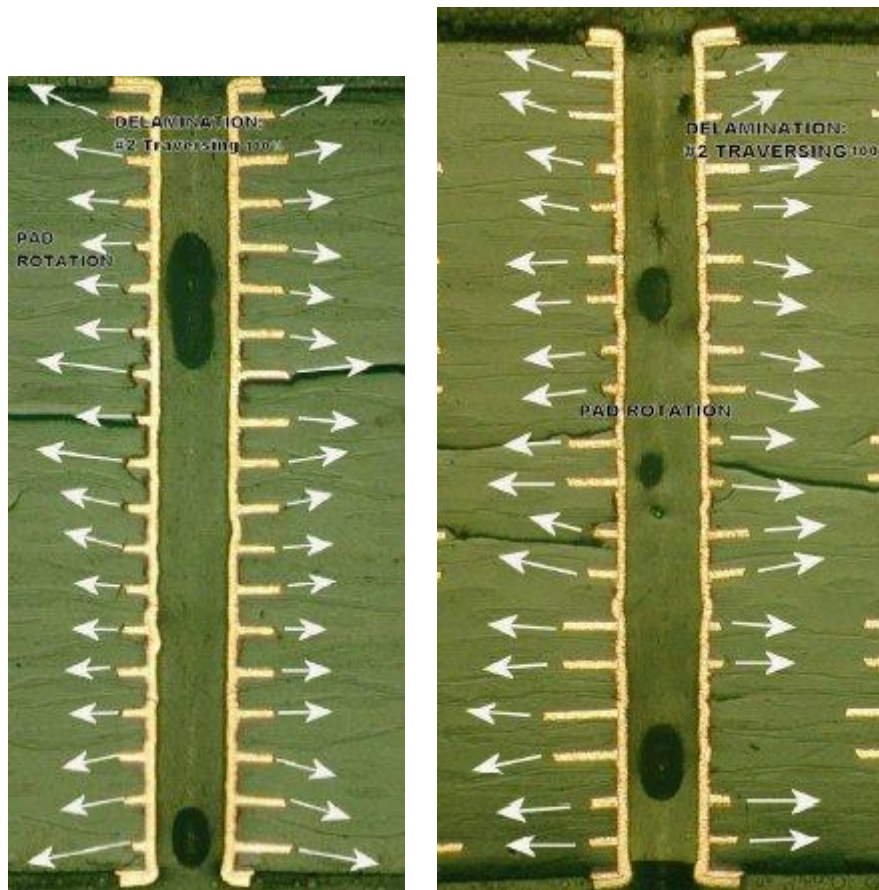
Noted elsewhere in this report (and reported for other testing^{8,9,10}) are examples of reflow simulation appearing to extend the cycles-to-failure of ATC and IST coupons relative to coupons that didn't undergo this preconditioning. Associated with reflow simulation-induced laminate cracking within the test coupon, Bill Birch of PWB Interconnect Solutions has attributed this to stress redistribution. Figure 16 shows examples of vias that experienced more cycles before failure compared with the case for sister coupons that did not experience reflow simulation. The directions of bending of the internal lands suggests that the vias essentially became subdivided into two zones, thereby extending their apparent lifetimes beyond what they would be in the absence of what is surmised (see above) to be otherwise undesirable laminate cracks.
