## **DIELECTRIC MATERIAL DAMAGE VS. CONDUCTIVE ANODIC FILAMENT FORMATION**

Paul Reid M. Sc.  
PWB Interconnect Solutions Inc.  
Nepean, Ontario, Canada  
paul.reid@pwbcorp.com

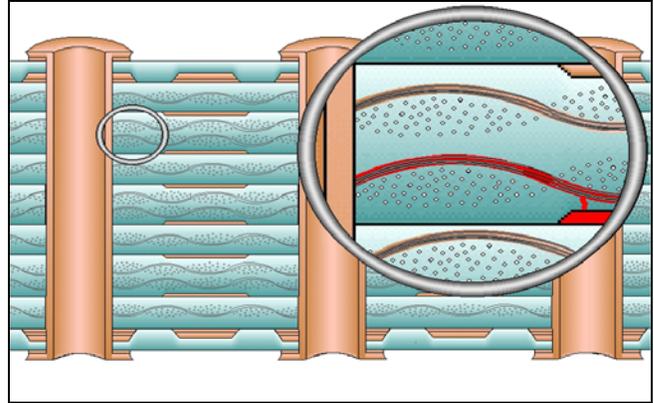
What appears to happen is that a very thin branching conductive path will form between two adjacent conductors until it produces an electrical path. Once the salts form a conductive path that path is initially very weak and it is destroyed by the arching of electricity. The short destroys some of the conductive path but not all of it. The path then reforms a more robust connection until the short forms again. This continues until a ‘hard’ short is formed at which time the copper can melt and the circuit board may catch on fire. Figure 5 illustrates how CAF (shown in red) can migrate along a glass bundle from the drilled hole wall across to an adjacent feature.

Figure 5. CAF shorting along a crazing type delamination

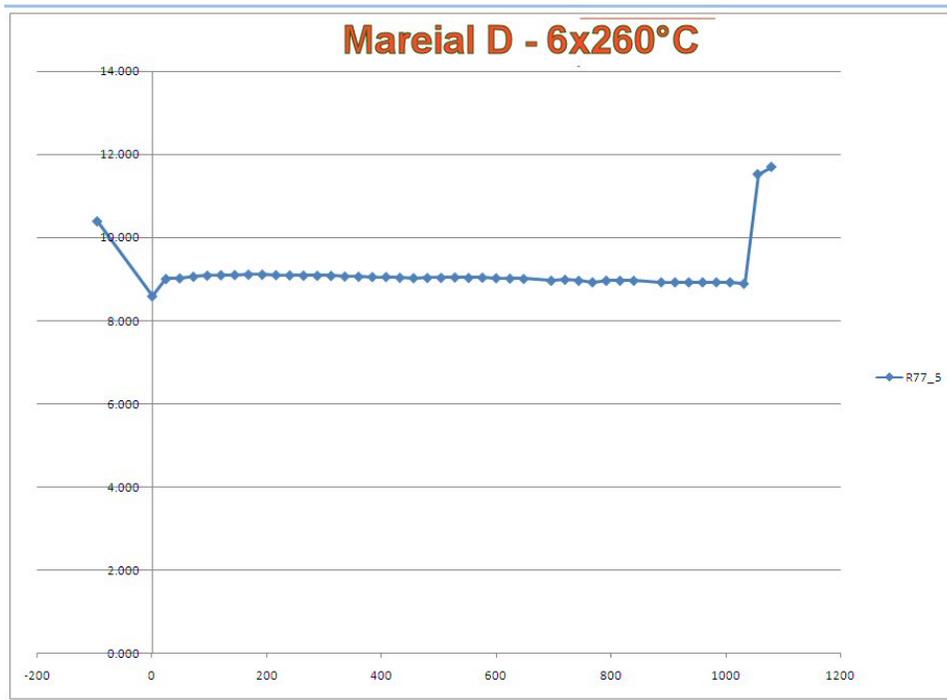
The graph 1 below represents material “D” which did not have a failure after 1000 hours in the humidity chamber. The graph 2 is of material “AA” which demonstrates a CAF failure some time after 800 hours.

**Graph 1. Material D – No Failure**

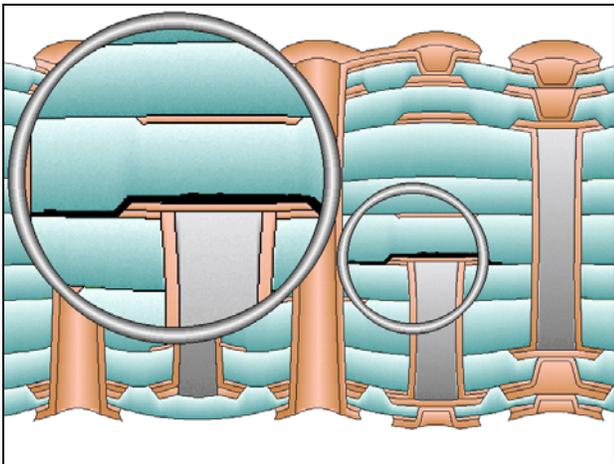
Adhesive Delamination is a separation between two laminated surfaces. It is usually between the B-stage and C-stage, B-stage and copper foil or between the glass bundle and the adjacent epoxy. This type of failure looks like a blister on microsection and usually ends in a single point that rarely branches. This is the only type of material damage that can respond to baking by driving down the amount of volatiles, like water, that are absorbed within the dielectric material. The problem is it is rare that baking will avoid the risk of delamination.

Figure 6. Example of Adhesive Delamination between B stage resin and copper plating

It is suggested that baking at 105°C for four hours is adequate to remove most of the latent moisture. Baking for a longer time or at a higher temperature can cause a degradation to the material that could increase the level of internal material damage.

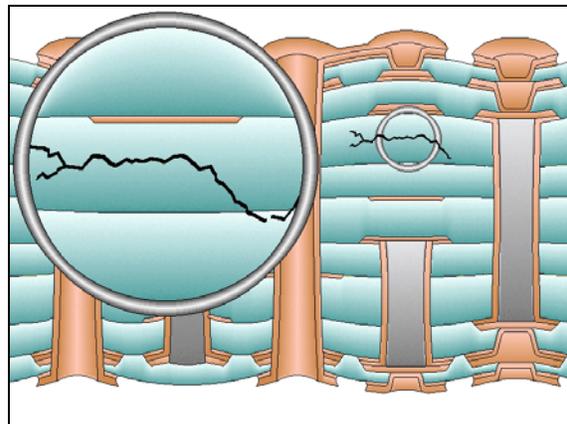
Cohesive cracks tend to produce cracks in the epoxy that go through the C-stage, B-stage layers and glass bundles. These cracks tend to go off in any direction and frequently branch, ending with multiple points. What appears to happen during multiple high temperature exposures is the material becomes over cross linked, shrinks, builds up stress and then ultimately cracks.

There are many factors that cause cohesive failure, like problems in lamination or material that is beyond its shelf life. One of the most common causes is lead/free assembly and rework. Assembly temperatures of 260°C are at the limit of what most modern, FR4, materials can withstand. Of the 24 material tested we had 15 that showed various degrees of material damage, cohesive cracking was the most prevalent in this study.

Figure 7. Cohesive Cracking Failure

When confronted with cohesive failure one should consider changing the material to one that is more robust in your assembly environment. Also it would be prudent to limit the temperature and the number of thermal excursions that are used for assembly and reduce the need for rework cycles. The goal of the assembly profile is to achieve a reliable solder joint at the lowest temperature possible.

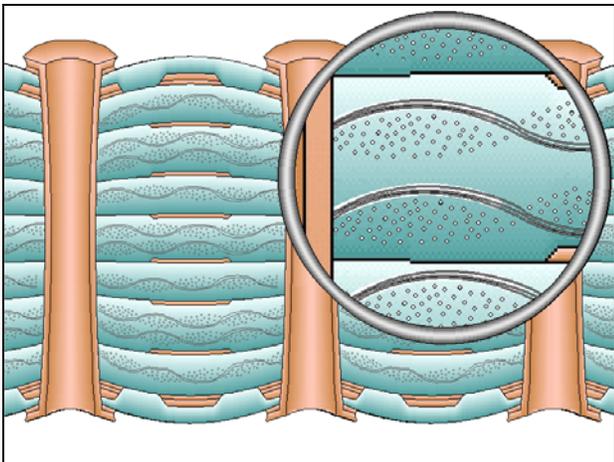
Crazing is a separation between the individual glass fibers within the glass bundle of the dielectric material. This type of material damage is not visible upon visual examination but it is seen in microsections as a silver separation running down groups of glass fibers. The silver sheen fluorescing from air gaps between the epoxy and the individual glass fibers. This type of material damage is particularly found when the grids size spacing is reduced to 0.6mm (.024”) or less. This type of material damage is a concern in CAF formation.

Crazing is usually associated with copper wicking at the drilled hole side wall (see photo 11). It appears that there is capillary action that aggressively draws water up the separation between the epoxy and the individual glass fibers.

**Figure 8.** Crazing

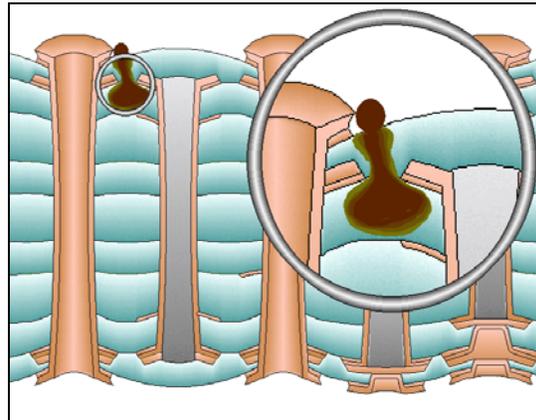
Material decomposition is visually obvious in that it produces a blackening of the dielectric material and in extreme cases black balls of carbon on the surface of the PWB usually adjacent to holes. This occurs when one uses low end/cost material in a lead free application. This is a rare type of material damage. None of the materials in our study exhibited Material Decomposition.

**Figure 9.** Material Decomposition
