Impact of Assembly Cycles on Copper Wrap Plating

Hardeep Heer, Ryan Wong, Bryan Clark - FTG Corporation
Bill Birch, Jason Furlong - PWB Interconnect Solutions Inc.

Abstract:

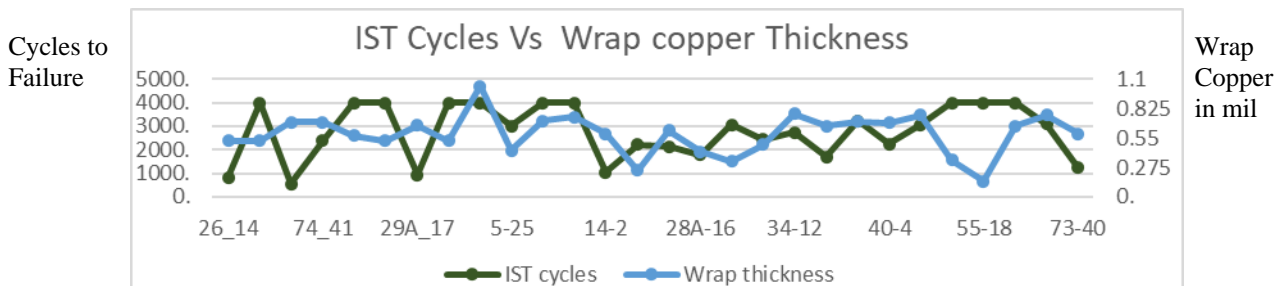
Plot #1

In addition, twenty eight of the tested coupons with various cycles to failures were sectioned. Copper wrap thickness and barrel copper plated thickness was measured on these coupons. IST cycles and plated wrap thickness data were plotted against each other (Plot#1) and likewise, IST cycles and copper plating in the barrel of the via was plotted against each other (Plot # 2). It was also noted that the coupons for the same part number with thicker barrel copper plating had higher cycles to failure. A clear correlation between barrel copper plated thickness and IST cycles was observed.

Covariance analysis between IST cycles and barrel plating thickness, and between IST cycles and copper wrap plating thickness was performed. Covariance between IST cycles and copper wrap plating thickness was 0.0517 whereas the covariance between IST cycles and barrel copper plating thickness was 0.694, indicating that barrel copper plating thickness has significant influence on IST cycles to failure. Minimum copper wrap plating thickness on the twenty coupons was 3.63 μ m (143 μ in) and this coupon did not show any failure at 4,000 IST cycles. None of the coupons sectioned had zero copper wrap plating (Class 1) as such reliability of the Class 1 (no wrap) condition could not be established.

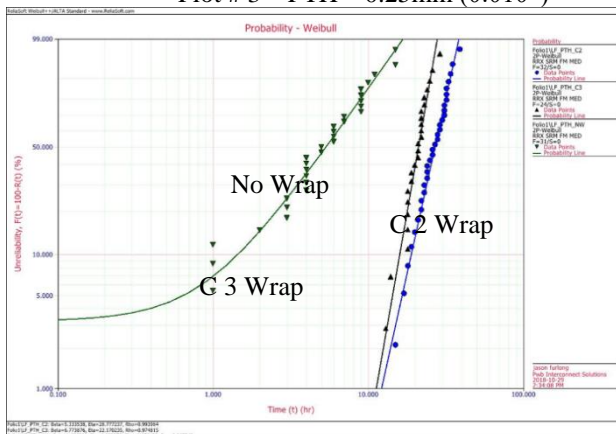
Plot # 3 – PTH – 0.25mm (0.010”)

Weibull Plots # 3 and #4 for 0.25mm (0.010”) and 0.4mm (0.016”) through vias showed that coupons with no wrap plating had butt joint and/or barrel cracking types of failure. Whereas Plot # 3 for 0.25mm (0.010”) buried vias had barrel cracking failures. Weibull charts Plot #5, #6, #7 and #8 also showed that Class 2 samples for through vias performed better than Class 3 samples. Analysis of resistance plots showed that resistance for PTH vias with Class 2 wrap was lower than the resistance for Class 3 wrap vias. This can mean that the copper thickness for Class 2 wrap was higher than the panels with Class 3 wrap.

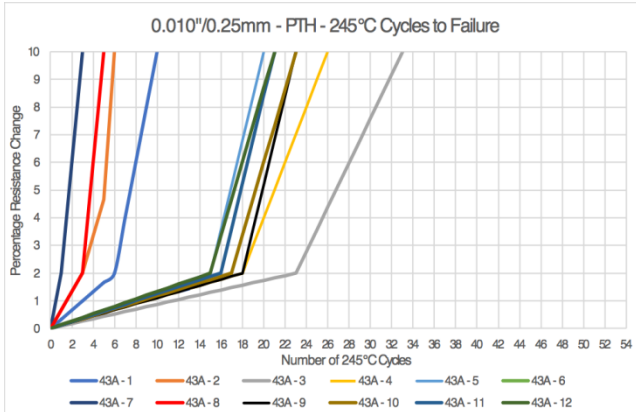
Plot # 9 – 0.25mm (0.010”) -PTH-245⁰ C to Failure

Plot # 9 and 10 are resistance plots for through vias for all three types of wrap conditions. Plots show that there is a gradual change in resistance to 2% and then the change in resistance accelerates at a much faster rate. For 0.25mm (0.010”) through vias coupons with no wrap, this change happens below 2 cycles and for 0.4mm (0.016”) through vias they went as high as 6 cycles. Whereas, for through via with Class 2 and Class 3 wrap the change in resistance to 2% started to happen beyond 14 cycles for 0.25mm (0.010”) via and 20 cycles for 0.4mm (0.016”) vias.

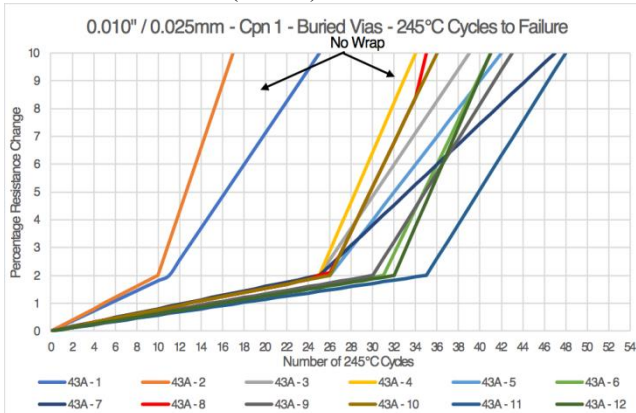
Plot # 11 – 0.25mm (0.010”) - Lot 1-BV -245⁰ C to Failure

Buried vias (see Plot # 11 and #12) lasted longer than through vias. No wrap coupons went past 10 cycles before >2% change in resistance was observed. At the same time Class 2 and Class 3 coupons did not change by >2% after 25 cycles. Another observation was that buried vias without cap plating performed better than buried vias with cap plating. Typically a PWB will go through a maximum of 6 assembly / repair cycles. In both cases for buried vias these coupons went well beyond 6 cycles.
