# INTERMITTENT CONNECTOR FAILURES IN ELECTRONIC ASSEMBLIES

Aravind Munukutla and Anil Kurella  
Intel Corporation  
Hillsboro, OR, USA  
aravind.munukutla@intel.com

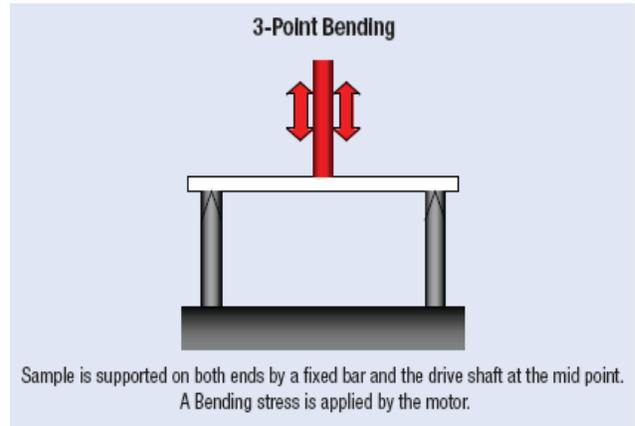
**Figure 7.** Schematic of 3-point bending [5] DMA analysis of the solid thin strips shows higher stiffness for HTN across any temperature range when compared to LTN as seen in Figure 8 & figure 9. The storage modulus values collected here are comparable to literature data points [6] as shown in Figure 10.
