## **“Metal Whiskers” Does Surface Contamination Have an Effect of Whisker Formation?**

**Terry Munson / Paco Solis**  
Foresite Inc.  
Kokomo Indiana

### **Abstract:**

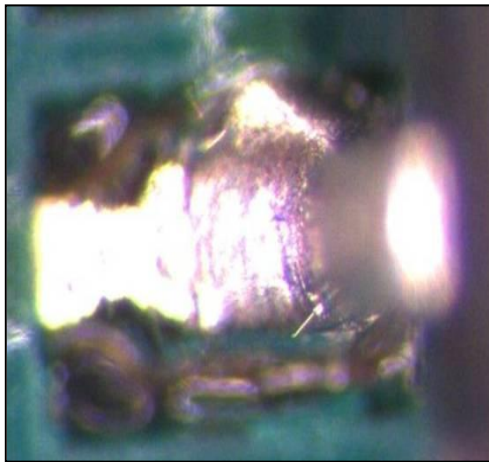
**Figure 12**

The ion chromatography data below shows high Chloride, sulfate, and Ammonia contaminations coinciding with the highest occurrences and density of whisker growth (shown in red).
