Reliability and Failure Mechanisms of Laminate Substrates in a Pb-free World

Kevin Knadle
Endicott Interconnect Technologies, Inc.
Endicott, NY

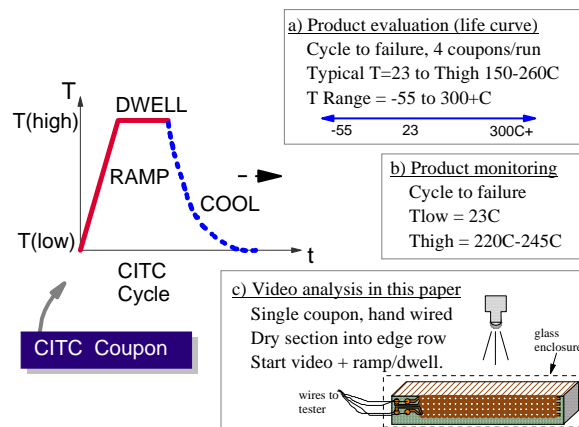
Figure 2--Definition of CIRC test including use for videos in this paper.
