Influence of Salt Residues on BGA Head in Pillow (Hip)

J. Servin, C. Gómez,
M. Domínguez, A. Aragón
CONTINENTAL CUAUTLA
Av. Ignacio Allende Lote 20
Parque Industrial Cautla
Cd. Ayala, Morelos 62749, México
E-mail: jose.servin@continental-corporation.com
cynthia.gomez@continental-corporation.com

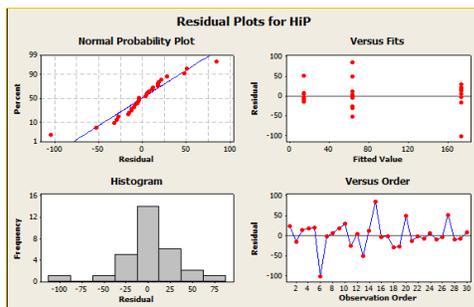
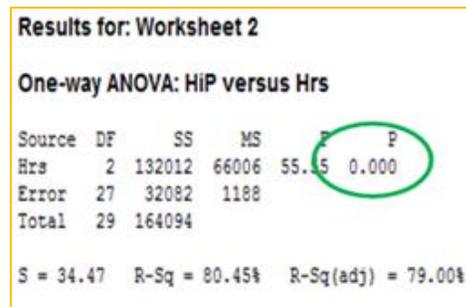
In residual plot analyses, see Figure 3(a), we can see there are some outliers, but we would consider these have low influence. The model would give good correlation, although the variances are influenced due to the final value, see top-right graph in Figure 3(a). The p-value is lower than 0.05, see Figure 3(b). This means the time under the salt containing steam has influence on BGA HiP.

Figure 3. (a) Residual Plot Analysis, (b) Result for DOE 1 Anova: HiP versus steaming hour

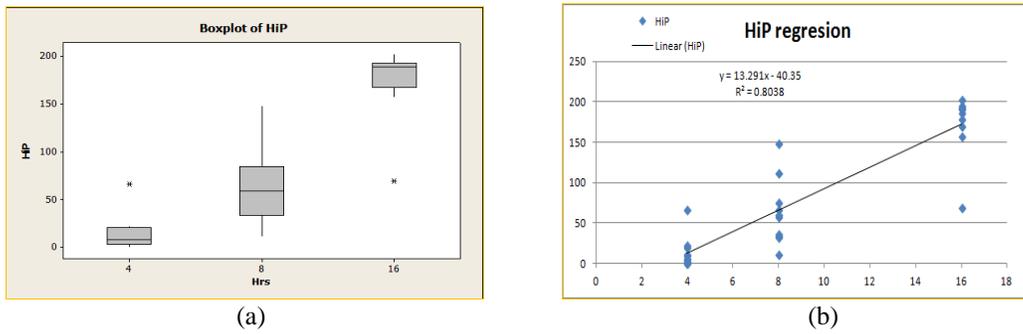
In the box plot, Figure 4(a), the results of HiP created per component versus time are shown. The more time, the more HiPs are created up to making the entire component not solderable. Because there is a clear relationship between HiP and time, a linear regression is proposed, see Figure 4(b). The linear regression has a R^2 of 0.80 which is an acceptable correlation.

Figure 4. (a) Box-Plot Graph: The results of HiP number versus time, (b) Linear regression with a R^2 of 0.80 (good correlation)

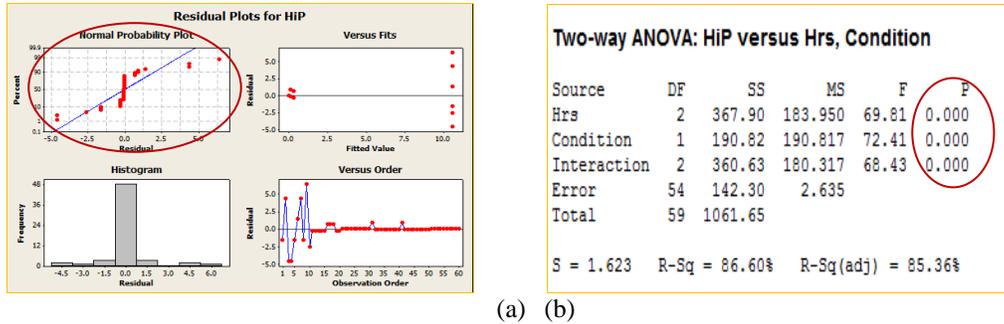
In residual plot analyses, see Figure 7(a), the normal distribution has a big deviation (See the left-upper graph). There are several outliers because there were results of zero HiP. The model would give good correlation although the variances are influenced due to the final values, see top-right graph in Figure 3(a). The p-values are lower than 0.05, see Figure 7(b); therefore, both conditions (Water condition and Exposure Time) and their interaction have statistical influence on BGA HiPs.

Figure 7. (a) Residual Plot Analyses, (b) ANOVA Table, the p-values are below 0.05 so factors are statistically significant

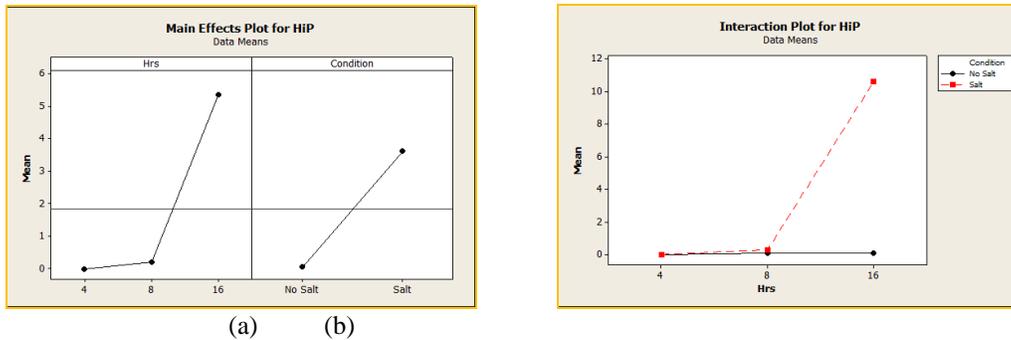
With respect to the analysis of results, the Main Effect Plots, see Figure 7(a), show the more time the more HiPs are created. The highest result is at 16 hrs. With respect to water conditions, the salt presence creates more HiPs. The interaction plot shows that presence of salt speed up more HiPs after 8 hrs of exposure, see Figure 8(b). When water has no salt, HiPs are not created.

Figure 8. (a) Main Effects Plot show the more time, the more HiP, (b) Interaction Plot shows that presence of salt brings about HiP

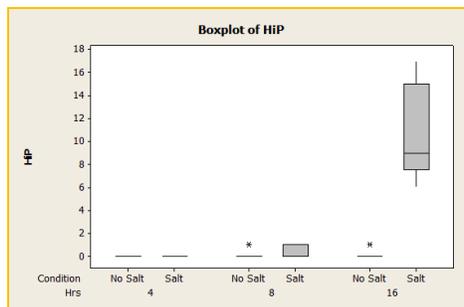
To verify the HiP distribution per level, a box plot is shown. The tendency is similar to the DOE 1 but the number of HiPs are much lower. This can be explained because the concentration of NaCl is lower in the experiments (10% + tap water to 0.1 % in DI water).

Figure 9. The Boxplot shows that HiP defects are lower than those shown in the DOE 1

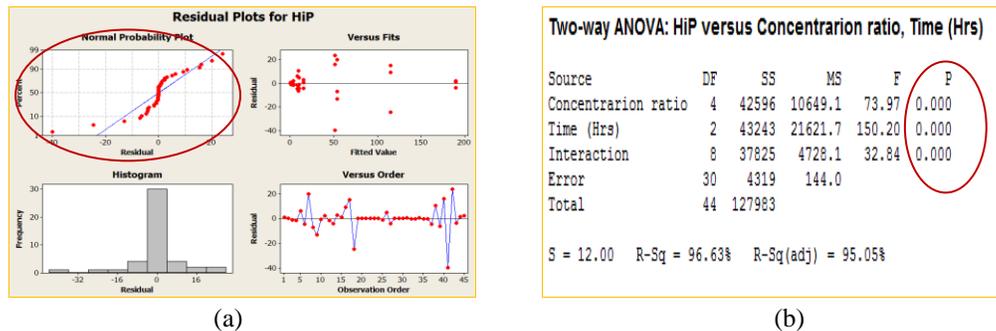
The results presented in the residual plot analyses, see Figure 11(a), show the normal distribution has a small deviation and correlation (see top left graph). The p-value are below 0, see Figure 11(b); therefore, both conditions (Concentration and Exposure Time) and their interaction have statistical influence on BGA HiPs, and the error are accepted.

Figure 11. (a) Residual Plot Analysis, (b) ANOVA: HiP versus Concentration, the p-values are below 0

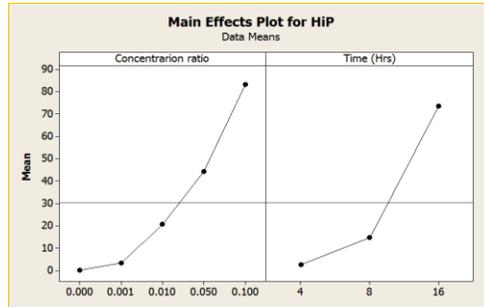
The Main Effects plot for HiP, see Figure 12, shows the relationship between the concentration and type of defects HiP. On the left side shows the relationship between HiP and time. It is observed that the higher concentration the greater HiP defects, and with a more prolonged time the greater is HiP. This is also seen in Figure 13, with the plot for HiP Interactions.

Figure 12. Main Effects plot for HiP versus concentration and time

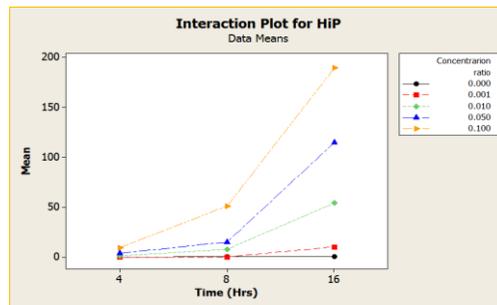
Figure 13. The Interaction plot for HiP in DOE 3

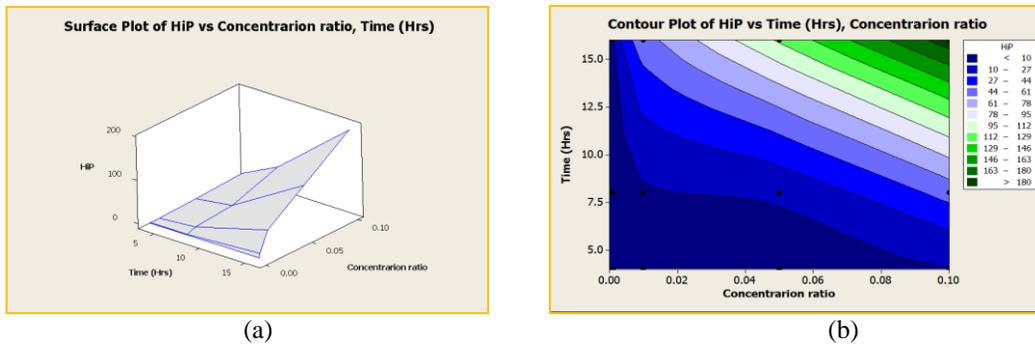
Figure 14(a) graph displays the Surface plot of HiP, and (b) is the 2D graph for visual. It indicates the number of HiP regarding the type of concentration and time.

Figure 14. (a) Surface plot, (b) Contour plot of HiP versus time (Hrs)
