“Metal Whiskers”

Does Surface Contamination Have an Effect of Whisker Formation?

Terry Munson / Paco Solis
Foresite Inc.
Kokomo Indiana

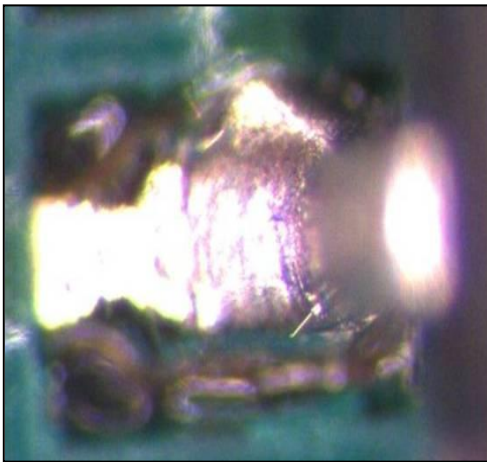
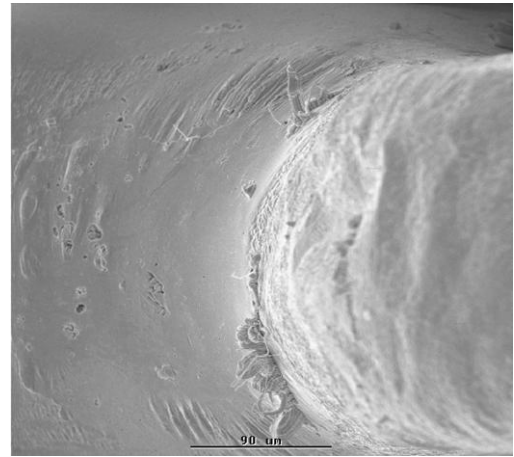
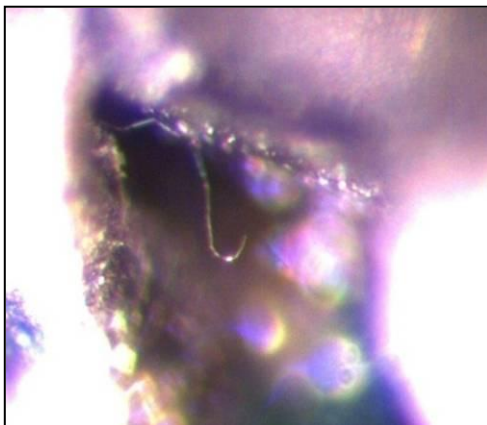
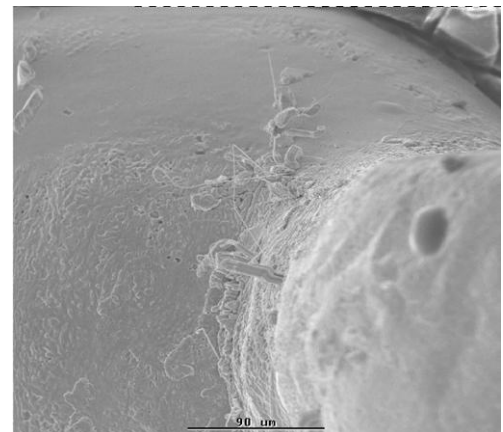
Figure 12

The ion chromatography data below shows high Chloride, sulfate, and Ammonia contaminations coinciding with the highest occurrences and density of whisker growth (shown in red).
