THE QUANTITATIVE ASSESSMENT OF MIXED BGA JOINT WITH THE ELIMINATION OF LOW-MELTING POINT ALLOY RE-MELTING PROCESS

Hongqin Wang, Guanghui He and Daojun Luo
China Electronic Product Reliability and Environmental Testing Institute
Guangzhou, China
wanghongqin2013@163.com

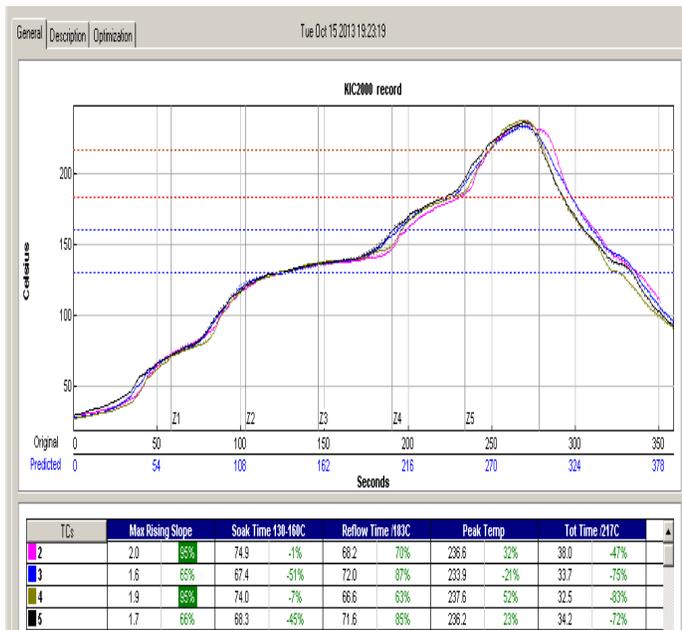
Figure 1. Representative reflow profile

The reflow soldering oven had five temperature zones of which the last two zones were the peak zones. The representative temperature-time profile was measured with a type K thermocouple, as shown in Figure 1. The reflow soldering process parameters were summarized in Table 1. The mixed solder joint did not experience or experience the waving process as shown in Table 2. The wave soldering process parameters were summarized in Table 3.
