## **Review of Interconnect Stress Testing Protocols and Their Effectiveness in Screening Microvias**

### **Abstract**

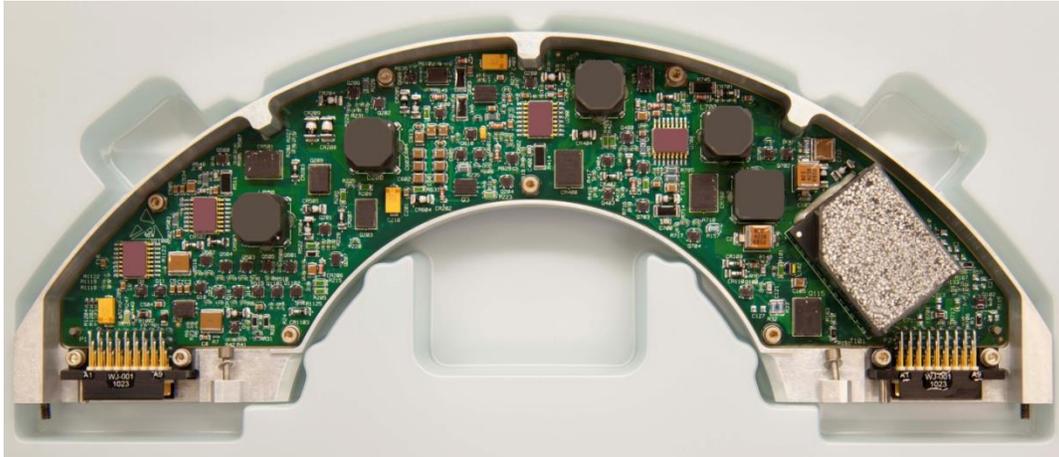
**Figure 1 - PWA Top**

The resistance in this circuit is only allowed to vary by 10  $\Omega$ , and an absolute resistance greater than 100  $\Omega$  would constitute a failure. An exhaustive troubleshooting procedure was undertaken to determine the root cause of the monitor circuit problem. Setup for the test isolated the trace by removing all parts, leaving only the suspect trace. The removed parts were then inspected and tested with no anomalies noted. Thermal cycling showed that the resistance of this circuit (two microvias and buried trace) spiked randomly up to, but not over, 500  $\Omega$  during the ramping of the temperature during thermal cycling. A bare board was used as a control unit during this thermal cycling. The resistance of the monitor circuit on the control unit changed in a linear and predictable manner consistent with the thermal changes. The conclusion is that there is a disturbance in the trace that could be attributed to a microvia failure and that this disturbance is isolated to one location, preventing full performance of the module. After this bench testing, a destructive physical analysis was conducted. The locations of interest can be seen in Figure 3 and Figure 4.
