Lessons Learned While Investigating Microvia Reliability Failures.

Tobias Bernhard, Roger Massey, Senguel Karasahin, Frank Brüning
Atotech GmbH, Berlin, Germany

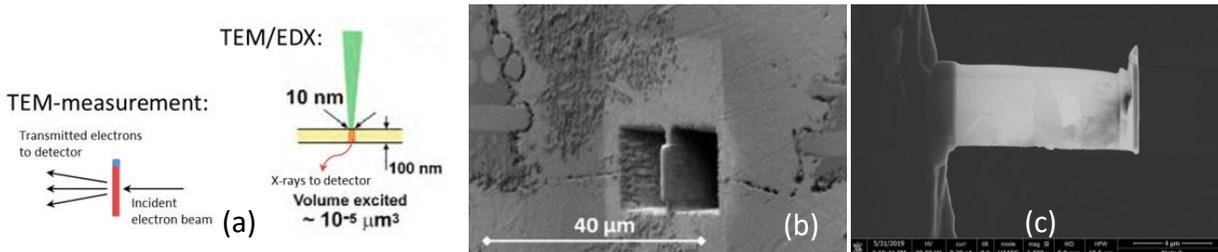
Figure 9. Schematic of TEM Technique (a) In Situ TEM Lamellae Preparation with FIB (b) and Lamellae After Removal from Sample. (c)

As the name, suggests, TEM is a transmission method, meaning that the detectors are typically positioned beyond the sample, and they collect particles following their transport *through* the sample, unlike SEM where the detectors are commonly in front of the sample and collect particles that have been scattered, reflected or emitted *off* the sample surface. TEM does require specialist sample preparation, typically involving SEM-FIB to cut a thin lamellae which can then be examined transmissibly. (Figure 8)

As a TEM sample is substantially thinner than a SEM sample, in the region of 50-100nm, there is a much lower effective beam penetration depth compared to SEM, thus enabling a lower “background” analysis during EDX and an increased elemental sensitivity detection, meaning that the lower Pd and Ni contents in an ELESS Cu deposit are more likely to be detected.
