DETECTION OF PAD CRATER INITIATION IN SHOCK USING ACOUSTIC EMISSION DETECTION

ABSTRACT

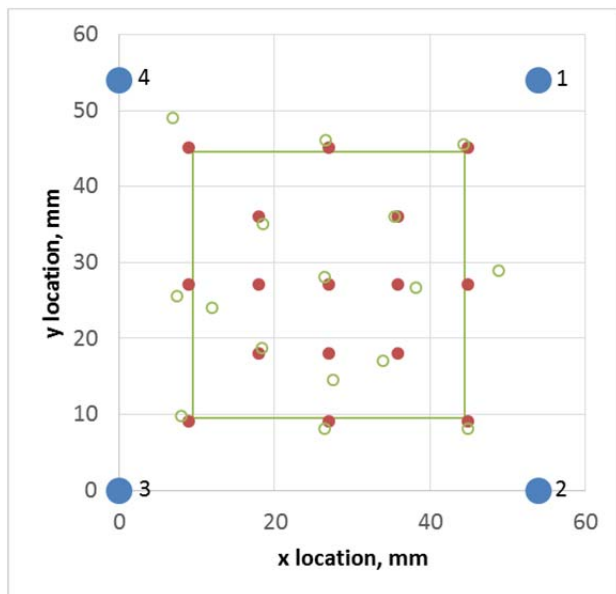
Figure 4. Sensor Location and Lead-Break Location for an Undamaged Board

The locations of events were then determined by triangulation from the times of arrival for the pulses using equations 1, 2, and 3, where x and y are the coordinates in an x - y grid, the subscript pertains to the locations of the transducers, C_c is the speed of sound in this material (3200 m/s) and t is the arrival time at a given sensor. Boron fiber breaks were used to create acoustic source events of a known location to measure the speed of sound in the material and to determine the accuracy of the triangulation method. Figure 4 shows sensor location (large circles) and lead-break location (small filled circles) for an undamaged board. The open circles estimate the boron fiber break location from triangulation equations. It was found that, in all but one case, the accuracy of the triangulation method was within ± 5 mm of the sensor location.

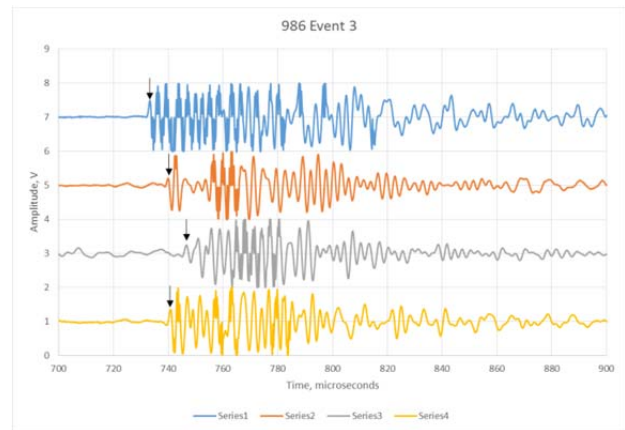
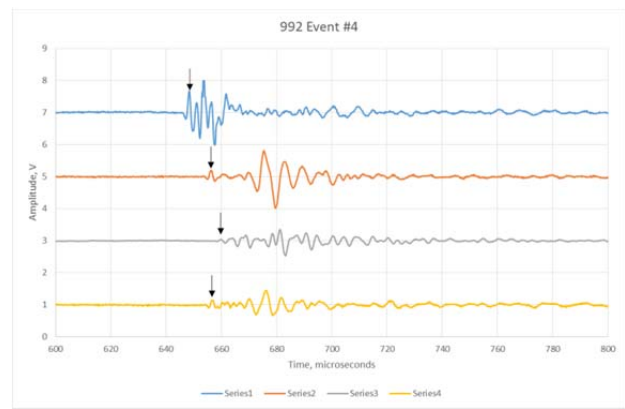
Figure 10. (a) The High Energy Event from Z986 after 275g Shock and (b) the Pulse Later in the Waveform

Two of the most successful correlations with the dye stain results were for boards Z986 and Z992. Figure 10 shows acoustic regions of interest from the pertinent waveforms for (a) board Z986 after 275g shock and (b) board Z992 after 225g shock. The frequency content of these waveforms is primarily in the 100 to 300 kHz range. The first peaks from which location analysis was performed are identified with arrows. Note that the Z986 test had the lower preamp setting but had the higher energy pulse (several peaks > 1 V). This was the only event in this test that showed a very high signal intensity of all the events which occurred within the sensor array. All other events appeared more like the event in Figure 10(b), where only one or two peaks of a given pulse exhibited a high amplitude.

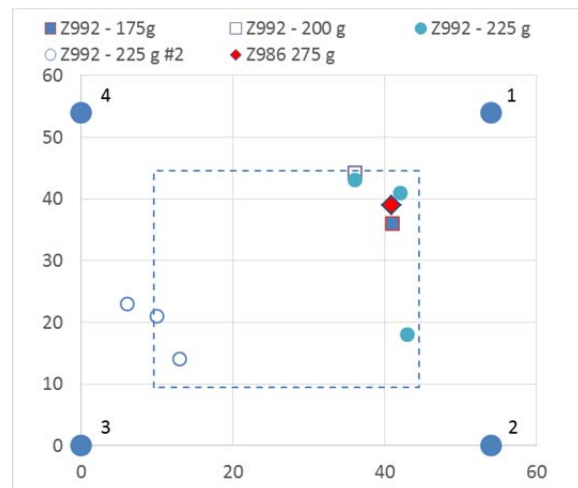
Figure 11. Location Analysis of Pulse Events from the Two Different Shock Tests for Panels Z986 and Z992

The location analysis for the two tests is shown in Figure 11. Board Z986 showed significant damage around sensor 1, which was in the region where the high energy event occurred within 0.016 microseconds of the initial acoustic signal associated with the shock event. The Z992 board drops exhibited events which occurred primarily on sensors 1 and 3 in the sequential shock tests with increasing acceleration. Note that one event did occur near sensor 2

but the other seven events occurred near sensors 1 and 3, which corresponded with dye staining.

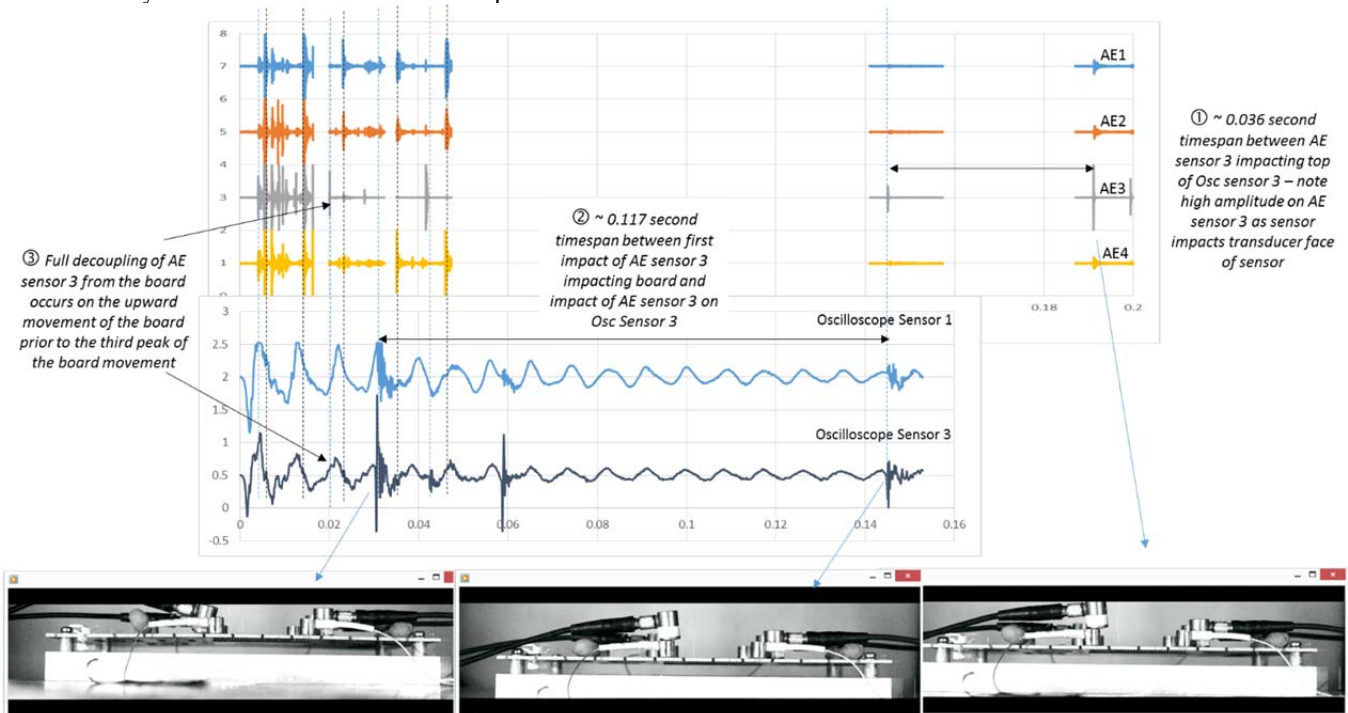
Figure 13. Comparison of AE, Oscilloscope, and High Speed Video Data

Figure 13 shows the AE waveform data from all four AE sensors (designated "AE#") pieced together from several events that were triggered and captured. Note that blank space in between data is due to the AE system not being triggered. Also shown is the data captured from the oscilloscope on sensors 1 and 3 to compare the farthest oscilloscope sensor from AE sensor impact with the nearest oscilloscope sensor to AE sensor impacts. Also shown are three frame captures from the video which could clearly be correlated with oscilloscope and/or AE waveform features.

Caption 1 corresponds to the events which occurred later in the test and have the clearest correlation between AE and oscilloscope since damage events are not occurring at the same time. The AE sensor struck the oscilloscope sensor at times of approximately 0.145 and 0.191 seconds. From this the AE and oscilloscope data could be clearly synchronized based on the event that corresponds to 0.145 seconds (the oscilloscope stopped recording data after 0.15 seconds). Note that for these two sensor-to-sensor impact events, the AE sensor struck the oscilloscope sensor flat on its face so that there was a very large amplitude peak on AE sensor 3, but much lower amplitude on the other AE sensors since the event had to travel through the oscilloscope sensor and the board to those sensors.

Finally, it was evident that the (unfiltered) oscilloscope output was in sync with the up and down oscillation of the board based on the two events described above. In other words, even though the sensor is tuned to higher frequency range than the board movement, it still captured the peaks and valleys of the board oscillation. In addition, the absolute time that an event is recorded on the AE system is only accurate to the millisecond decimal; therefore, the AE sensor time is +/- 0.0005 seconds from that shown in Figure 10. Nevertheless, it is apparent that groups of acoustic activity picked up on the AE system correspond to the periods of upward and downward movement of the board. However, the timing of those groups appear to be nearer to the zero position of the board amplitude (black lines in Figure 13) rather than the peak or valley.
